# ASSESSMENT OF CAUSE OF ROAD PAVEMENT FAILURE ALONG TEJI-TULU BOLO ROAD

A Thesis Submitted to the Department of Civil Engineering School of Civil Engineering  
and Architecture

Presented in Partial Fulfillment of the Requirement for the Degree of Master's in Civil  
Engineering (Geotechnical Engineering)

August, 2023  
Adama, Ethiopia

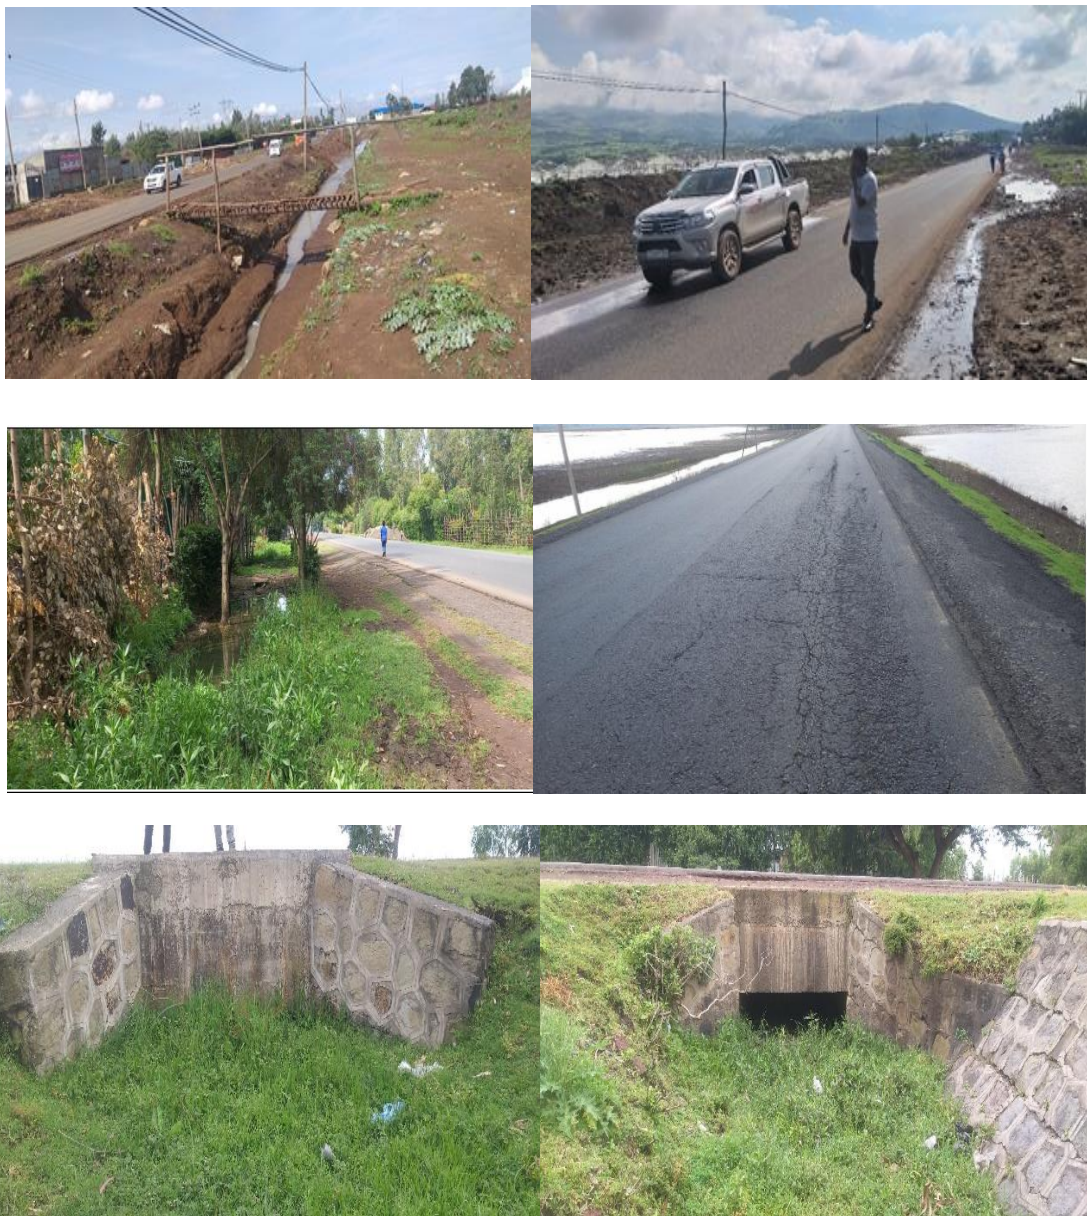
Figure 21: drainage problem along the road stretch

Unless drainages measures are taken, there is moisture migration towards the road due to very flat terrain and flood plain of the road alignment in this stretch. Drainage structure was not installed sufficiently and the available one was damaged by siltation.

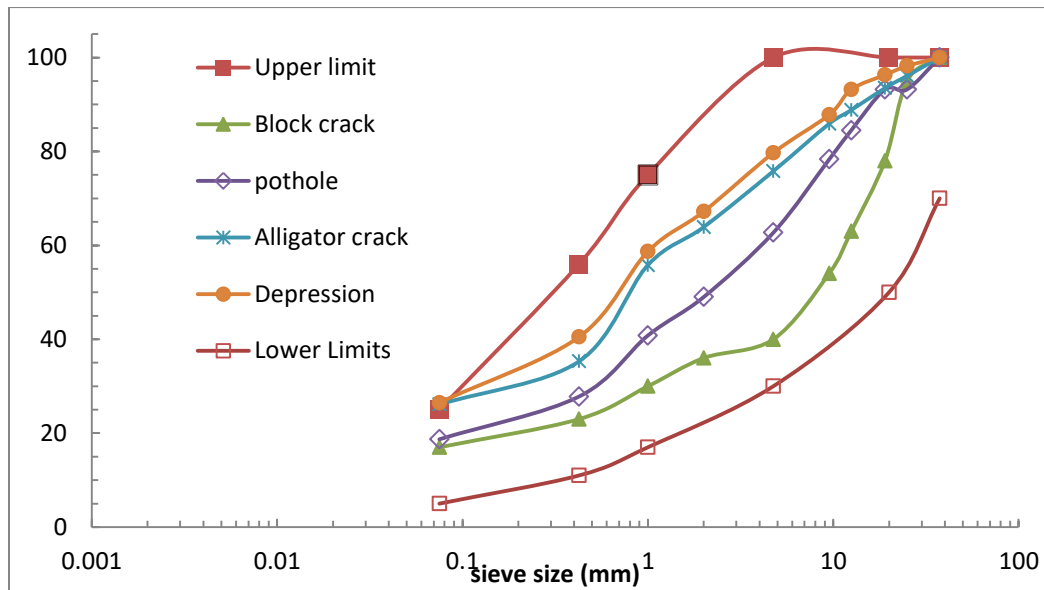
Figure 22: Section A Grain size distribution of Sub Base layer

In the whole stretch of Teji-Tulu Bolo road segments, the brown granular Reddish scoria blended with grayish gravelly sand material was used as a sub-base material. Based on ERA, Ethiopian roads authority 2013 Standard Technical Specification and Method of Measurement, the grading envelop for natural gravel sub base was used which is given in Table 1. When considering the gradation test results for sub base material at all three sections, the percentage passing for all sieve sizes are fully within the range of specifications based on ERA grading requirement. This indicates that the materials were well graded and this can insure the sub base at this section was compacted readily to form stable and firm layer which have good bearing capacity and shearing resistance.

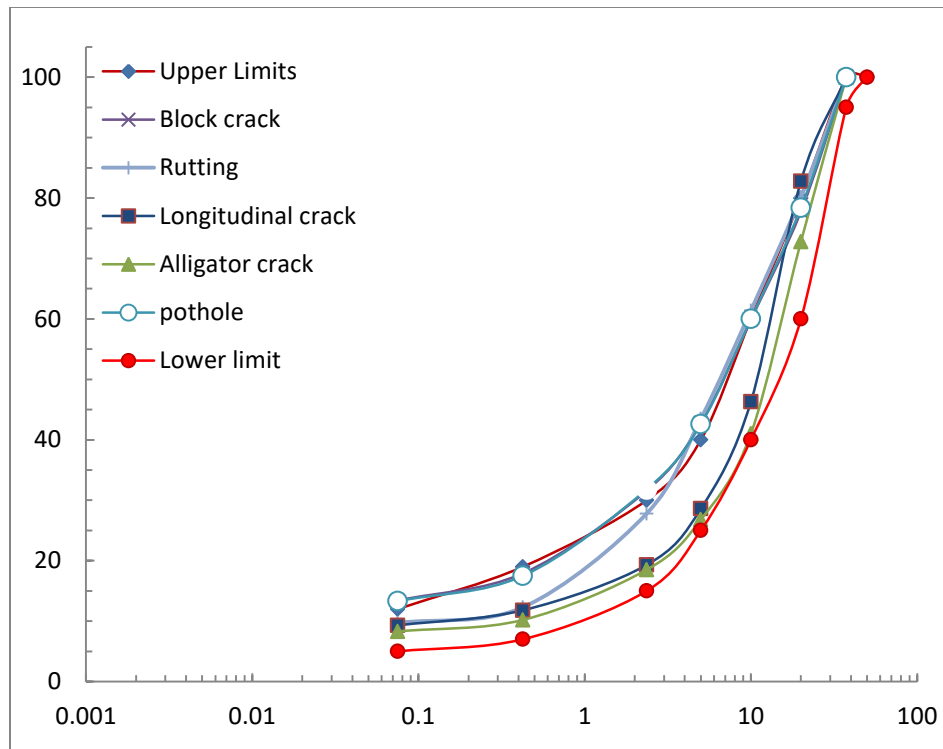
Figure 27: Section C Grain size distribution of Base Course layer

The base course layer at every section of this segment was constructed with base course material obtained from crushed basaltic rock. Therefore the laboratory test results for gradation is compared with gradation envelop of crushed rock. The results showed that from all the three sections only C sections was within the limit. On the contrary gradation curve of section A alligator crack shows the material is finer than expected since it occurs above the upper limits curve and gradation curve of section B transverse crack shows the material is courser than expected since it occurs below the lower limits curve and this implies base course material at this two spot is poorly graded.

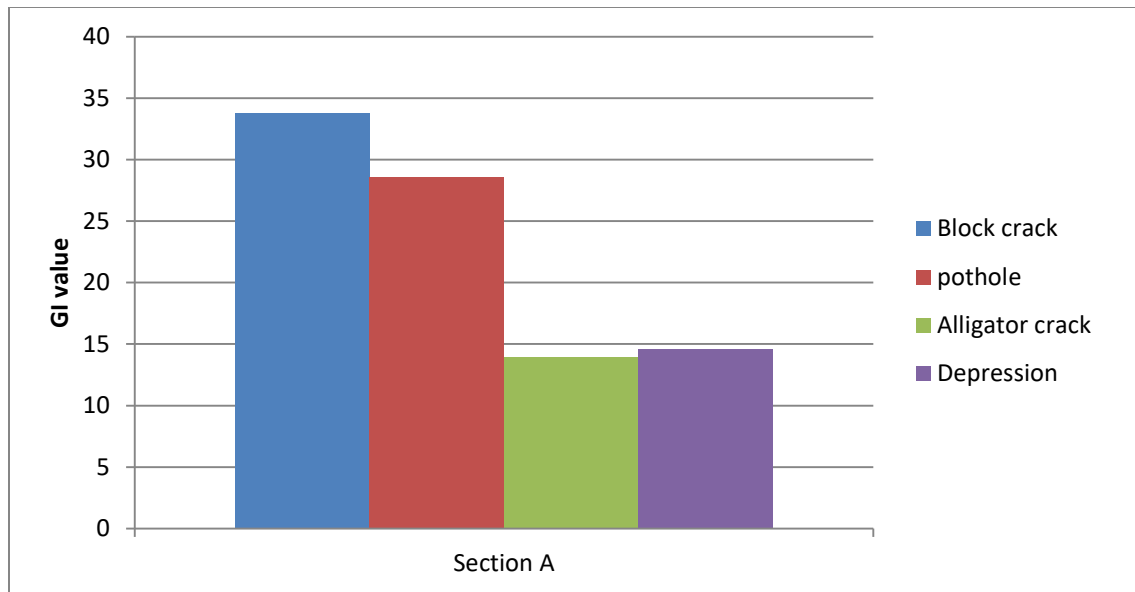
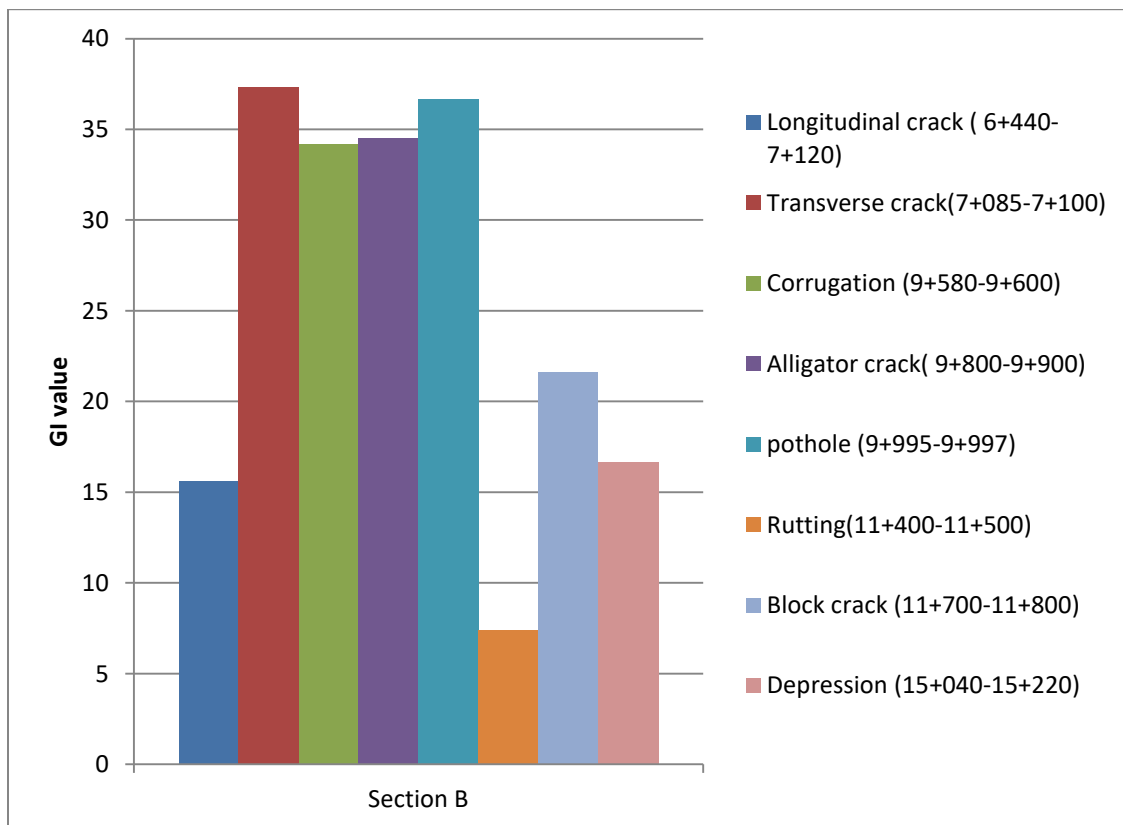
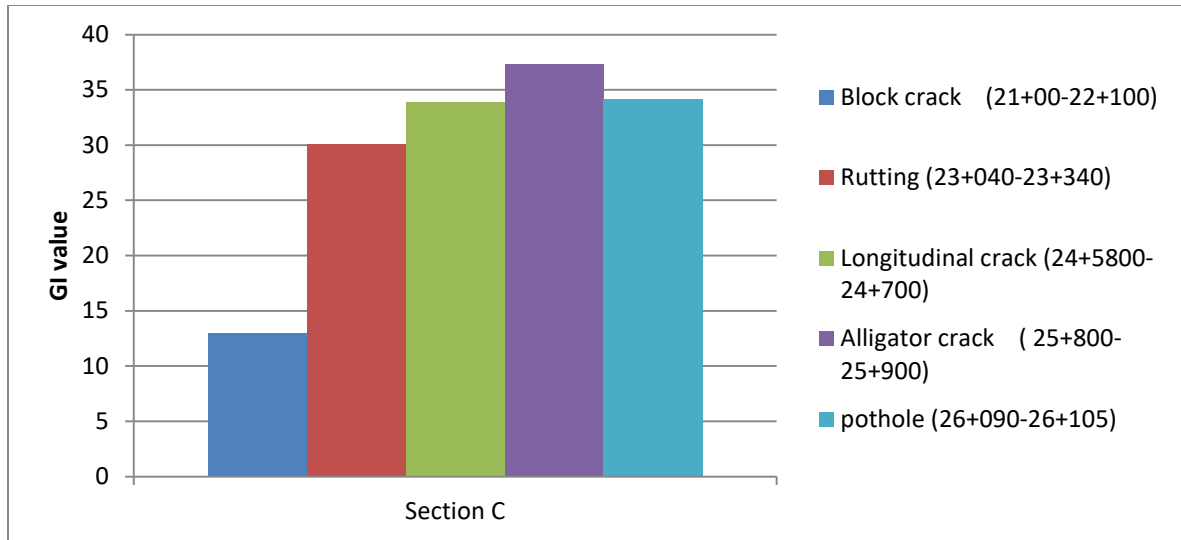
In order to check suitability of road bed material as subgrade of the road I have calculated the group index of each sample and the result were showed on Figure 31, 32 and 33.

A group index of zero indicate good subgrade soil, on the other hand a group index of 20 or above shows very poor subgrade soil. Depending on this my finding shows that the native subgrade soil of teji-tulubolo road segment is very poor subgrade with GI value ranges from 8 to 40 and most of the samples have GI value greater than 20.
