EVALUATION OF EXISTING WATER CONVEYANCE, STORAGE AND  
CONTROL STRUCTURES: A CASE OF AMIBARA IRRIGATION SCHEME,  
ETHIOPIA

Wondafrash Wondmagegn Meshesha

A Thesis Submitted to

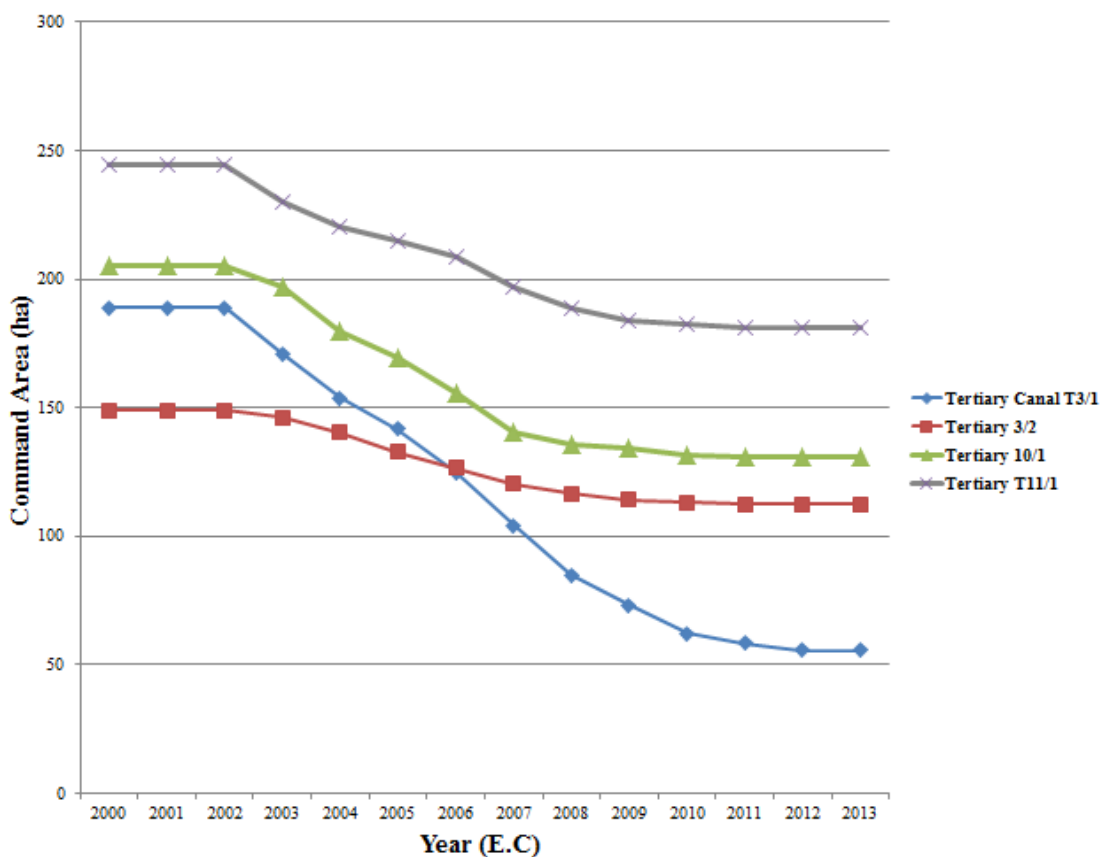
Figure 4.1: Command Area Reduction

From households' questionnaire, field assessment and interviews, it was found that surface flooding regularly affected part of the command area causing yields to be depressed and land to be left uncultivated. Thirteen years command area data collected from Middle Awash Agricultural Enterprise, indicated that command area was reduced from one year to another due surface flooding, shallow ground water and salinity problems. Some of command areas with significant reduction were shown in figure 5 below. From the graph, the command areas irrigated through tertiary canals 10/1 and 3/2 remained constant after the year 2007 while tertiary 3/1 continued in decreasing command area up to the 2012. It was observed that T3/1 was near the Awash River where the river escaped from its course and flowing near the dyke. This situation caused the rise in ground water table and salinization of the area gradually increased.

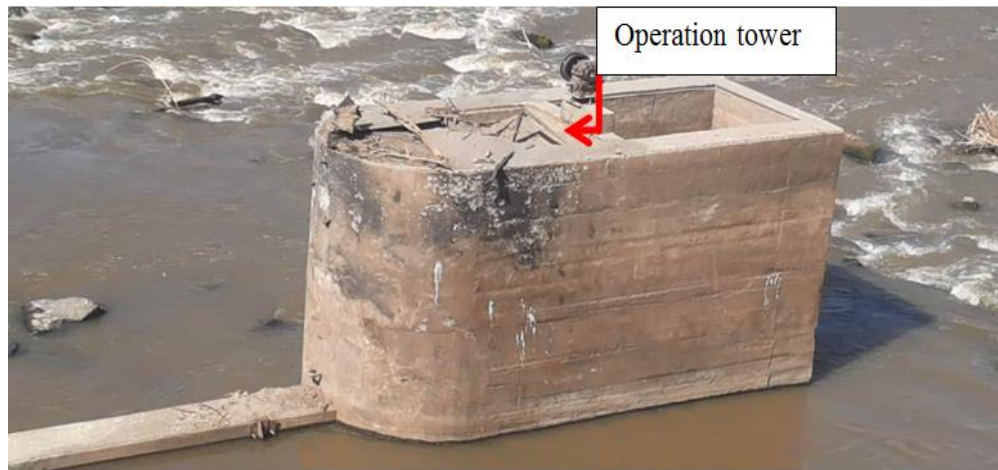
Figure 4.2: Current condition of scouring sluice

Therefore, the condition assessment in general indicated that the headwork faced multiple problems which can collapse the scheme at any an expected time. No structures, the weir, the intake, the scour sluice and the head regulators were in a condition of delivering their duties in appropriate way.

The analysis results of the headwork generally indicated that, the overall condition of the intake structure and the scour sluice fall under very poor condition with priority index of 180 whereas the weir and the head regulator were found to be under poor condition with priority index value of 75 and 120 respectively.

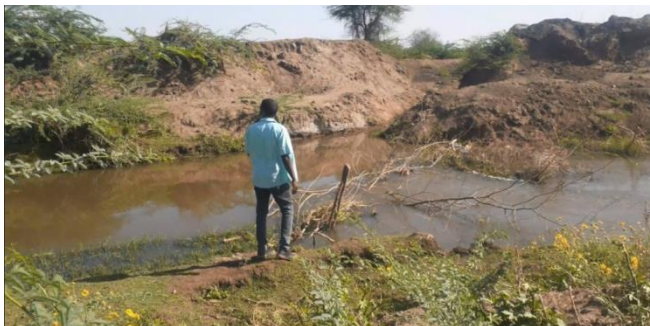
Figure 4.3: Illegal Diversion from main canal (reach CD1-CD2)

There is no formal institution taking the responsibility of operation and maintenance of the scheme. Consequently, there is no regular maintenance of all structures including the main canal. During the investigation, the main canal was found with dense weeds of *prosopis juliflora* on its left and right banks and partially filled with sediment load. The canal was blocked illegally at a number of spots by debris, sand bags and other materials.

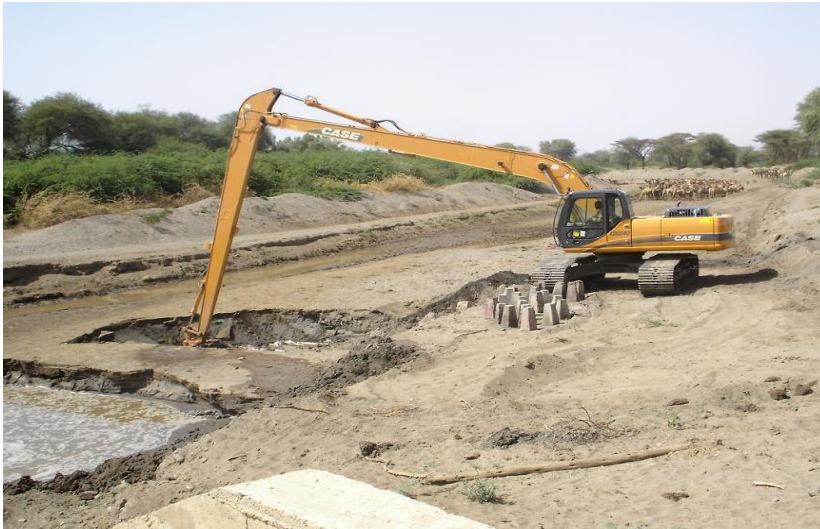
Figure 4.4: Current condition of main canal before disilting

The operation staffs and farmers reported that the main canal repeatedly filled with sediment and no proper disilting work executed. Sometimes some of irrigation users with relatively large irrigation command area tried to maintain the canal by themselves just in front of their farm. This operation hadn't solved the problem because of inconsistent canal bed slope. As a result the canal reach that had been by the users immediately filled with silt load after delivery of irrigation water.

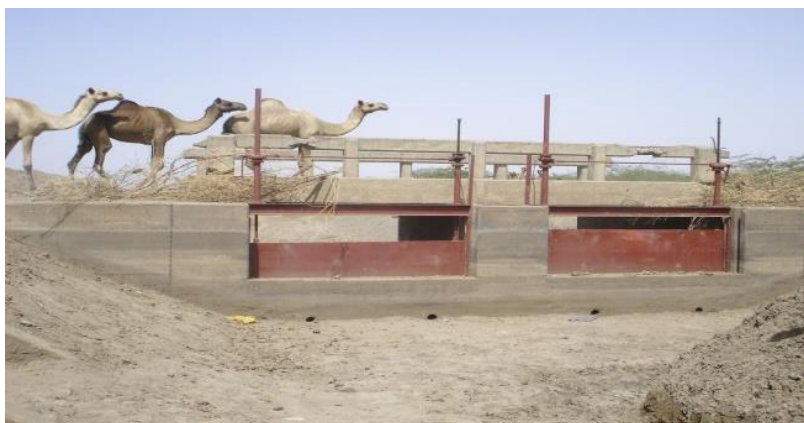
Figure 4.5: Current condition of CD <sub>3</sub>

The gated cross regulators across the main canal are six in number. During the investigation, it was observed that almost all the gates are not functioning; they are difficult to open or close. The reading gauges are distorted or missed whereas downstream aprons are damaged. The concrete structures are almost in good condition with minor maintenance demand. All the gates should be dismantled and replaced by new ones.

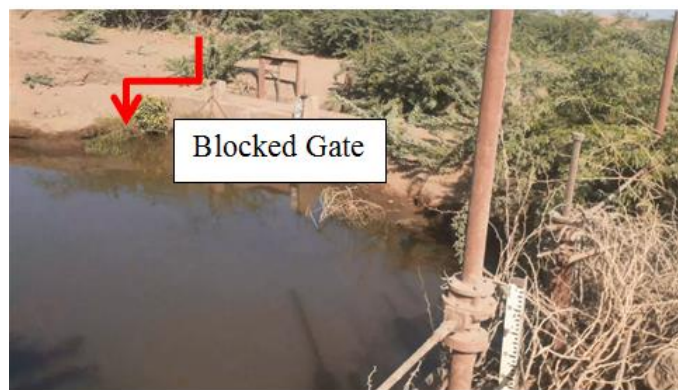
Figure 4.6: Current condition of gated offtake 2 (PO<sub>2</sub>)

The main problems observed on the gated offtakes were the difficulty to open and close the gates, corrosion of the gates, and blockage of intakes by sediment load and debris. The reinforced concrete structures are more or less in good condition.
