Assessment and Characterization of Road Embankment Failure

Along Bako-Shanbu Road Project

A Thesis Submitted to the department of civil Engineering

Adama Science and Technology University

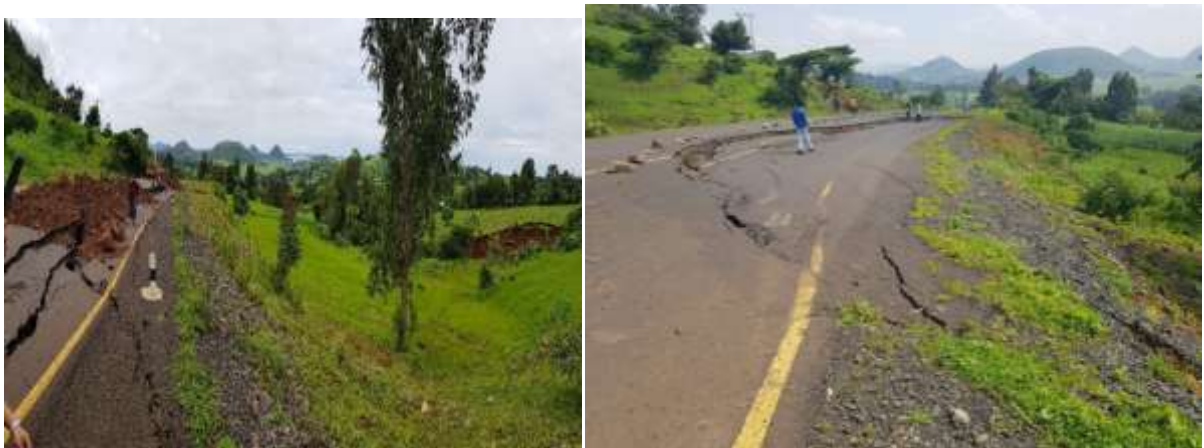
Figure 3.3: The typical rotational embankment failure at Site-1(Reference Author)

The failure is a typical circular embankment failure (Km 94+150-94+220) that is associated with toe erosion and saturation by the near river found in LHS within old landslide zone. The embankment failure caused back slope slump and tension cracks in the RHS with nearly equivalent slip and displacement indicating the direct response of the embankment failure. The erosive river coming from the RHS mountainous section crosses the road with slab culvert at Km 94+300. It is causing intensive erosion starting from the outlet and already removed the protection masonry wall at the outlet and keeps aggressively eroding both river banks as shown in the photo below. The river bank is constituted by in the thick residual soil, representing the sub grade nature of the failure section. There are minor surface flows from mountainous section as a sheet flow, and creating a water logging in the RHS to saturate the fill; and the more pronounced surface flow is also found at around Km 94+220 causing water logging in the RHS to saturate the failed section. The actual failure mass extended to the river side and failed mass width is 40m and extends not far from 50m on average from the detachment (failure) to the river bed with about 10-15m elevation drop to river bed.

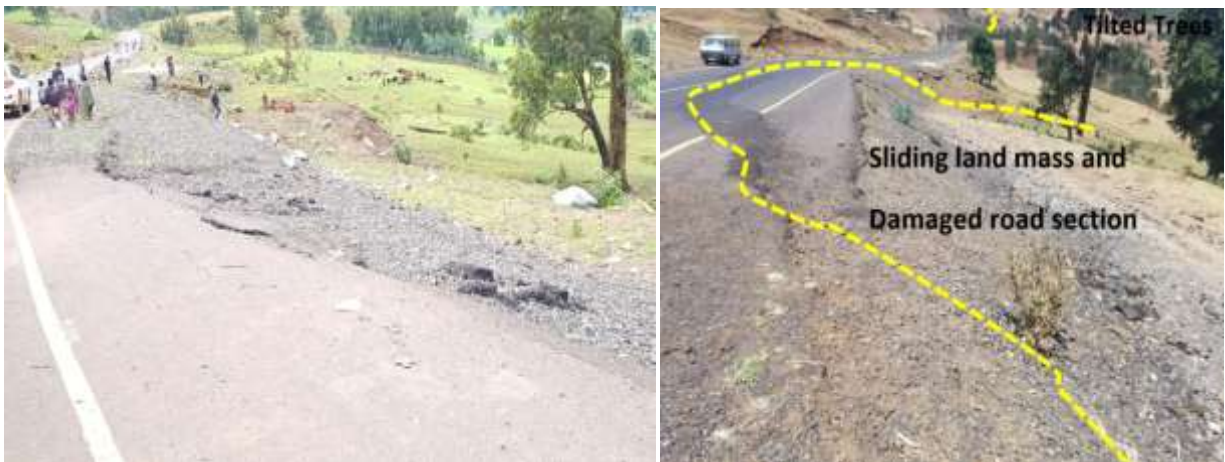
Figure 3.4: The typical rotational embankment failure at Site-3(Reference Author)

This section is affected by a side slope failure, which is associated with typical rotational fill embankment failure, in LHS for about 80m and associated with toe erosion and saturation by the river found in LHS. Furthermore minor pavement distress also noticed between km 97+910 to 97+940 at the sharp curve section that might be related with subgrade saturation. The area is constituted by soft, wet and erodible residual soil and moderately sloping side slope. It is affected by river erosion, which is also fed by the turnout flash from the road ditch. The river caused huge riverbank mass movement that is triggered by its intensive erosive nature to that of the soil's erodibility. The river action further caused the embankment failure which is founded on the weak formation where regular saturation is common. The failure is bounded by river in the west. The road is situated in the lower volcanic that has a thick reddish residual soil formation.

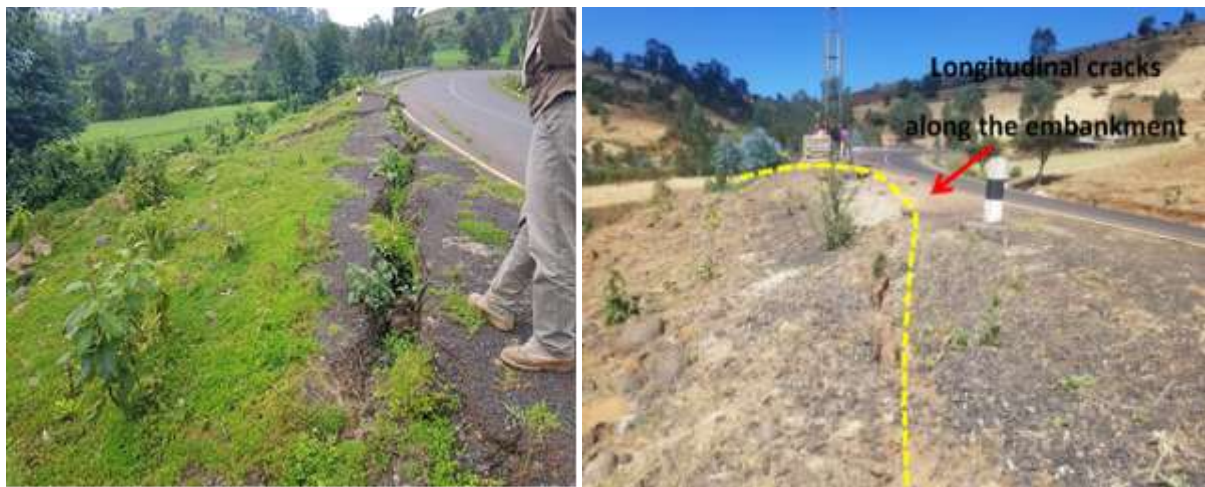
Figure 3.5: The typical rotational embankment failure at Site-5(Reference Author)

The erosive river runs parallel to the side of the road in the RHS and get closer only in the failed section with about 80m. It is causing intensive erosion at the toe and meandering. The actual embankment failure limited in the fill section and the tension cracks in the side slope limited to 10-15m. The moved mass width is 50m and extends not far from 15m on average with about 7-10m elevation drop to the tension cracking ends the embankment is constructed up on the loose, unconsolidated sediments. The RHS of the road is relatively lower elevation and covered with swampy brown soil mixed with gravel, volcanic boulders and clay matrixes. The soil is weak and affected at the base by the erosive river that located west about 80-100m away from the centerline.

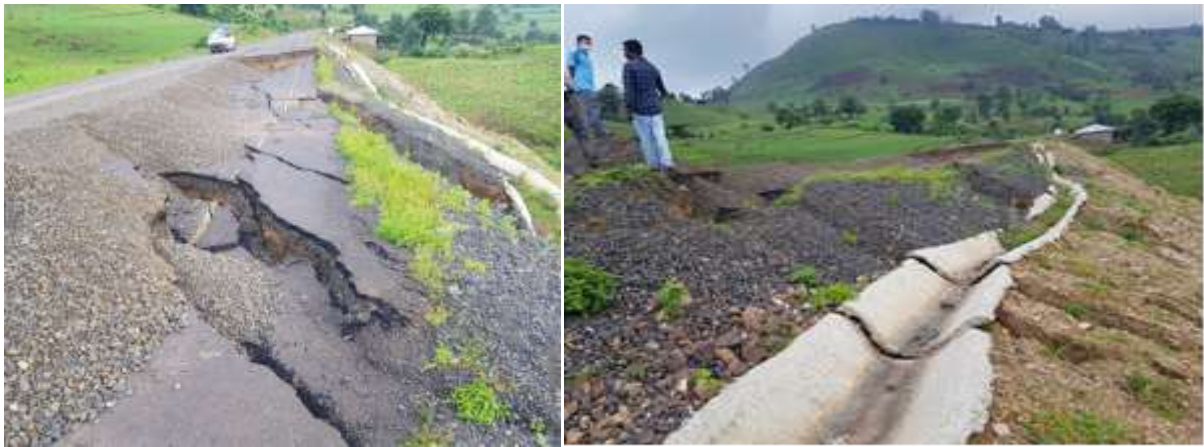
Figure 3.6: The typical rotational embankment failure at Site-6(Reference Author)

The road traverses to SE direction, crossing gently sloping hill within the mountainous section. The LHS is the hill section the dips in gentling sloping (80-150) to the RHS along a side hill. In this section, the road is an embankment fill section with a fill height of about 4.0m and 1.5H: 1V side slope ration. The reconstruction also included an infiltration gallery constructed in the LHS to a depth 4.0m below the subgrade level to intercept and guide the subsurface flow to drain in the pipe culvert at 99+910. In addition, masonry retaining wall constructed on RHS with a total height of 4.2m with only 1m extending above the surface and placed on 1.0m rock fill at RHS and founded at 3.3m below the OGL. The embankment material rested on rock-fill of 1m below the OGL with a minimum of 3% slope. Geotextile also placed on top of the rock-fill before the placement of embankment/fill material.

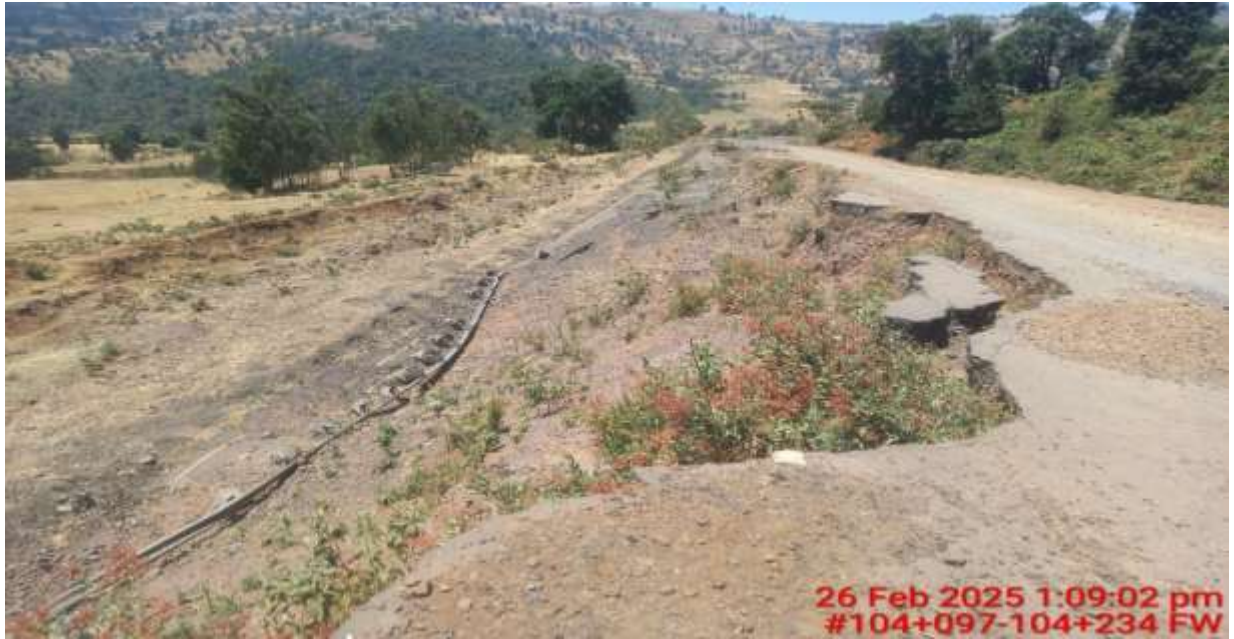
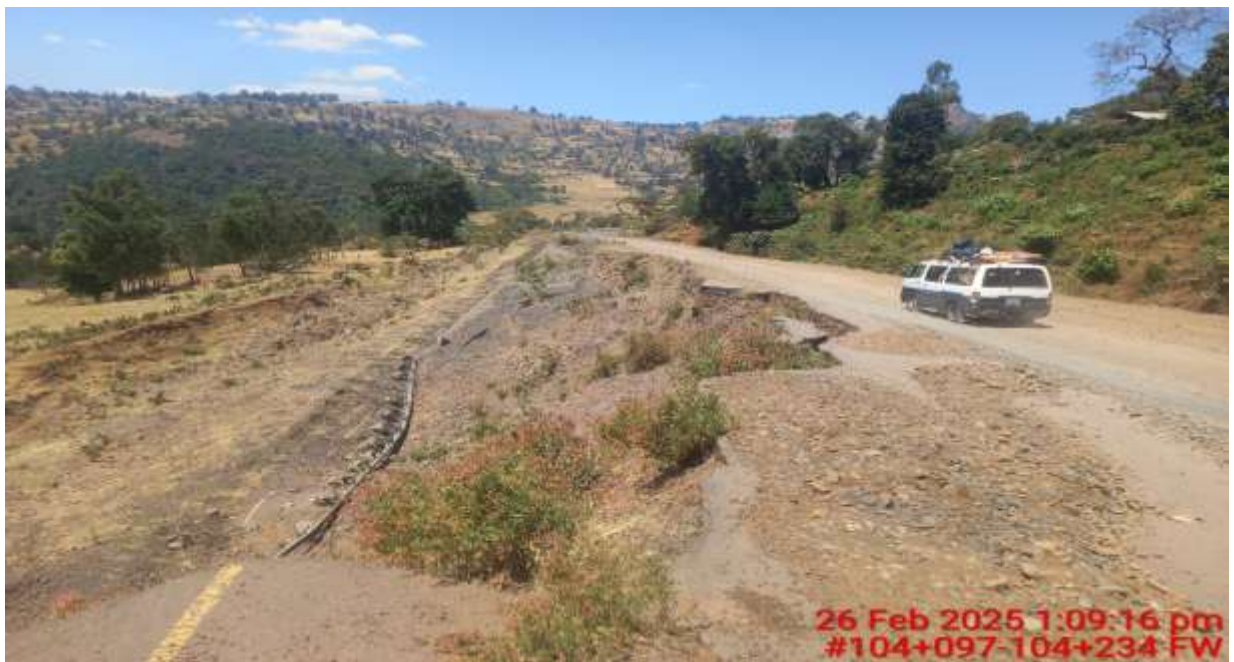
Figure 3.7: The typical rotational embankment failed at Site-7(Reference Author)

The road traverses to SE direction, crossing gently sloping hill within the mountainous section. The LHS is the hill section the dips in gentling sloping (80-150) to the RHS along a side hill. In this section, the road is an embankment fill section with a fill height of about 4.0m and 1.5H: 1V side slope ration. The reconstruction also included an infiltration gallery constructed in the LHS to a depth 4.0m below the sub grade level to intercept and guide the subsurface flow to drain in the pipe culvert at 99+910. In addition, masonry retaining wall constructed on RHS with a total height of 4.2m with only 1m extending above the surface and placed on 1.0m rock fill at RHS and founded at 3.3m below the OGL. The embankment material rested on rock-fill of 1m below the OGL with a minimum of 3% slope. Geotextile also placed on top of the rock-fill before the placement of embankment/fill material.

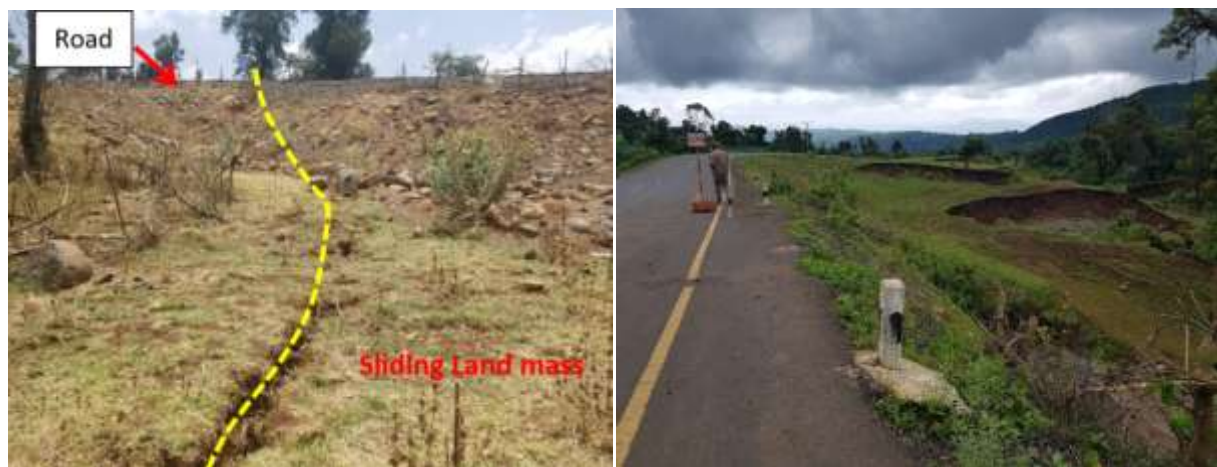
Figure 3.9: The pavement and embankment failures in Site-9(Reference Author)

Pavement failures are triggered by saturation related to the crossing and meandering river and as its cause's spills in the flood plain and also water logging to crate swampy sections.

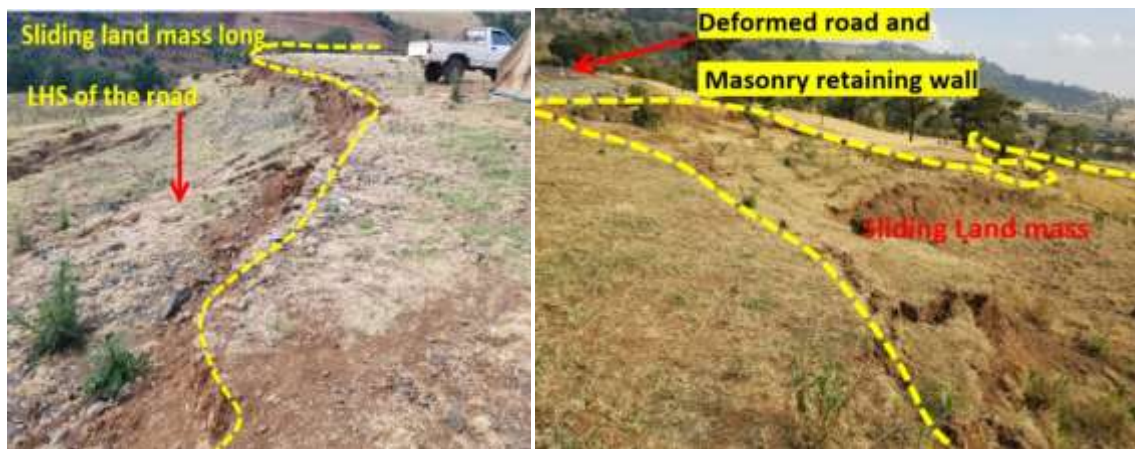
Figure 3.10 side slopes failures at Site-11(Reference Author)

On the RHS of the road section observed serious of sliding following the direction of the river and turns back to the LHS after crossing at Km 106+780. The big river then caused serious erosion and saturation again in the LHS side which is loaded by the huge spoil pile, and caused major landslide in the LHS. The actual failure mass width in the LHS extended to the river side for about 230m and then it extends again about 100m. Within this river section observed also river bank collapse in many section. Pavement deformations and failures triggered by saturation from the shallow groundwater, rainfall and bank erosion due to the meandering river across and along the carriage way. It is bounded by streams in both sides of the road.
