A Project Submitted in partial fulfillment of the requirement for the  
Degree master of Engineering in construction technology and  
management.

An assessment of building defect the case : of National meteorological Agency  
head office Building .

*An assessment of Building defect: the case of the National meteorological Agency HQ Building*

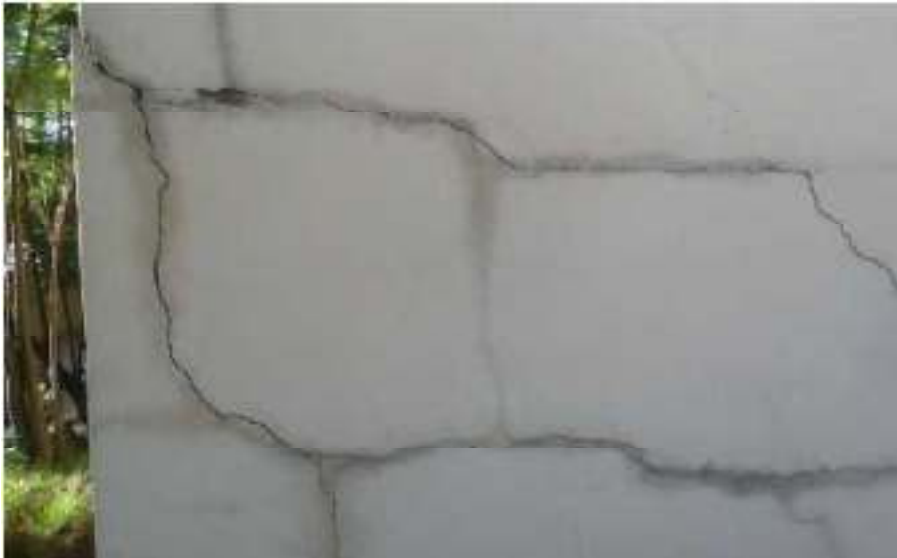
Figure 1. Wall crack on Block 2, Right wing

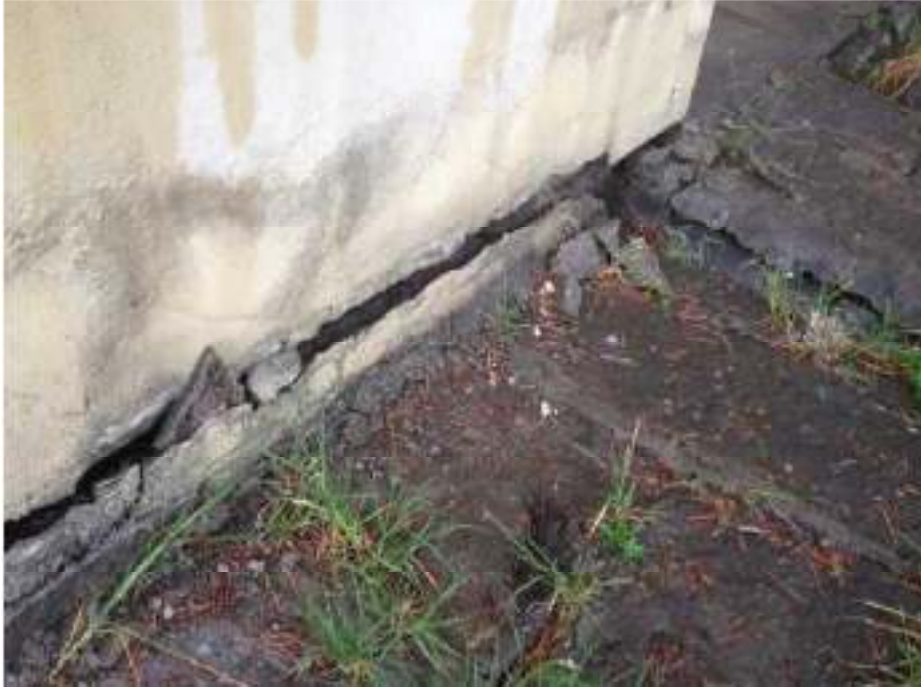
Figure 2. Separation of super structure with the peripheral masonry and Walkway on Block 2, left wing

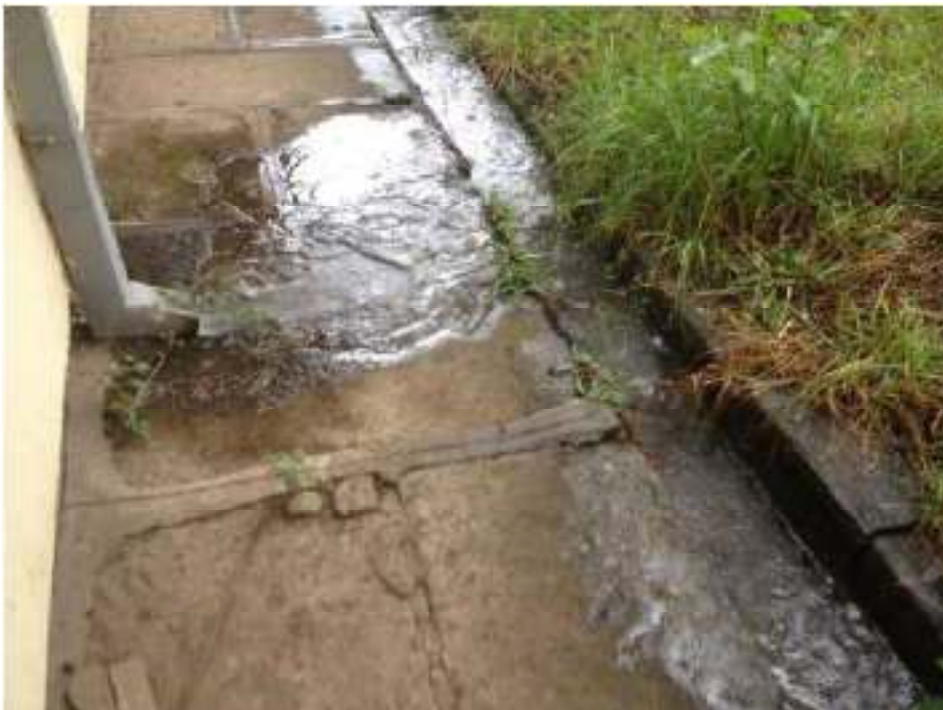
Figure3. Percolation of rainwater from down pipe through separation of Walkway and non-functional side ditch to underneath of the building on

Block 2, right wing

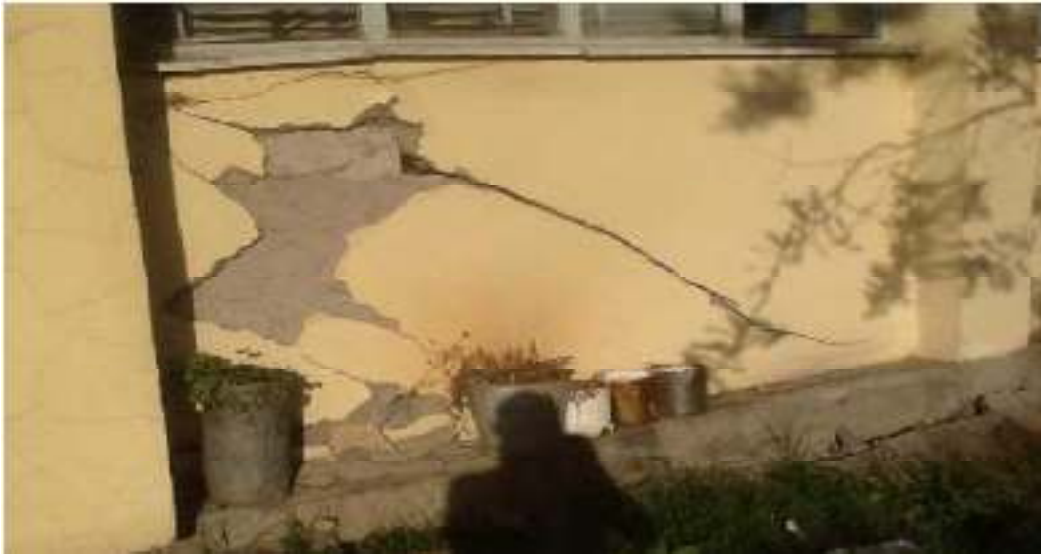
Figure 4. Severe wall crack and failure on Block 3, right wing

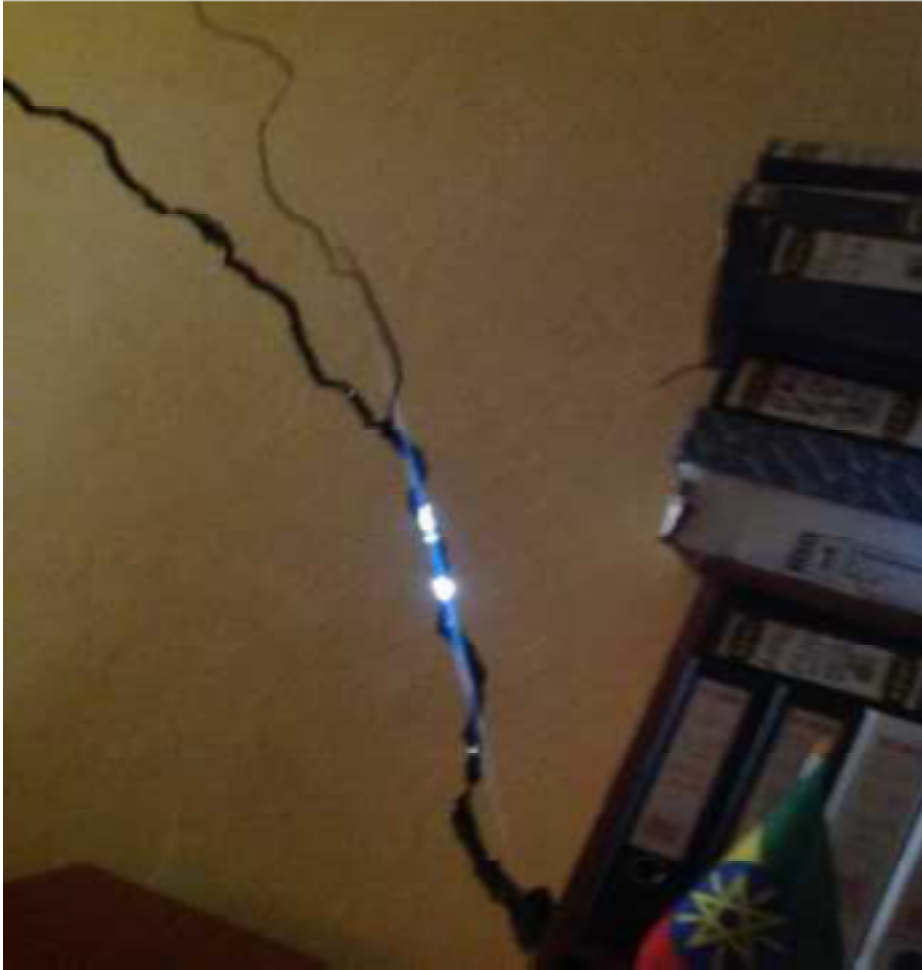
Figure 5. Severe wall crack and failure

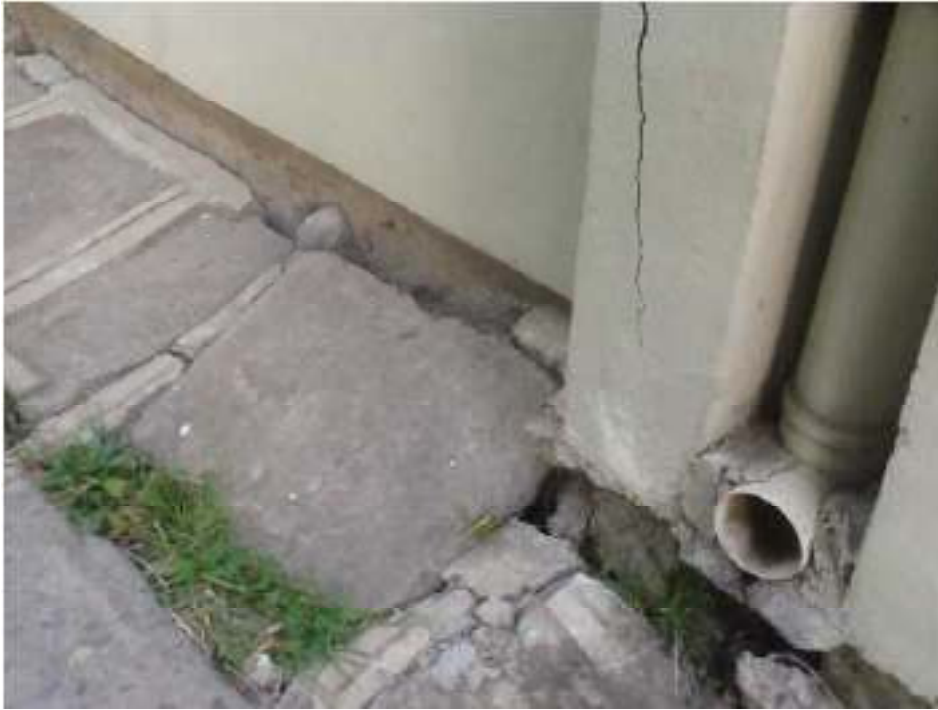
Figure 6. Separation of structure and walkway on Block 4

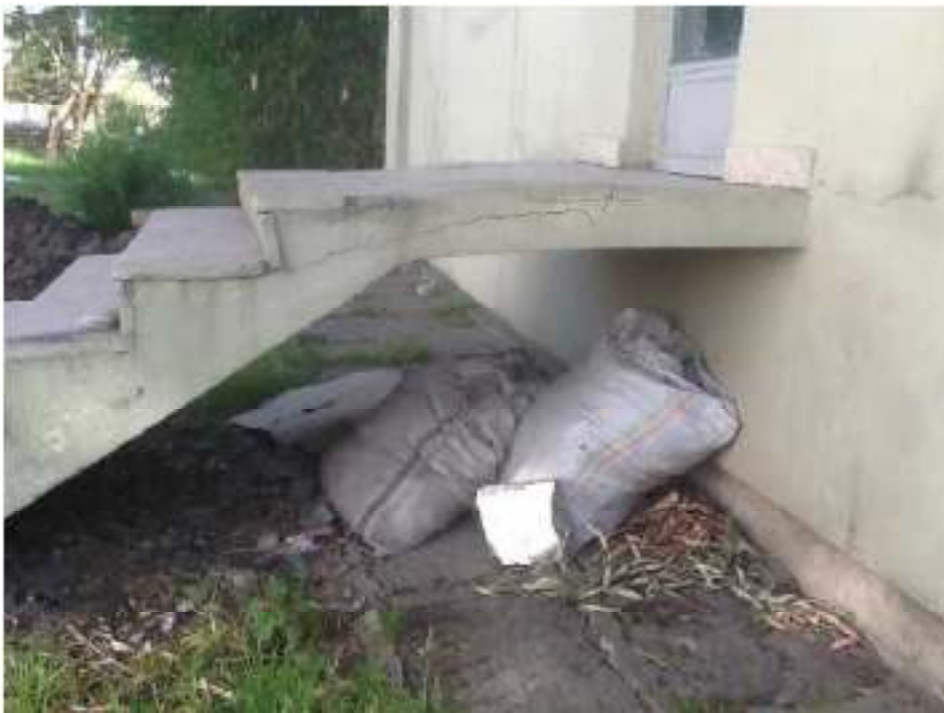
Figure 7. Bending of external stair case on Block 4

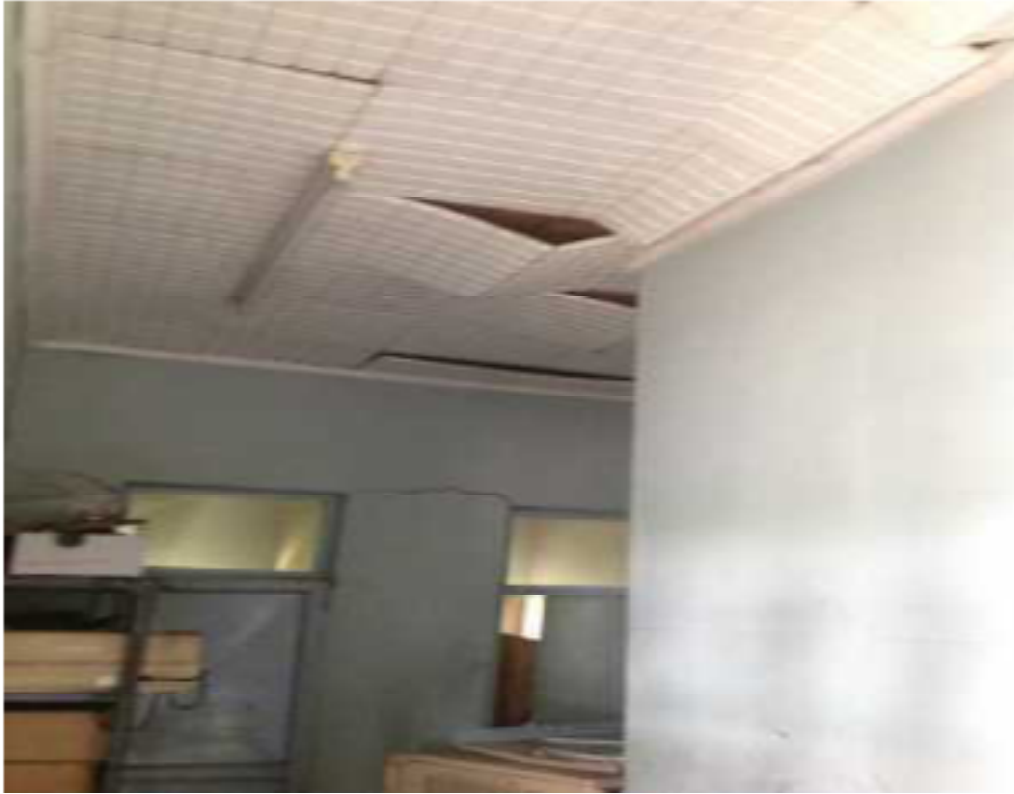
Figure 8. Bending of Ceiling Block -4

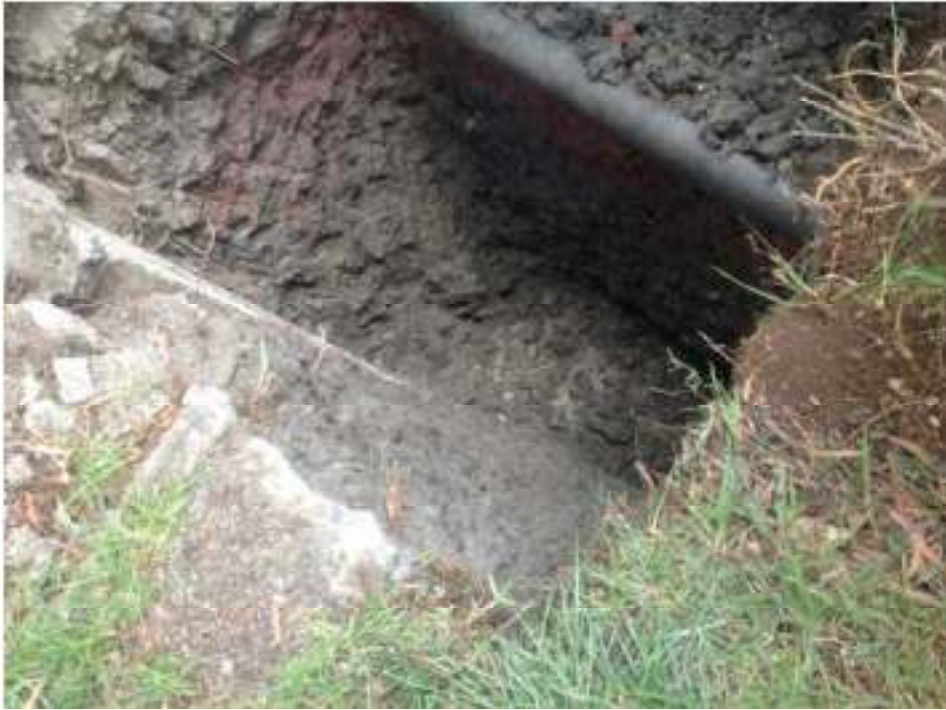
Figure 9. No selected material is found around the footing

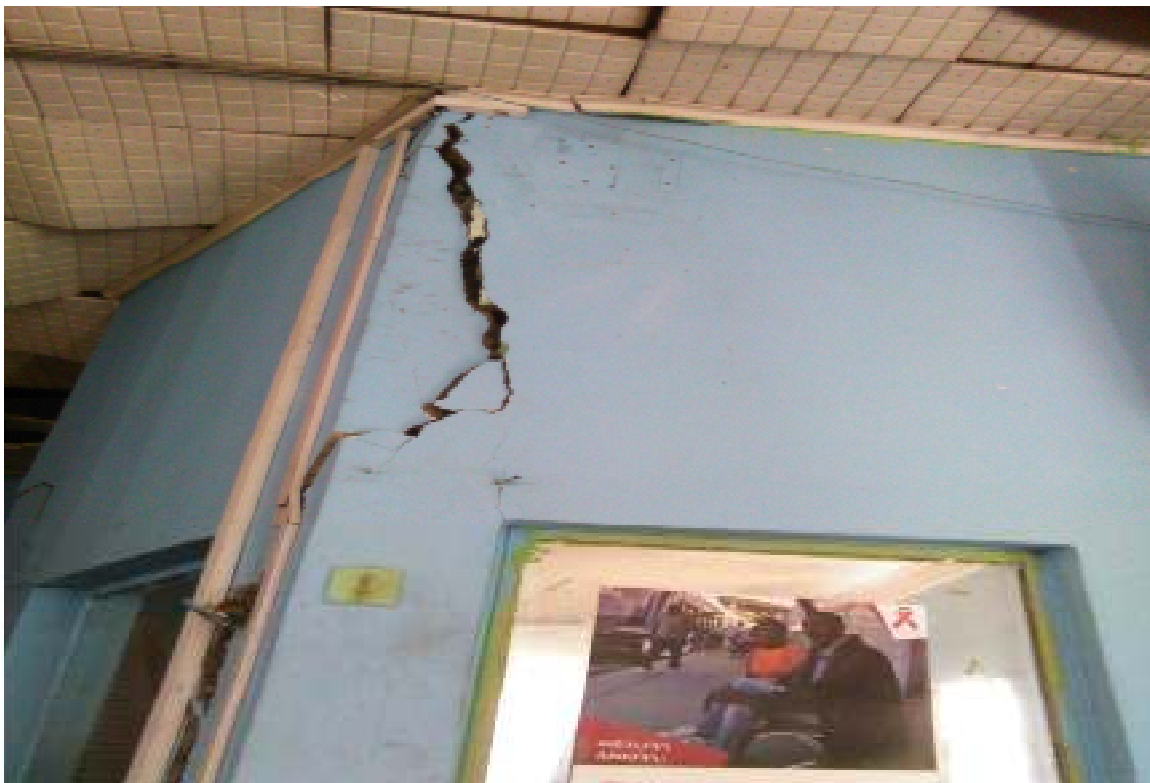
Figure10.Seriouswall crack on multi –purpose hall block -4

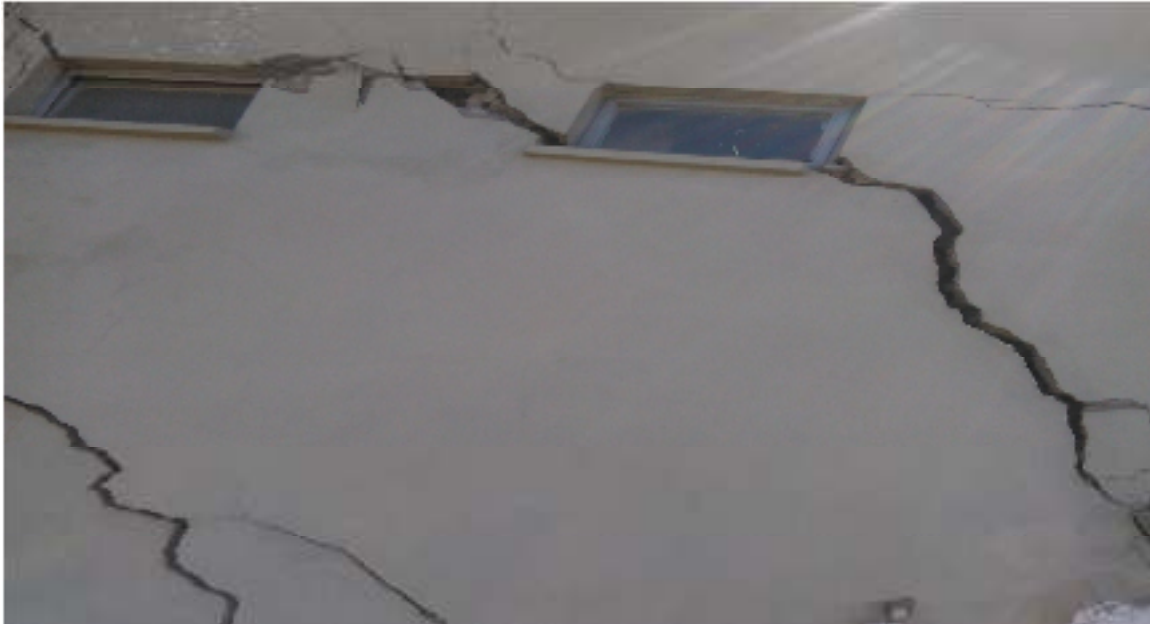
Figure11.Serious wall crack around window on multi –purpose hall

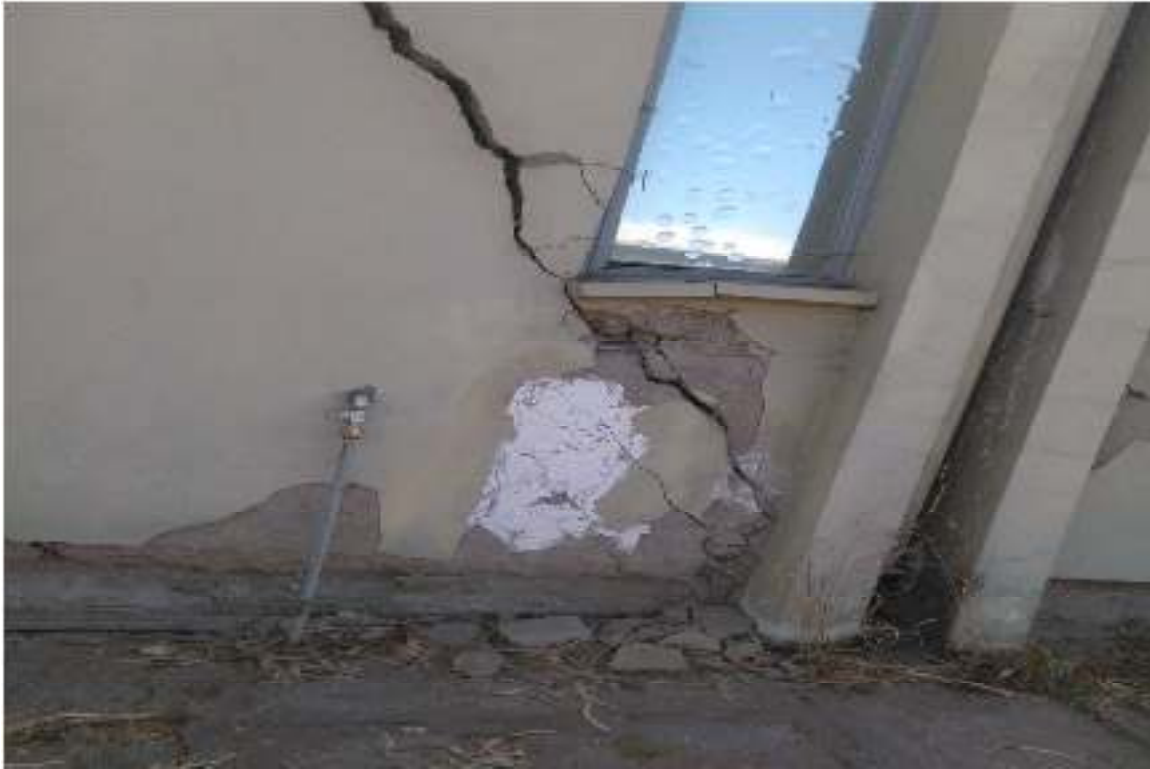
Figure 12. Serious wall crack and separation of beam to foundation masonry on multi –purpose hall

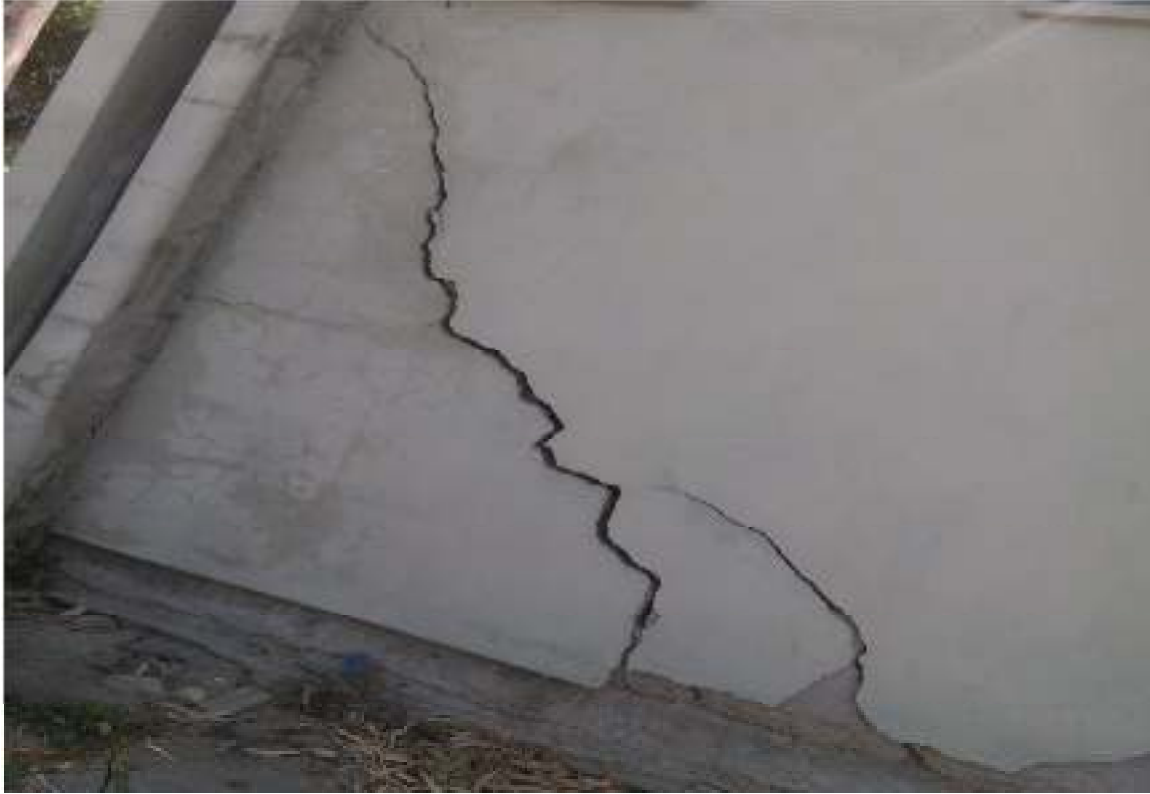
Figure 13. Serious wall crack and separation of beam to foundation masonry on multi –purpose hall

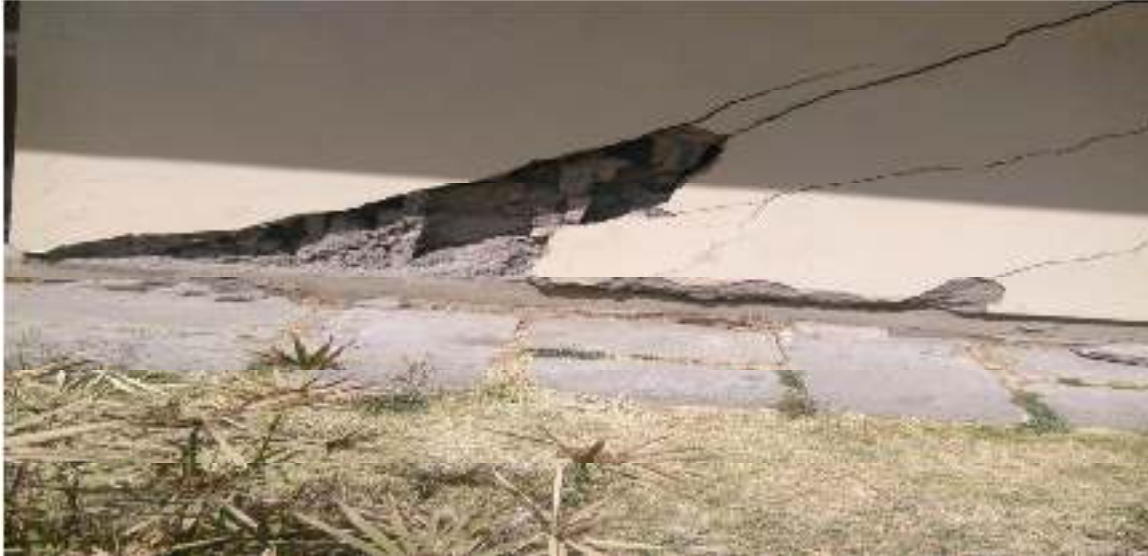
Figure 14. Serious wall crack and separation of beam to foundation masonry block-3
