**Engineering Geological Investigation of Katar Dam  
Foundation and Abutment Slope Stability Analysis, Arsi  
Zone, Oromia, Ethiopia**

A Thesis Submitted to the Department of Applied Geology

Adama Science and Technology University

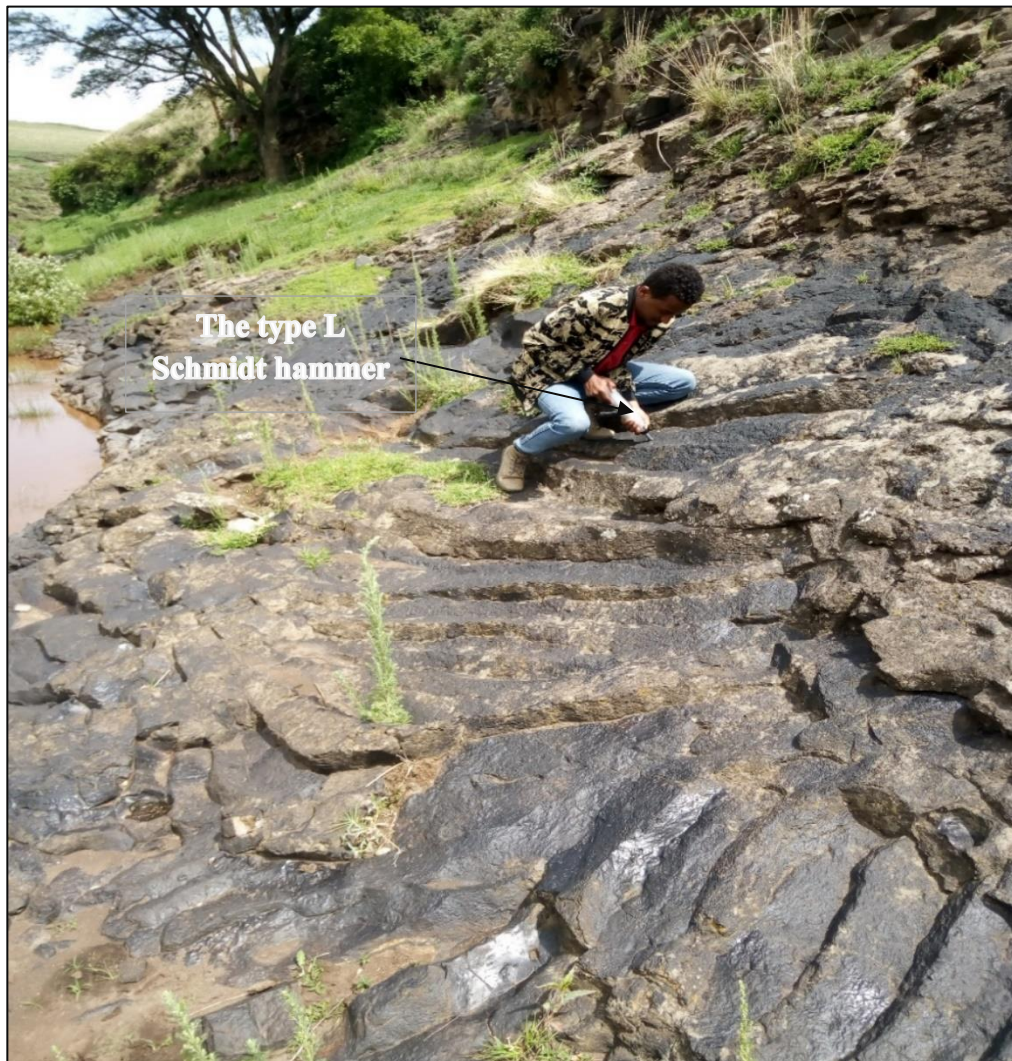
constant pressure on the rock during testing is crucial to obtain consistent results as shown in the figure below (Figure 3.1).

Figure 3. 1. The type L Schmidt hammer test on the left abutment ignimbrite rock mass.

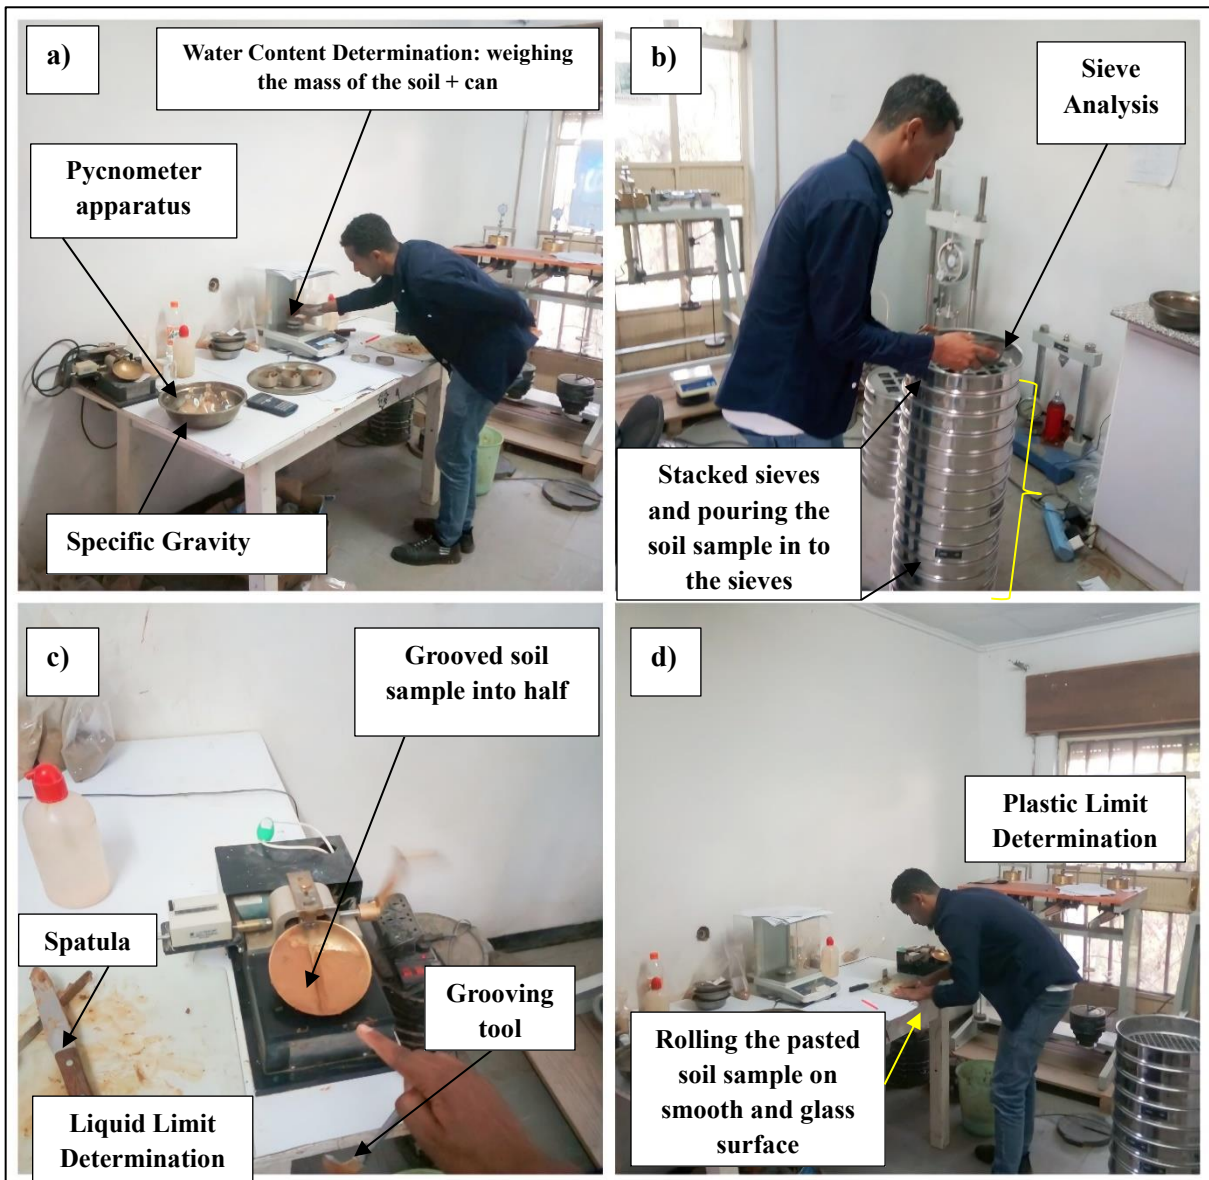
Figure 3. 2. Laboratory Soil Sample Analysis indicating some of the procedures in the tests. a) water content determination and specific gravity, b) grain size analysis, c) liquid limit determination using the Casagrande apparatus, d) plastic limit determination.

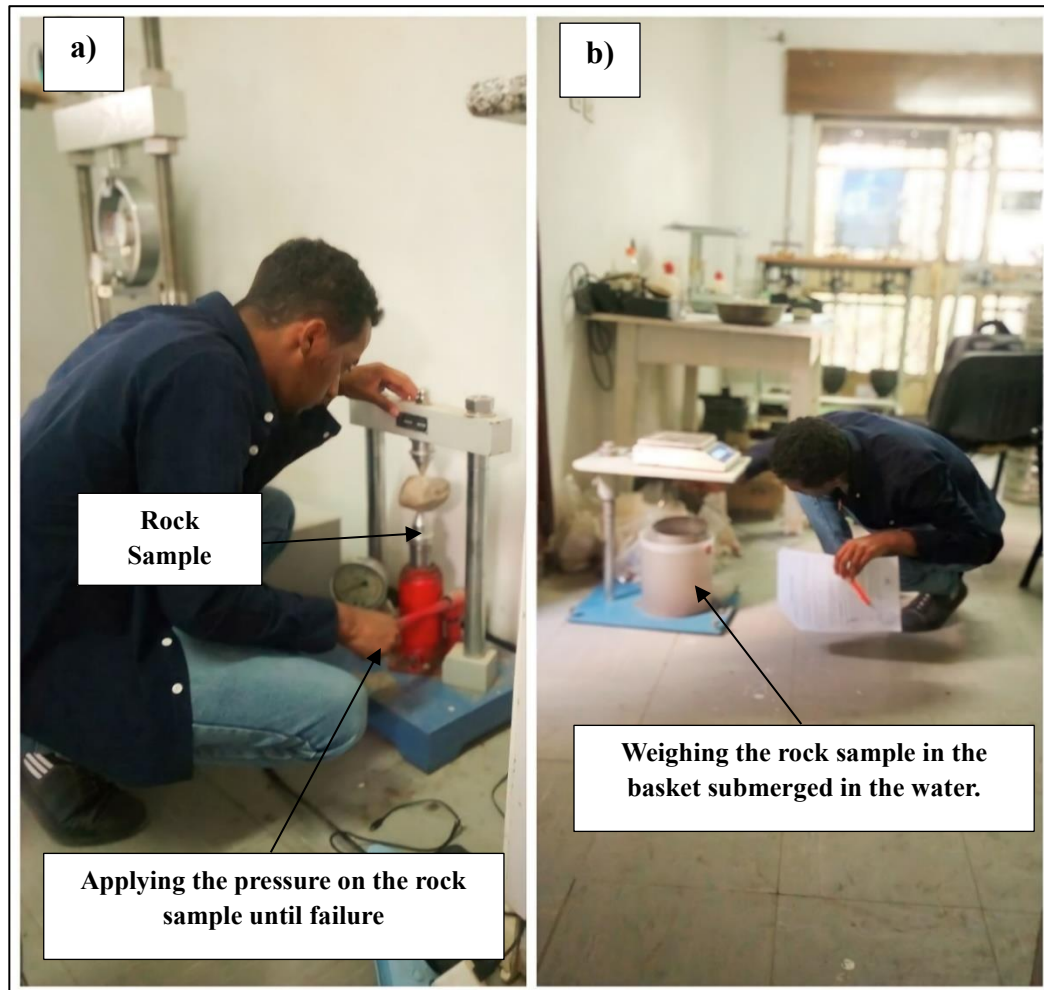
Figure 3. 3. Rock sample analysis in the laboratory. a) point load index test, and b) water absorption determination.

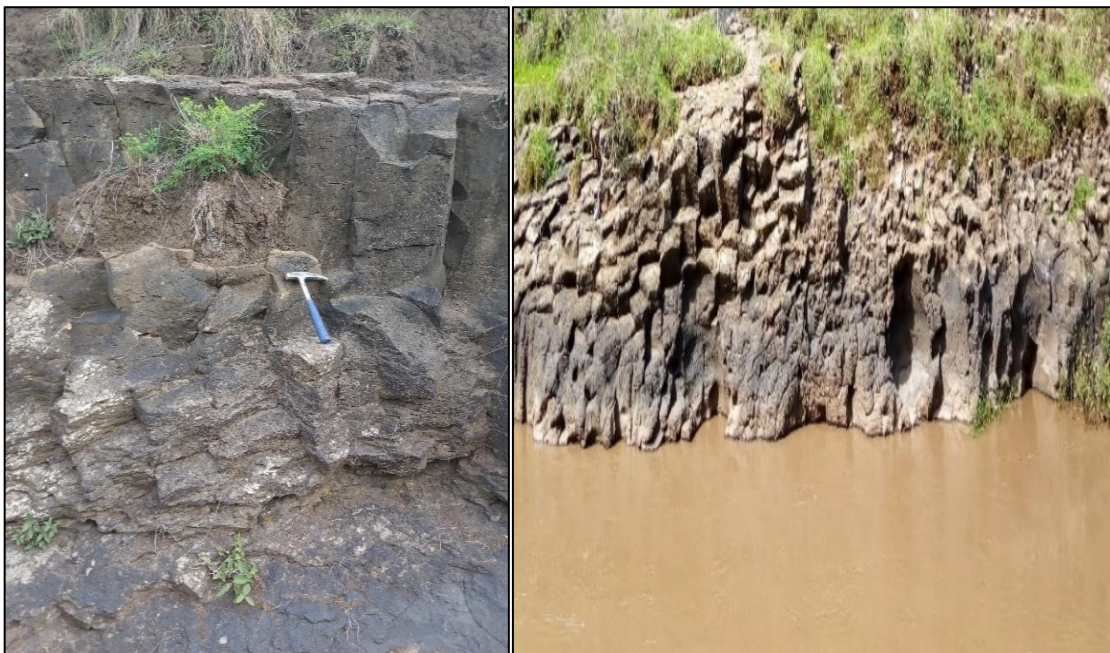
Megascopically, these rocks are well welded/hardened pyroclastic flow rocks made up of crystal (glassy crystals) and rock fragments (medium to coarse sized lithic fragments of rocks of various composition) within dark grey to light green glass sheared groundmass. The ignimbrites mapped in the dam area exhibit welding, giving the ignimbrite the texture of a solid rock mass. Based on field rough estimation the lithic fragments and are irregularly shaped, poorly sorted and of various composition. Compositionally, these rocks are felsic.

Figure 4. 2. Ignimbrite at the katar dam axis.

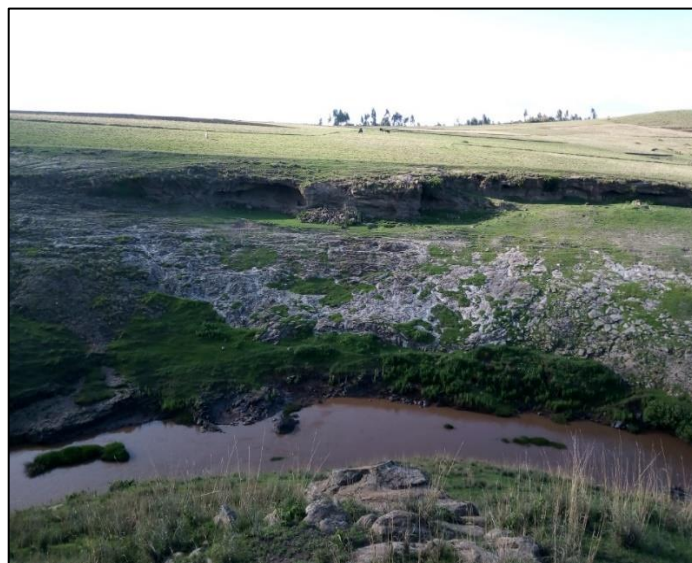
Megascopically, this unit is relatively consolidated to unconsolidated pyroclastic deposit made up of medium to coarse size lithic fragments within voluminous dark green to light yellowish fine groundmass (volcanic ash). The proportion of lithic fragments versus fine groundmass varies laterally/vertically and at places can be rich by lithic fragments. Moreover, the size, shape and composition of lithic fragments and glassy crystals also varies laterally and vertically. Similar to the other formations, irregularly networked erosional surfaces due to selective dissolutions are common. Moreover, to the other units in the area, this unit is also jointed by two sets of systematic, penetrative and tight sub-vertical joints that parallels and transverse the rift system.

Figure 4. 3. Welded tuff of the study area.

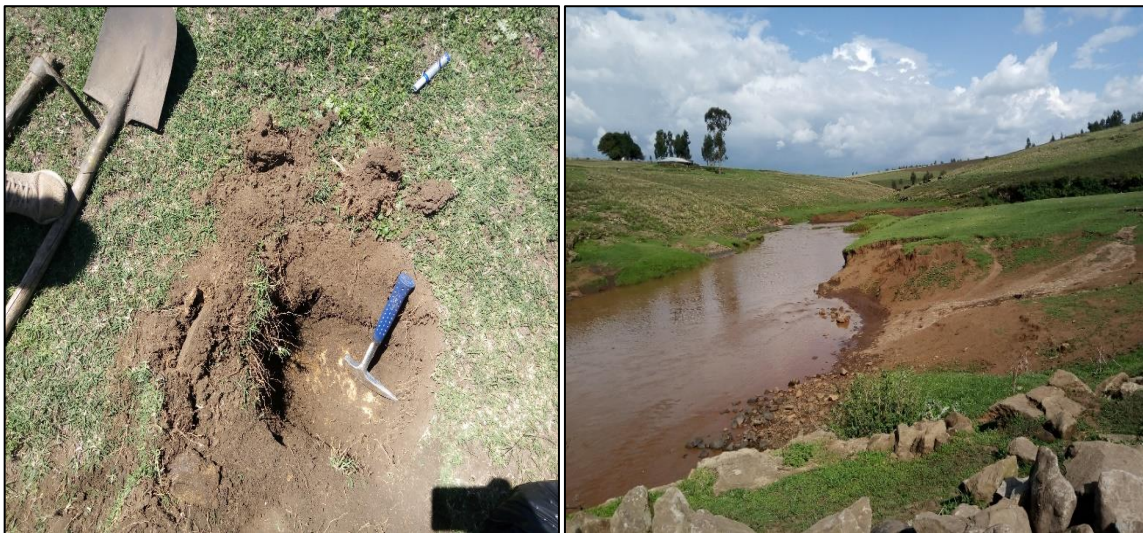
The Quaternary alluvial deposits also occur on local river valley of Katar and Ashebeka junction, in their tributaries and some grabens formed by rift within the main rift around the dam site area. Alluvial soil is typically made up of a variety of materials, including fine particles of silty clay, clayey silt and coarser particles of sand and gravel. It is dark brown in color, moderately plastic, fine grain size clayey silt to round sandy gravel ignimbrite and basaltic rock composition.

Figure 4. 4. Alluvial soil at the study area.

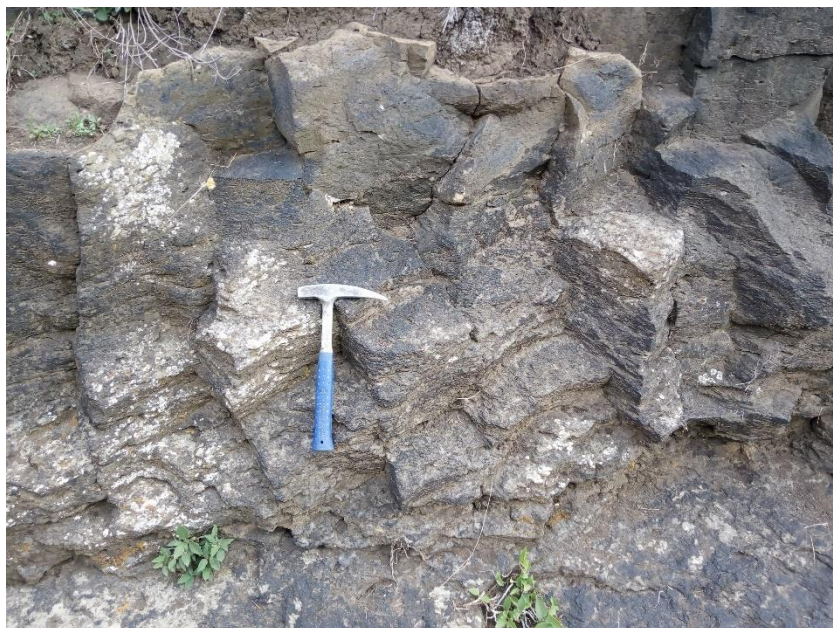
Joints are the dominant geological structures in the study area, which is observed mostly in slightly weathered to moderately weathered pyroclastic rock. There are different joint sets oriented on both abutment side of the dam site. Discontinuity conditions, orientation, spacing, aperture, persistence, type of infill material, and degree of wall weathering were determined in the field.

Figure 4. 5. Joints and their representative description of the dam site (joint sets at the right abutment).
