**ASSESSING THE IMPACTS OF STREET VENDING ON THE PEDESTRIAN  
WALKABILITY-IN THE CASE OF SEBETA TOWN.**

Presented in Partial Fulfillment of the Requirement for Master of Science degree in Urban  
Planning and Design

Adama Science and Technology University

September 2022  
Adama, Ethiopia.

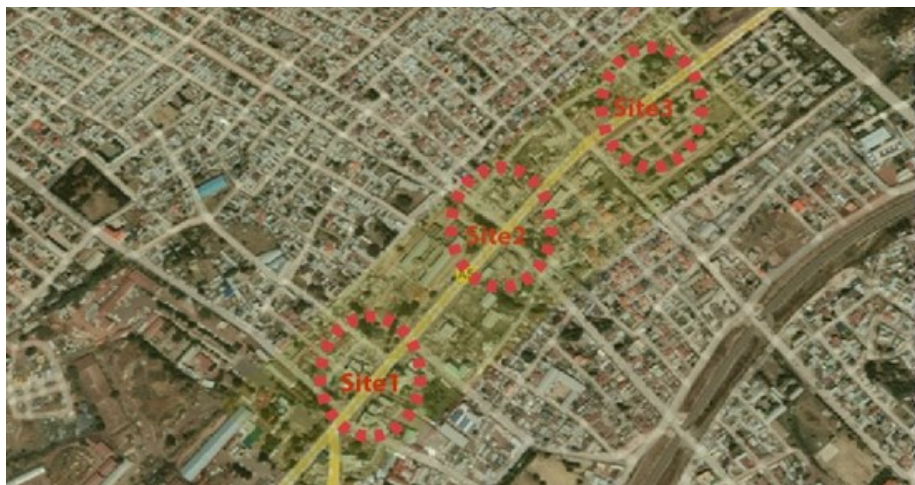
Figure 5:site selected for PLOS

To measure the pedestrian flow, manual counts were carried out based on pedestrians per hour. This is where pedestrians were counted manually along the sidewalks using a tally marking sheet. Manual counting of pedestrians was done at 15-minute intervals because the pedestrian account is effective if it is taken between 10-15 minutes using cordon count. The observation site was carefully chosen to make sure that the prevailing demand was observed. The merits of this approach are that it is flexible and simple to carry out. Pedestrians count within the selected sites based on pedestrian activity from the street was carried out in 3 different sites in 1.6 km within a 400–650-meter range. This count within selected sites from the street was carried out on 5 weekdays and weekends. To identify the space occupied by vendors, vendors' manual counts were carried out based on the sidewalk space or sidewalk width. Monday, Tuesday, Wednesday Thursday, Saturday, and Sunday were selected to analyze PLOS. The reason for selecting those days is that Monday is the first working day, Thursday and Saturday are market days in the city, and Sunday is a break, which helps to understand pedestrian activities on different days. This would occur on March 19,20,21,22,2022, from 12:30:00 to 7:30 am to 8:00 am and 6:30 to 7:00 the night. The measurements were taken on "typical" days that were free of weather-related distortions.

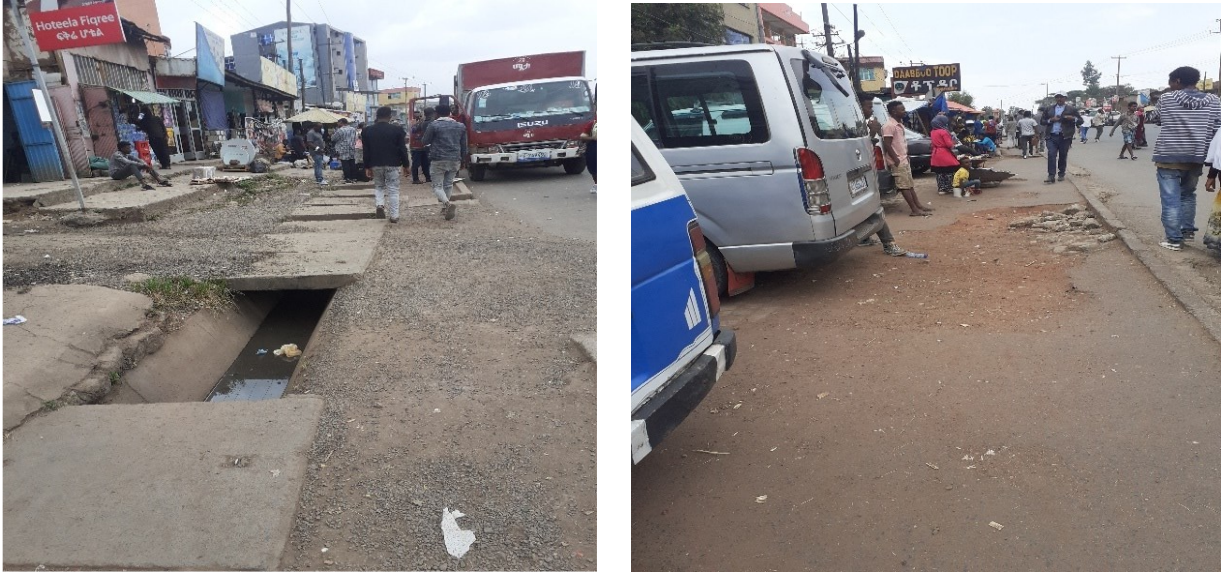
Figure 7:parking condition in the study area

Table 14 and figure 7 illustrate the parking condition of kenter Street. The street lacks proper on-street and off-street parking; hence, vehicles are parked on sidewalks along both sides of the street. However, both the right and left side parking situations have scored 6 and 7 points respectively, and both sides of the walkways have an average score of 5 points which implies that the sidewalks are blocked by vehicles and it is a disaster for walking.

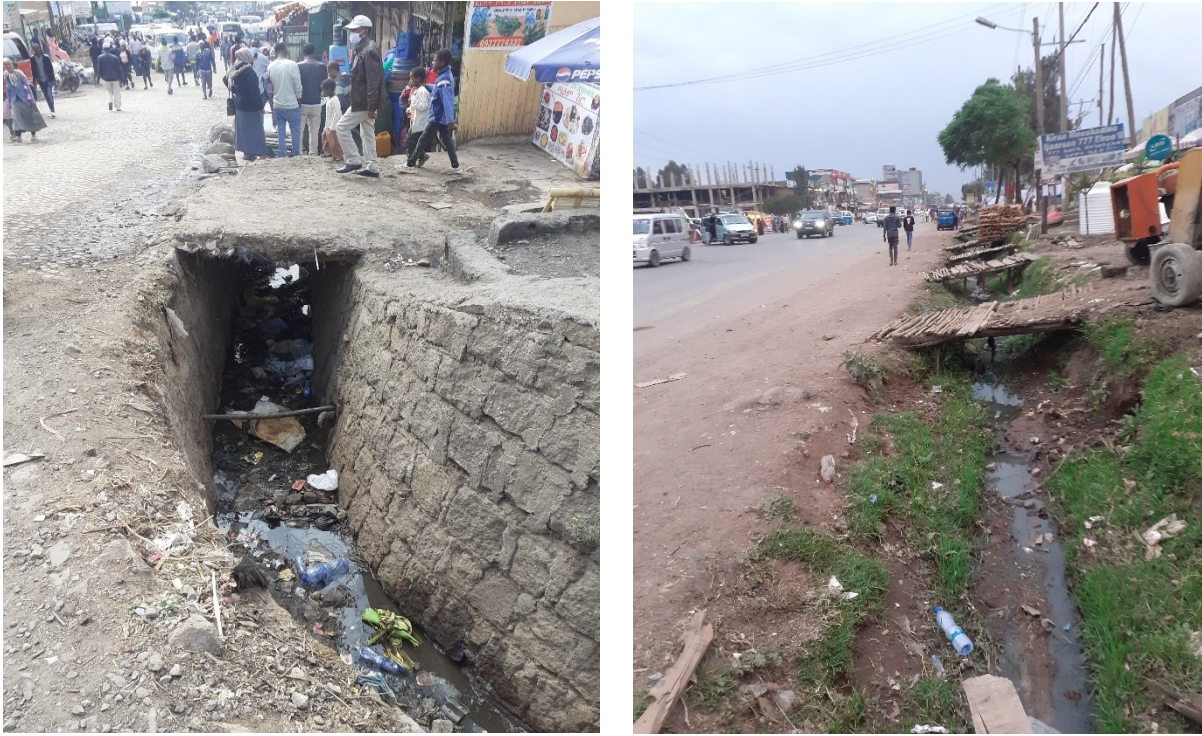
Figure 8:utility condition in the study area

Table 15 and figure 8 illustrate the situation of utilities along both sides of kenter Street. Thus, the utilities from both sides of the street are not pedestrian-friendly due to; open and unpleasant smell ditches, improperly installed utilities, lack of visual and environmental qualities, and physically obsolete electric power. Hence, the utility condition of the street from both sides has scored 5 points, which implies that the utilities are a disaster to pedestrians for walking.

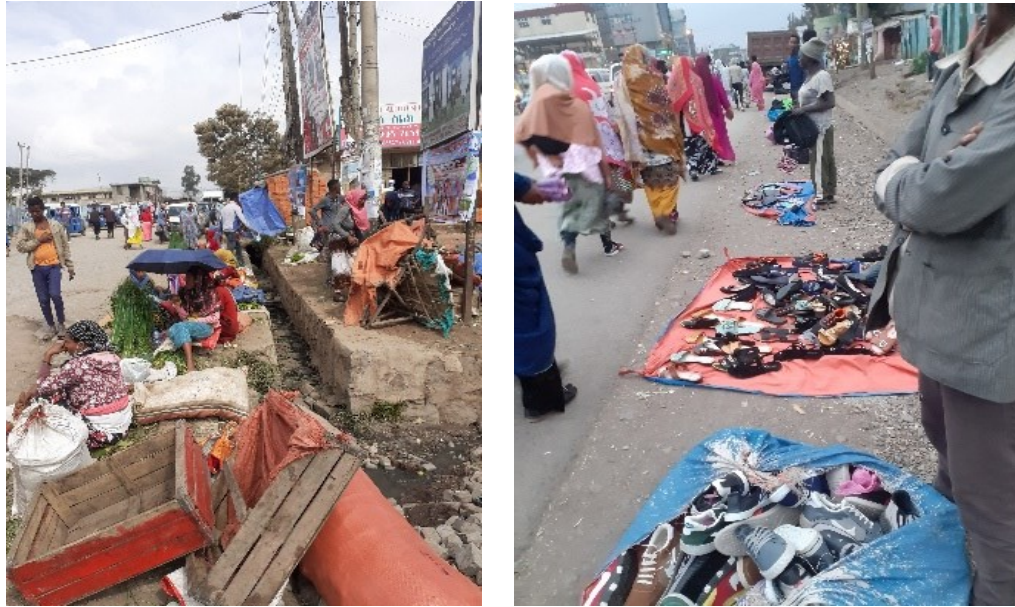
Figure 9:street vendor on the sidewalk

Based on the sector information and data obtained from key informants, many informal business shops are occupying the road yet as on the footpath of the study area. Differing types of outlets are concentrated on these are cloth, food, ornaments, fruit, and blacksmith. These business shops created different problems for vehicular additionally as pedestrian movement. The physical scenario of the roads reveals pedestrian movement is interrupted thanks to a footpath that is almost blocked. The footpath is additionally blocked by the shopkeepers and market owners. They often

keep their instruments on the footpath. The walkway is sort of blocked because of illegal vendors that operate informal businesses. This case deteriorates the protection and convenience of the walkers on the walkway surface, too.

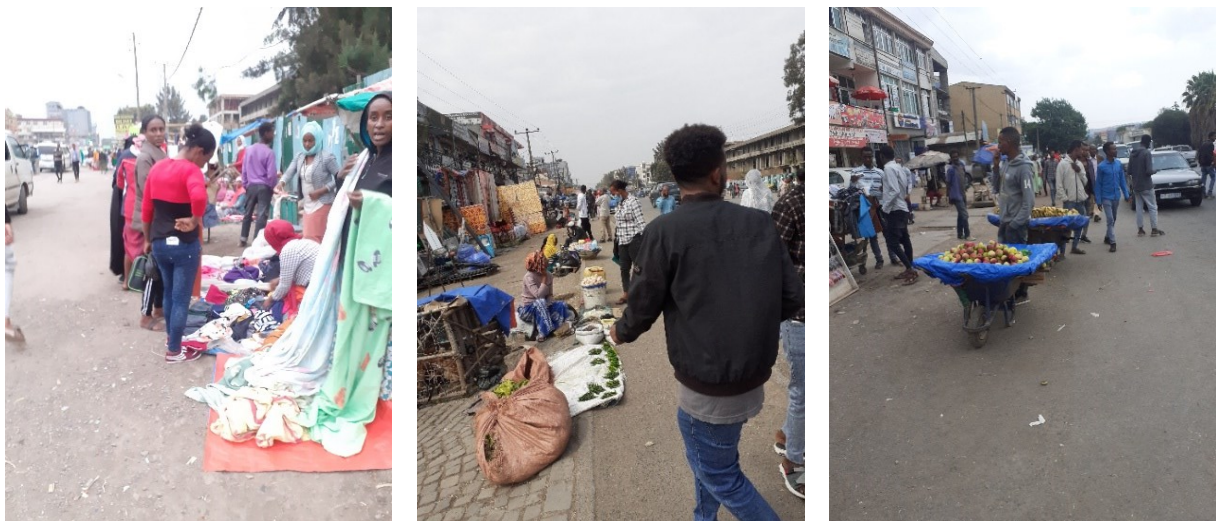
Figure 14: Vendor on the roadway

Figure 14 illustrates the roadway with the street vendor. As figure 18 indicates Vending takes up street space, blocking pavement and parking spaces and causing congestion for other road user. Street trading is carried out in public spaces that are not specifically designated for trade, and thus results in competition with other urban services and uses such as traffic flow, access to buildings, and other commercial activities in the city. Informal trading streets are mostly linear public spaces i.e., streets, including the niches and street corners that are appropriated and occupied by street traders

Based on the site observation, The existence of street vendors on the study road segment trespasses the carriageway's effective width. Road encroachment due to the existence of street vendors reduces the intended street performance. Traffic malfunctioning from dynamic impedance was relatively higher than those from static ones. That is why the study tried to assess the traffic turbulence by considering the dynamic nature of the street vendors rather than direct measurement of the effective roadway width reduction by those actors of road friction under investigation. the study showed that there is a measurable decrease in the Capacity of a lane width below 1.5 m. But there is no measurable decrease in urban street capacity when through lane widths are narrowed from 2.5 m to 1.5 m. On the peak hour of the pick day of street vendors' existence on the study road links almost 1.5m of the carriageway from the curb of the street was occupied by street vendors. Thus, it's empirical to deduce that the safety, speed, and capacity of the urban arterial road were significantly reduced.

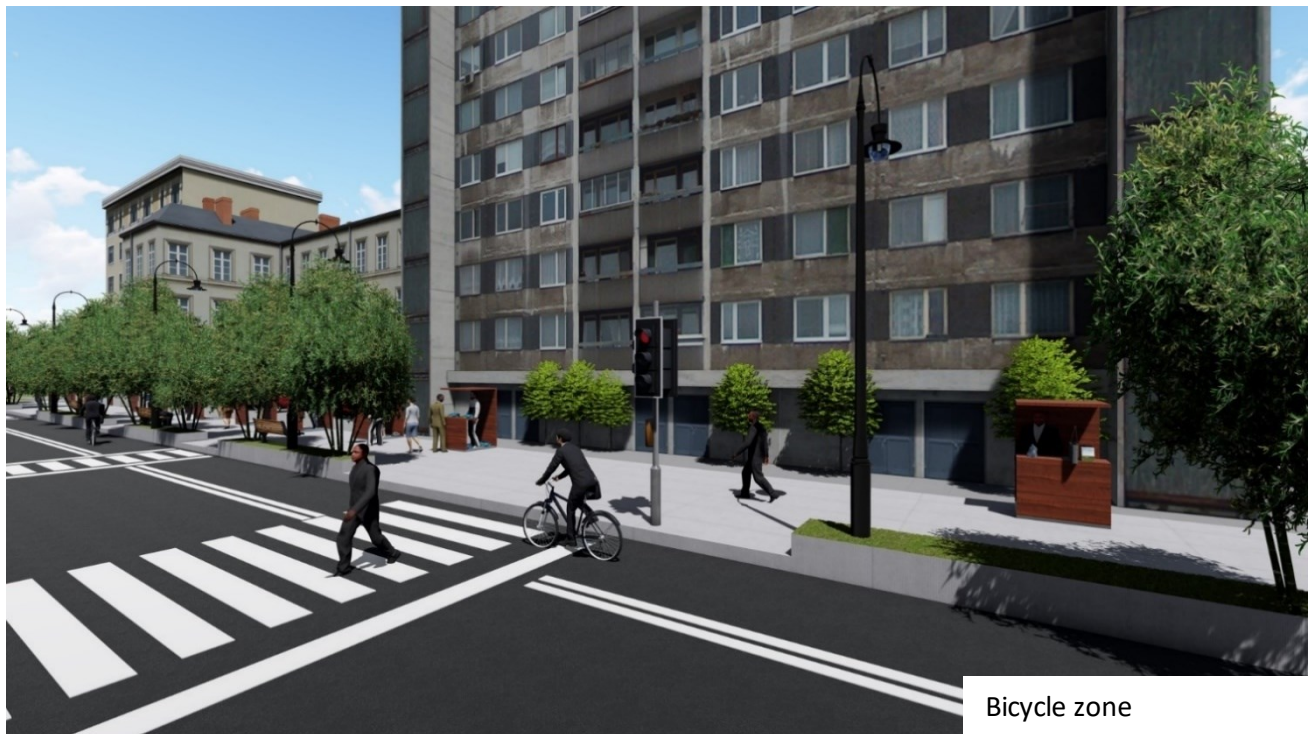
Figure 22: Bicycle zone

Bicycle zone

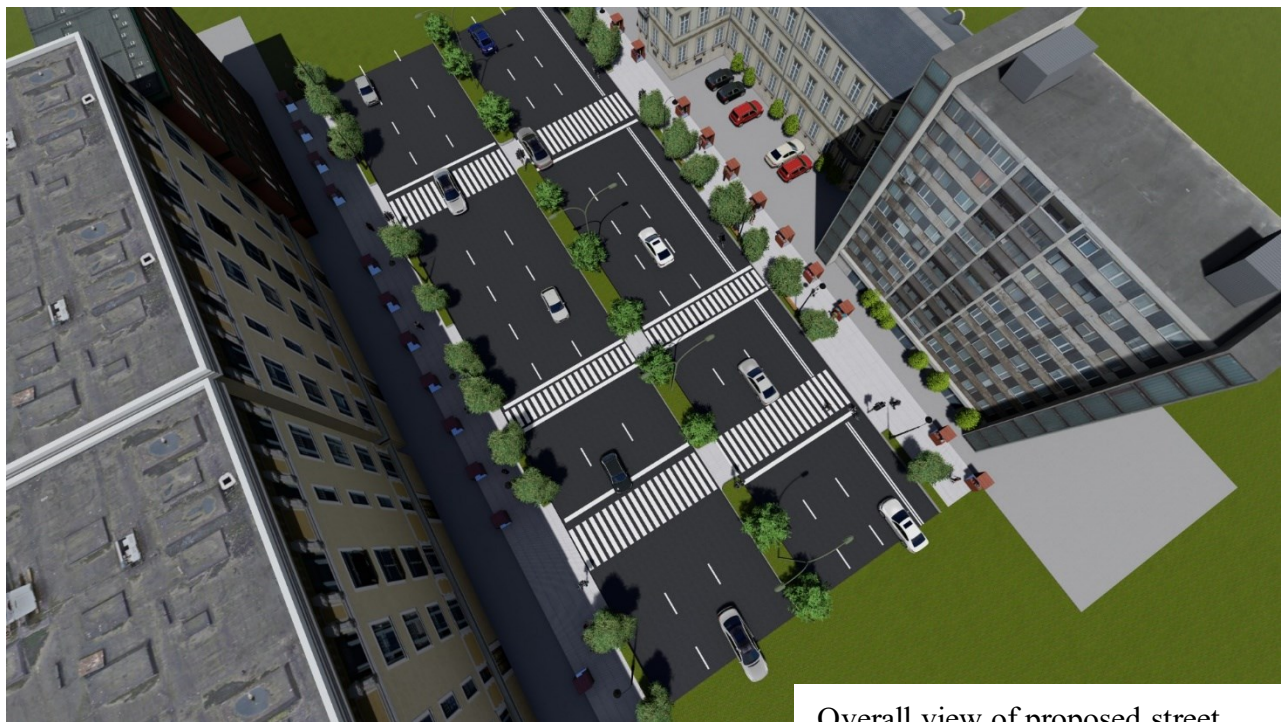
Figure 23: Overall view of proposed street

Overall view of proposed street
