**Evaluation of the Stability and Suitability of Ashebeka Dam  
Foundation and Reservoir Area, Arsi Zone, Central Ethiopia**

**A Thesis Submitted to the Department of Applied Geology**

**Adama Science and Technology University**

**February, 2024**

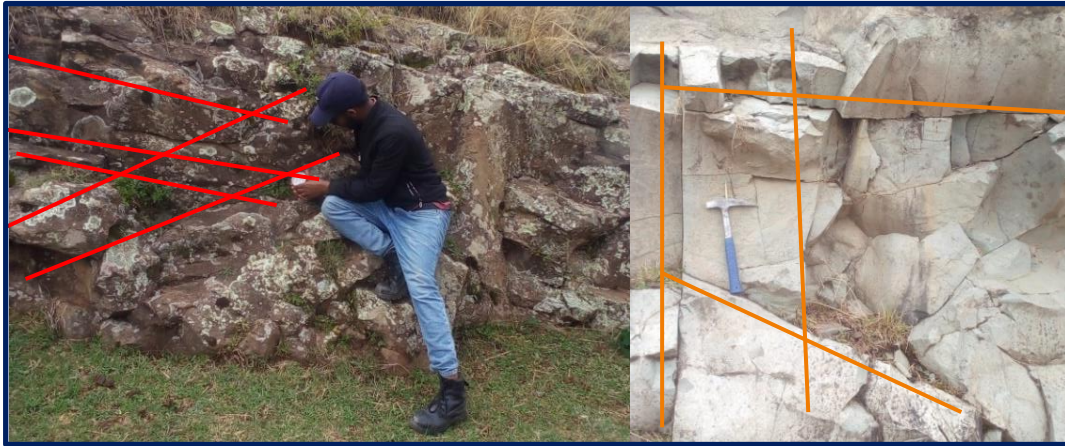
Figure 10 Joint measurement using brunton compass and discontinuity surveying.

rocks at the dam axis and the reservoir area. Slope height, dip, and dip direction were also measured. The Brunton compass was used to measure the joint orientations such as strike, dip, and dip direction (Figure 10).

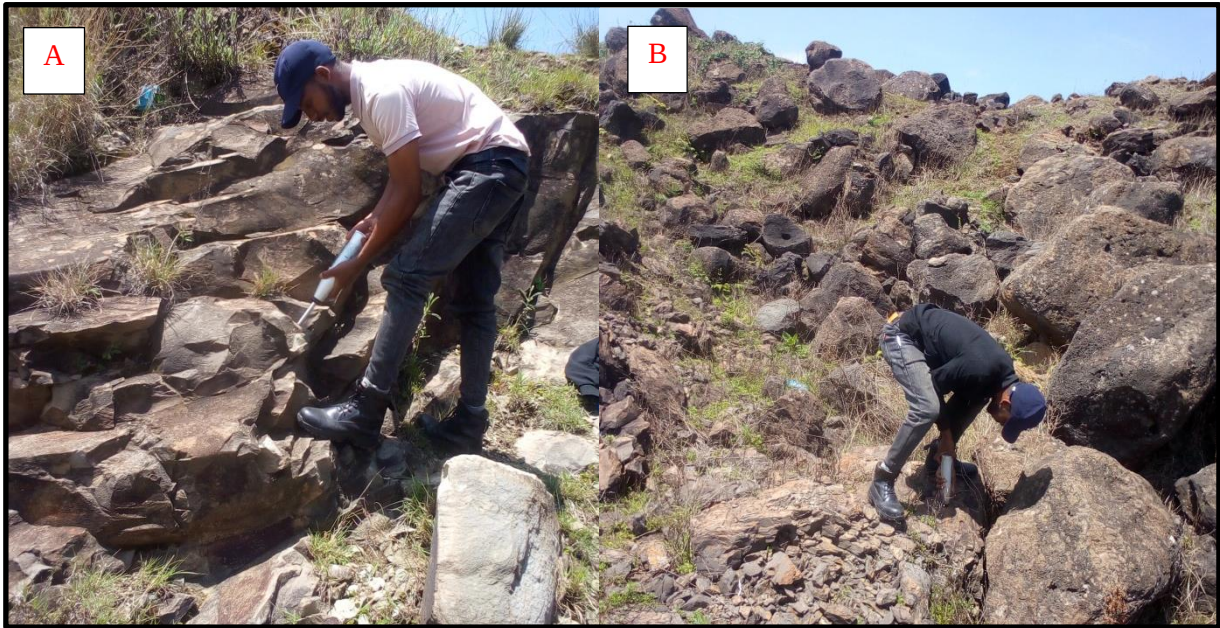
Figure 11 Insitu strength measurement using schmidit hammer on ignimbrite rock (A) and on fractured basalt rocks (B).

Finally, by averaging result of representative rebound values, the uniaxial compression strength (UCS) of the rock were estimated using equation 6.

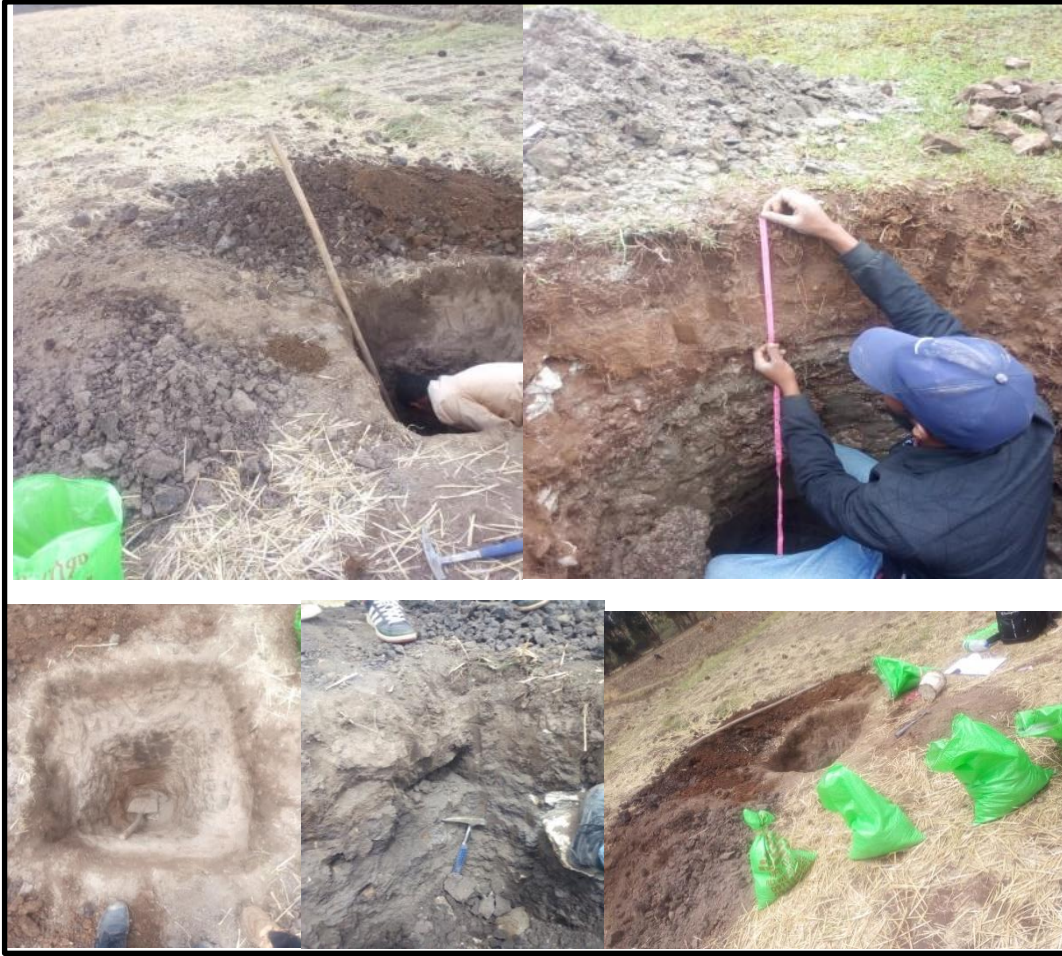
Figure 12 Test pit excavation from different part of the study area and soil sampling .

In order to conduct several laboratory tests, disturbed soil samples were taken from the test pit. Four test pits were excavated by the researcher and ECO, with a maximum depth of 2.5 meters. Of these, one was located in the reservoir area (ASHTP-04), (ASHTP-02) was at river beds, and (ASHTP-01) and (ASHTP-03) was located on the left and right abutments of the dam respectively (Figure 12). The plastic bag was used to preserve the soil samples' original moisture content after they had been collected. Also, the engineering characteristics of the rocks that make up the dam site and reservoir area were described. Later, based on degree of weathering and wetness rock samples from the exposed surface were collected for laboratory analysis.

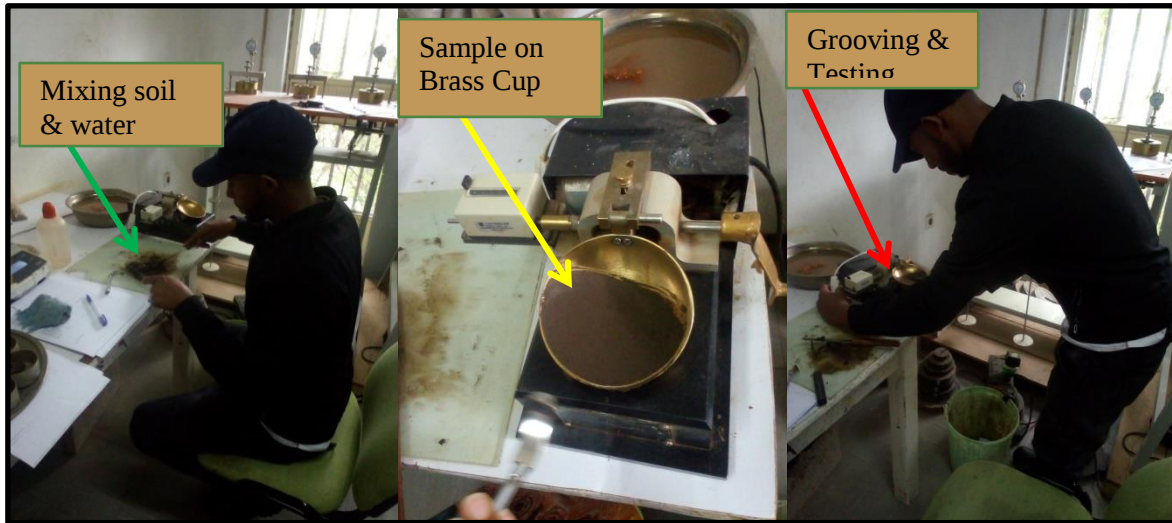
Figure 13 Liquid limit test using digital casagrande apparatus.

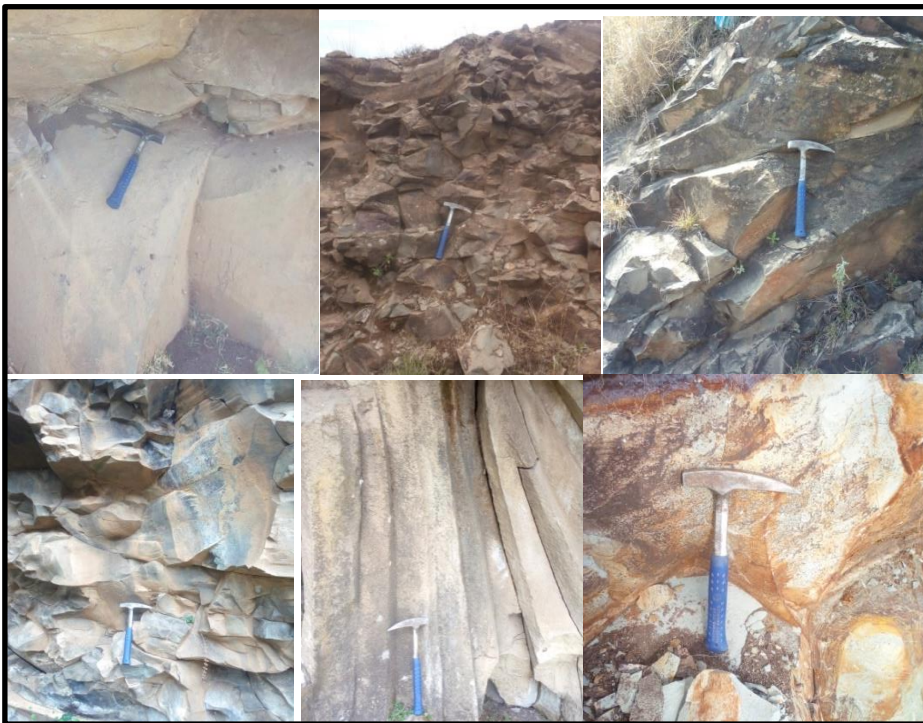
Figure 18 Ignimbrite rock with different fracture and weathering rate.

The rock is welded to highly welded and massive in most places with different degrees of fracture and some coarser fragments are visible in some parts of the area. The rock is characterized by different types of geological structures including columnar joints.

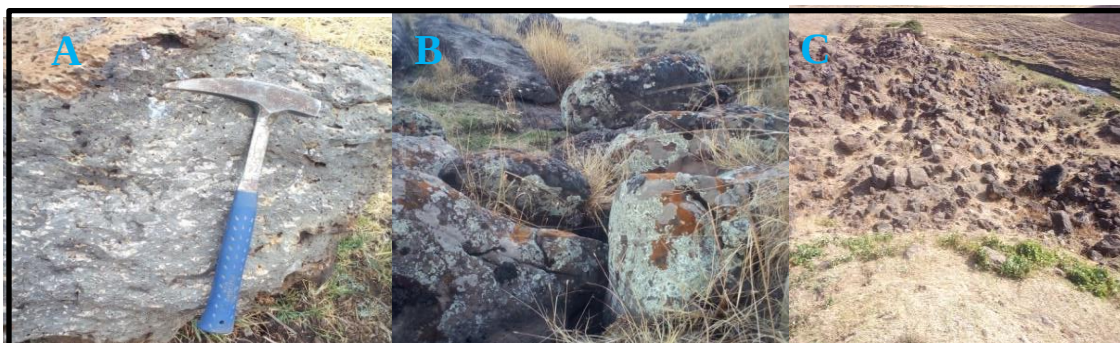
Figure 20 Basaltic rock with vesicular texture (A) and bolder forming outcrop in the reservoir (B) and near the dam axis (C).

The basalt units are mostly bolder forming and fresh to slightly weathered rocks. They are found in the reservoir area and thin layer near the axis of the dam. This rock is vesicular in texture and amygdaloidal with light to dark gray color.

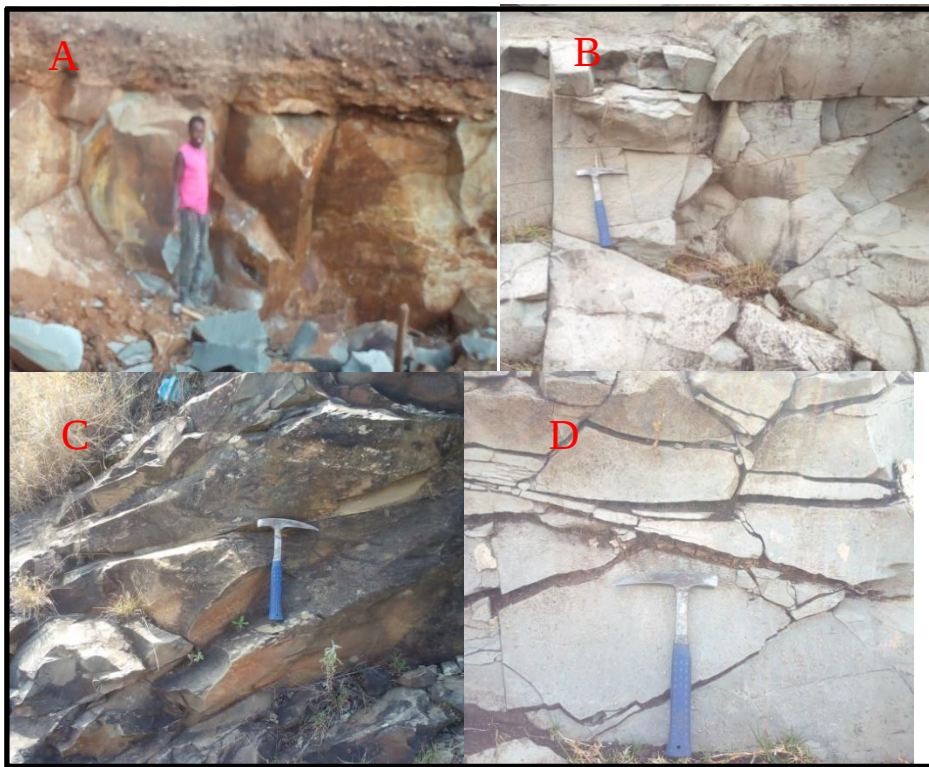
Figure 22 Different joint sets a) in reservoir area b) on the right abutment c and d) on the left abutment.

Joints are the dominant geological structures in the study area, which is observed mostly on ignimbrite rocks. Several strike orientations of the joints are seen in the rock mass in the study area. Most joints have three sets of striking directions: NE-SW, NW-SE, and WNW-ESE on the left abutment, and NNW-SSE, and NE-SW on the right abutment. They have medium continuity/persistence and moderately spaced, represented by vertical/sub-vertical rough surfaces, no filling material, and slightly weathered wall. Joints with stike orientation of ENE-WSW and WNW-ESE are favorable for leakage, because they are parallel to sub parallel with the river directions. Some joints are parallel to the dam axise and cross with perpendicular joints causes leakage by connecting to the neighbor valleys.

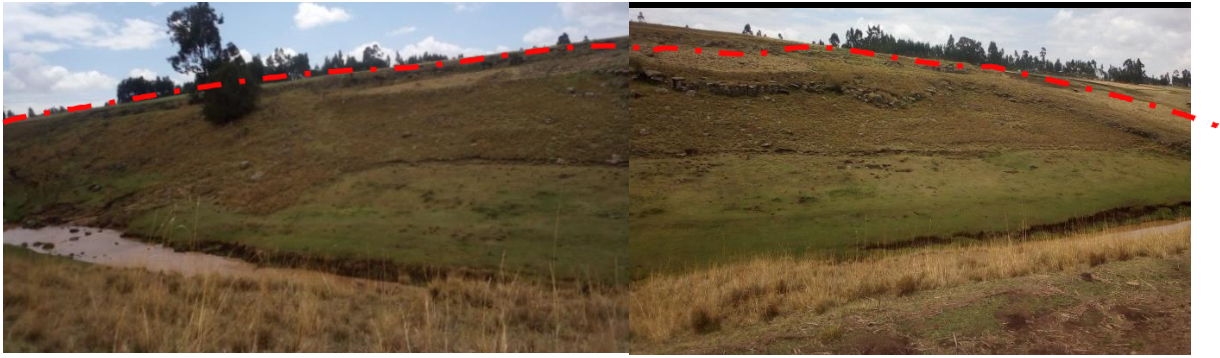
Figure 50 Unstable slope section in the reservoir area RRSS1.

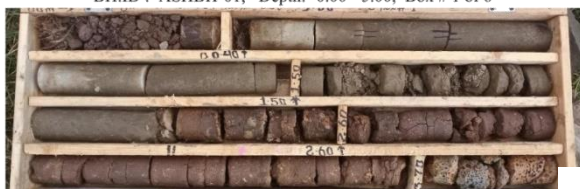
Proj :- Ashebaka D. & I. Project  
BH.ID :- ASHBH-01, Depth:- 5.00 - 12.0, Box # 2 of 6

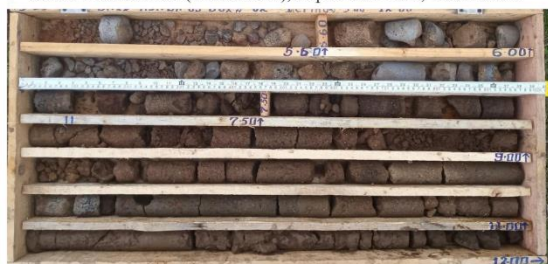
Proj :- Ashebaka D. & I. Project  
BH.ID :- ASHBH-03 (R. Abutment), Depth:- 19.0 - 26.0, Box # 4 of 7

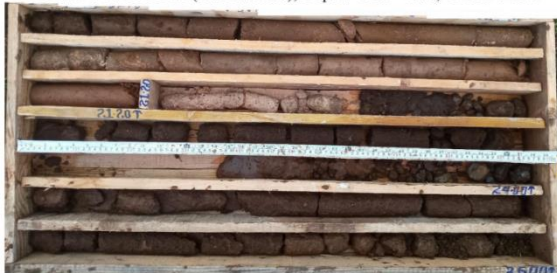
Proj :- Ashebaka D. & I. Project  
BH.ID :- ASHBH-03 (R. Abutment), Depth:- 12.0 - 19.0, Box # 3 of 7

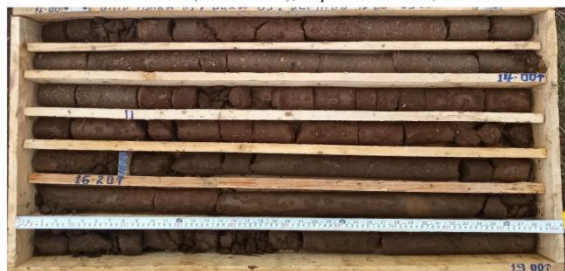
Proj :- Ashebaka D. & I. Project  
BH.ID :- ASHBH-03 (R. Abutment), Depth:- 26.0 - 33.0, Box # 5 of 7

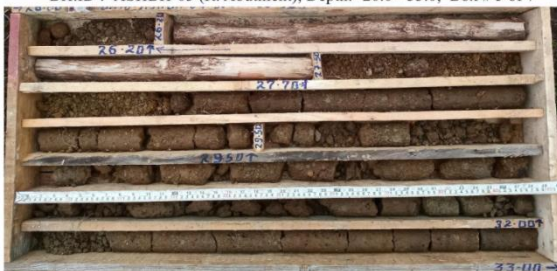
Proj :- Ashebaka D. & I. Project  
BH.ID :- ASHBH-02, Depth:- 0.00 - 5.00, Box # 1 of 5

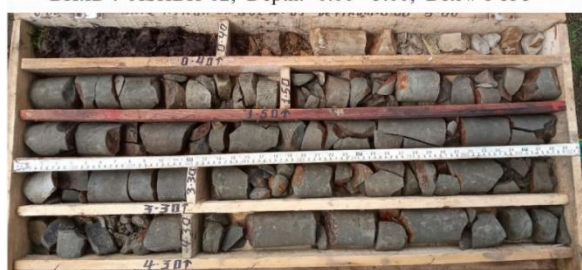
Proj :- Ashebaka D. & I. Project  
BH.ID :- ASHBH-02, Depth:- 12.00 - 19.00, Box # 3 of 5

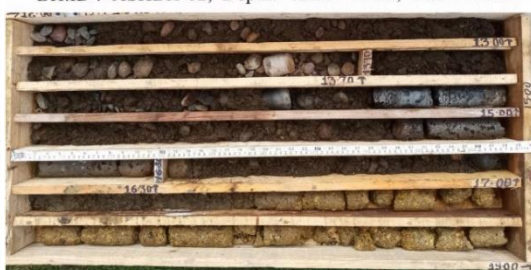
Proj :- Ashebaka D. & I. Project  
BH.ID :- ASHBH-02, Depth:- 5.00 - 12.00, Box # 2 of 5

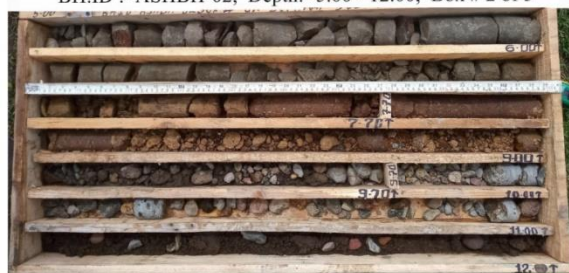
Proj :- Ashebaka D. & I. Project  
BH.ID :- ASHBH-02, Depth:- 19.00 - 26.00, Box # 4 of 5
