# **Slope Instability Assessments And Mitigation Measures On Road Failure: In Case Of Addisu Gebeya To Sululta Road**

A Thesis Submitted to the Department of Civil Engineering  
School of Civil Engineering and Architecture

Presented In Partial Fulfillment of The Requirement for The Degree of  
Masters in Civil Engineering (Geotechnical Engineering)

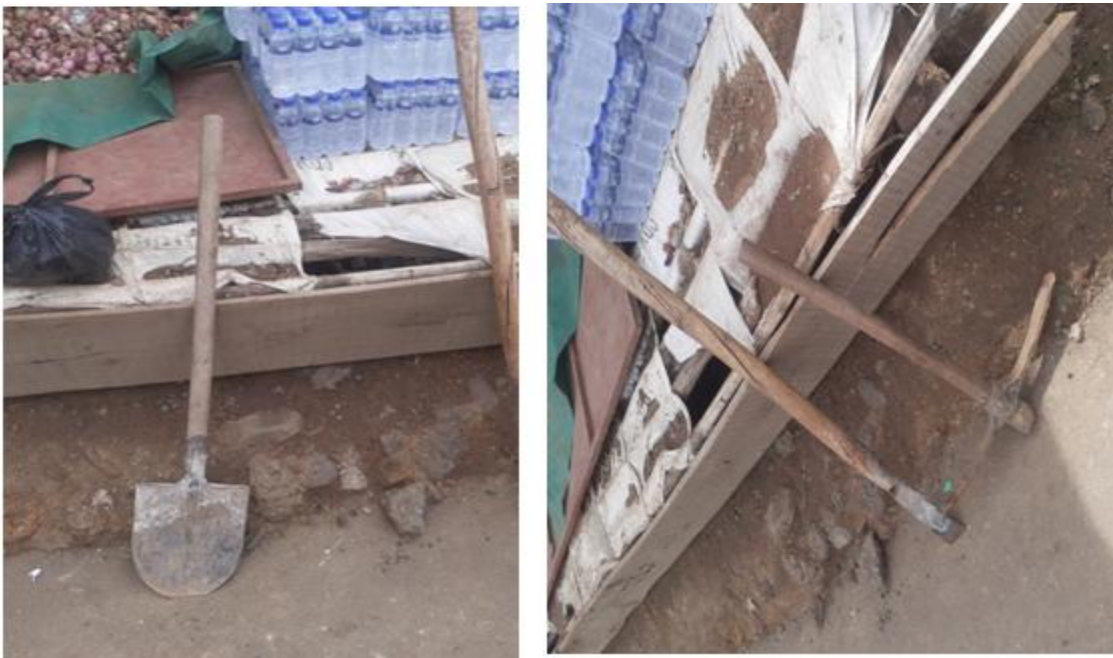
The sampling was done using the traditional excavation equipment's like Doma, Akafa, Geso and Bucket in order to remove the soil from the bottom of the pit with the help of local workers.

Figure 3.4: Traditional excavation equipment's used for excavation
