# **Evaluating the Impact of Sidewalk Physical Challenges on Pedestrian Walkability in Adama City: A study of selected arterial Streets**

A Thesis Submitted to  
The Department of Architecture  
School of Civil Engineering and Architecture

Presented in Partial Fulfillment of the Requirement for the Degree of Master's in  
Urban Planning and Design

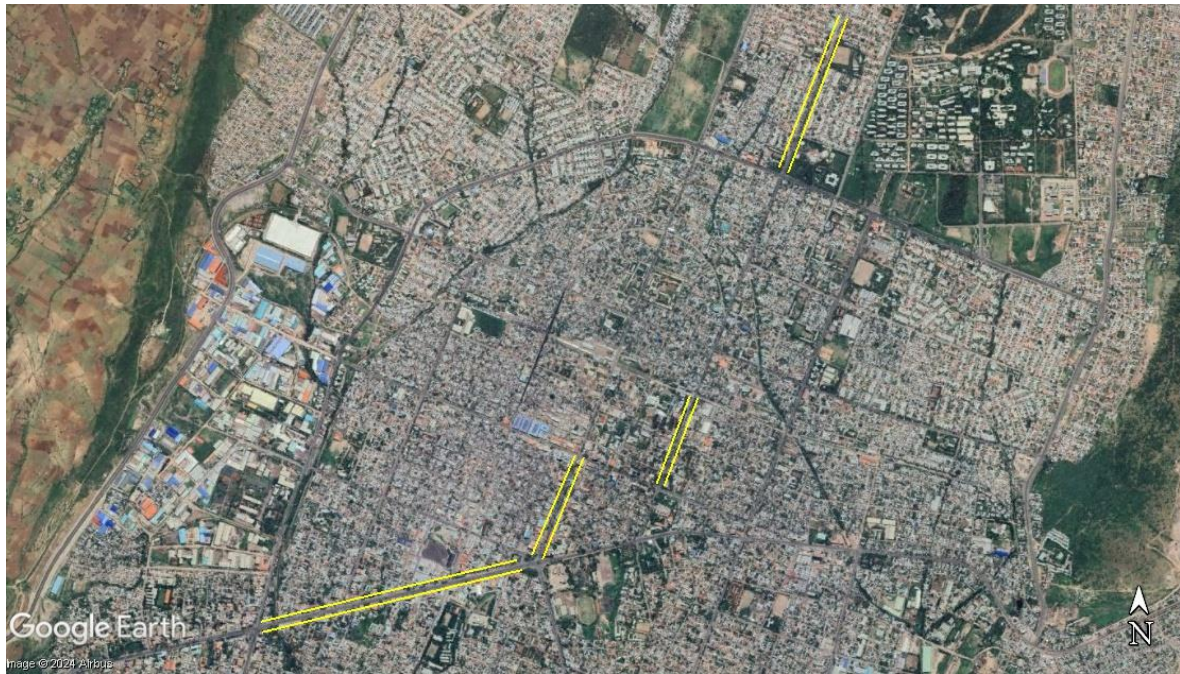
**Figure 3-3: Location of Selected Street Segments (Source: Google Earth (edited by the author))**

poor quality of sidewalk were indicators for commercial business districts. So, two sidewalk segments from the CBD, one from the transit zone and one from the residential zone, were selected. The selected segments are shown on the Figure 3.1-3.

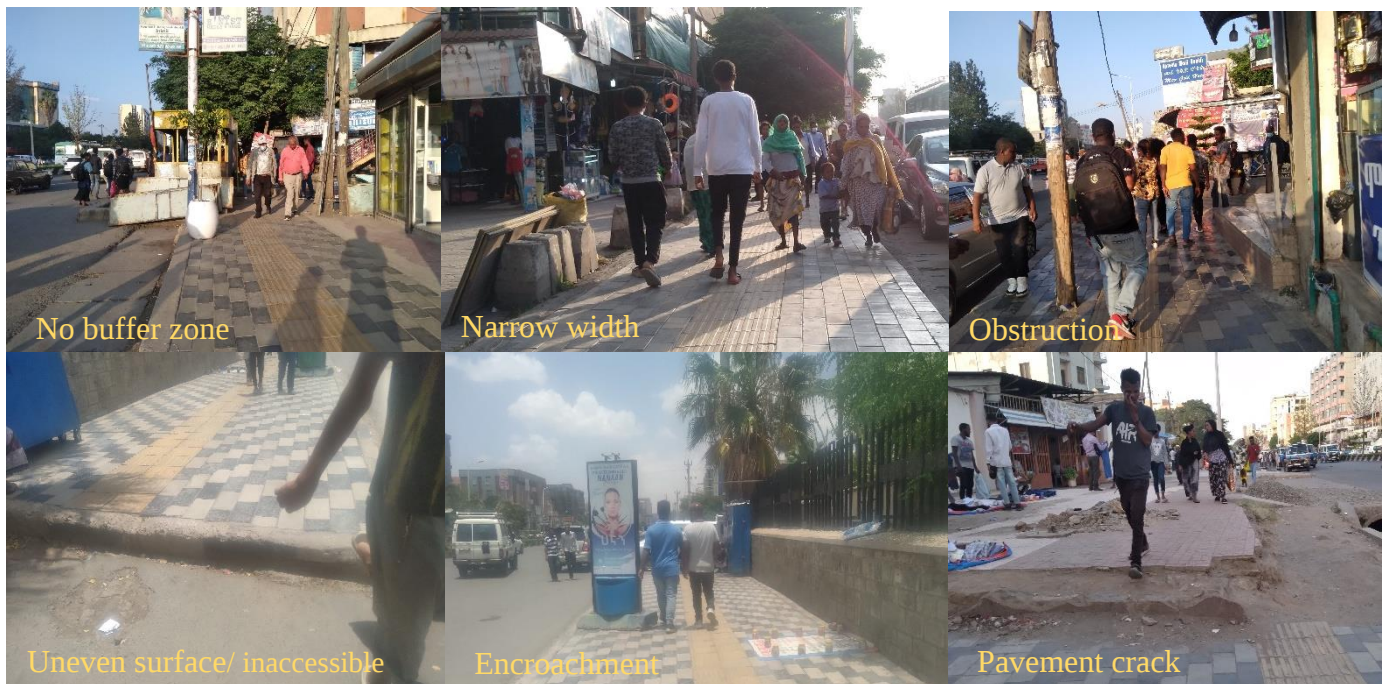
Figure 4-1: Franko segment sidewalk physical condition (source: Author site observation)

Entire the segment few sections of the sidewalk were absent, interrupting continuous pedestrian pathways and forcing individuals to walk on the road, posing safety risks. This analysis of the

Franko Street segment highlights critical issues that need to be addressed to improve pedestrian safety, accessibility, and the overall walkability of the area.

| Figure 4.2-1: Franko segment sidewalk physical condition ..... | 51 |

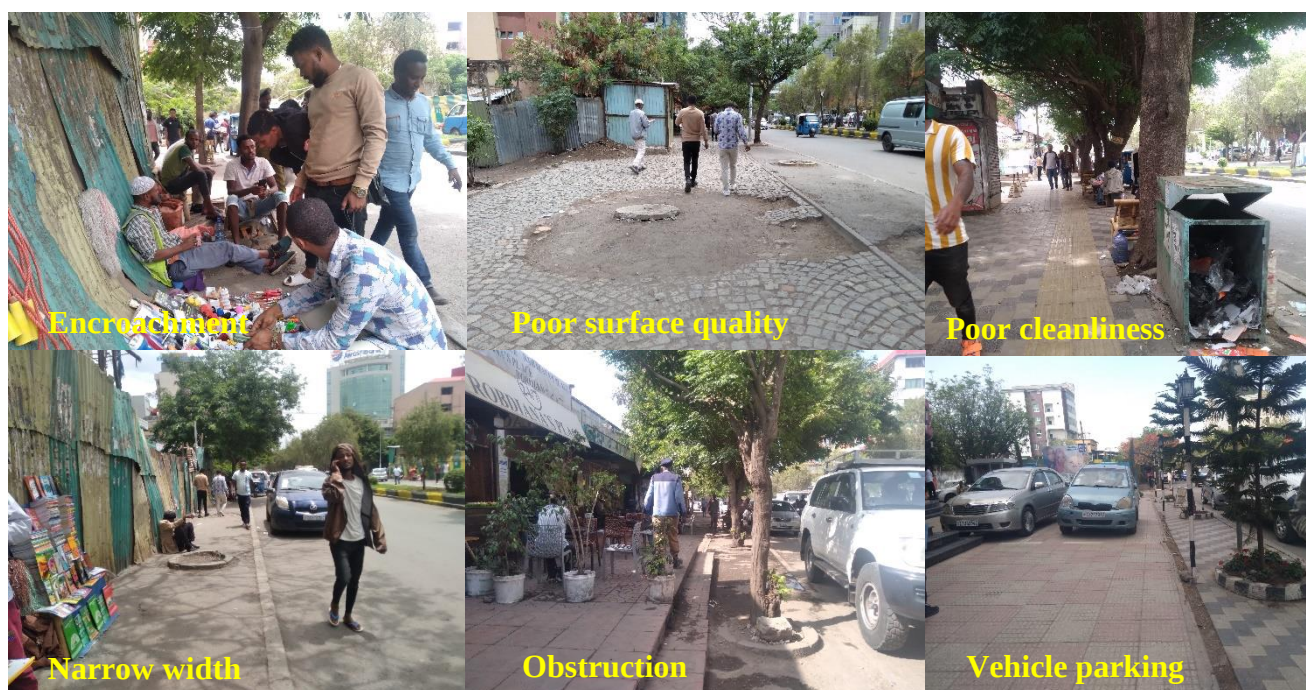
Figure 4-2: Postabet - Mebrathayil segment sidewalk physical condition

The width of the sidewalk along this segment varies significantly. Most sections of the sidewalk are narrow and insufficient to accommodate the high pedestrian volume, though a few locations are wide enough to handle the traffic. The quality and material of the pavement also differ across this segment. While some sections are paved with asphalt or cobblestones, a few areas remain unpaved. Most of the site is paved with terrazzo, including tactile surfaces designed to aid visually impaired pedestrians. However, the sidewalks are filled with obstructions, negating the benefits of the tactile paving. There are also uneven level changes at every curb cut. Additionally, the sidewalks are heavily encroached upon by street vendors, shoe shiners, retail activities, business displays, and other related activities, further complicating pedestrian movement.

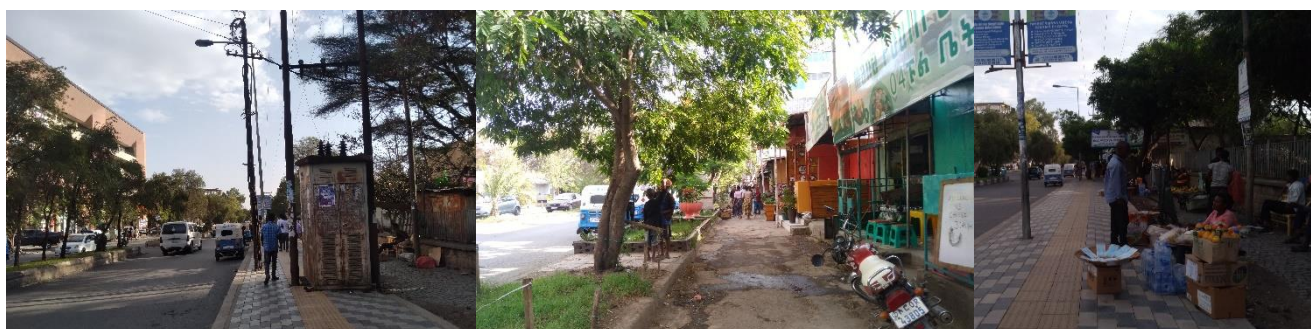
Figure 4-3: 04 - Mariam church segment sidewalk physical condition

This segment of the sidewalk was relatively clean and in fair condition, though it exhibited several issues. There were some obstructions and a number of cracks throughout, along with several missing sections that disrupted continuity. The sidewalks were quite narrow, making it difficult for pedestrians to navigate, especially during busy times. Accessibility for wheelchair users was severely limited due to the lack of proper ramps and the uneven surface.

Additionally, while there were some trees along the sidewalk, they did not provide adequate shelter from the sun or rain. The trees were sparsely planted and did not offer significant shade, diminishing their effectiveness in enhancing pedestrian comfort. The combination of these factors resulted in a challenging environment for all users, highlighting the need for significant improvements to ensure safety and accessibility

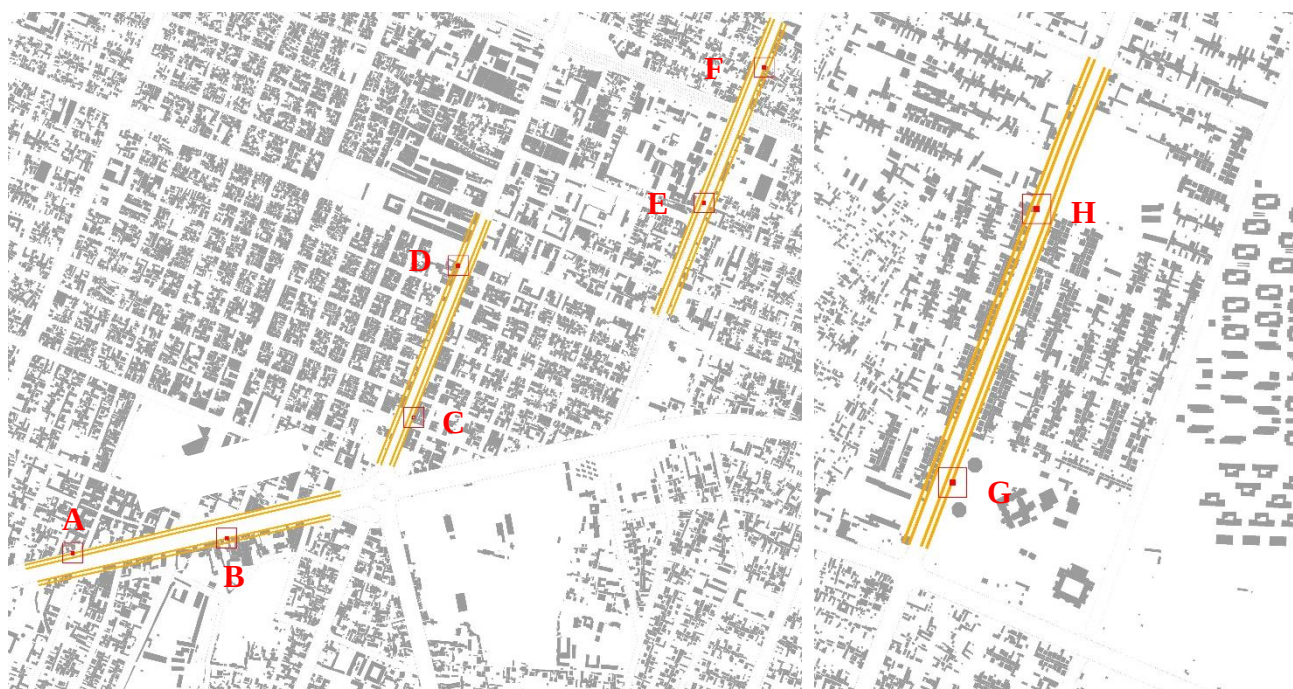
Figure 4-7: Selected pedestrian count points

For evaluating walkability and Pedestrian Level of Service (PLOS), the study recognized the presence of various perspectives, as detailed in Chapters 2 and 3. Each perspective demands different types of data, complicating the data collection process. In this part of the study, the methods for collecting the necessary data for PLOS evaluations are explained under pedestrian counts, infrastructure data, and pedestrian speed. Pedestrian level of service at the four selected street segment was evaluated by conducting data's from two data collection points in each segments and take the average for the segment. Based on this eight points were selected from all street segments.

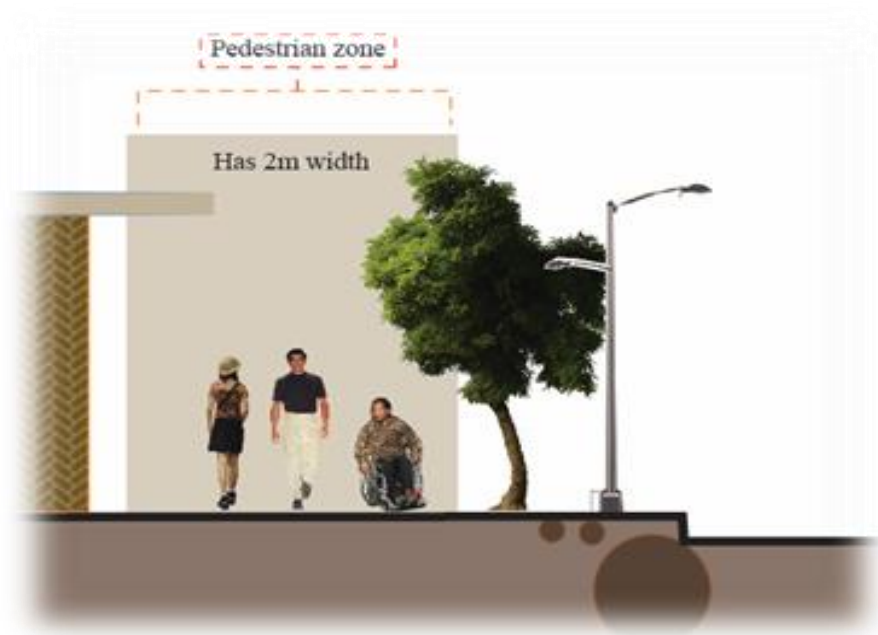
Figure 5-2: pedestrian and planting zone (Author design)

The planter/ furniture zone lies between the curb and pedestrian zone and intended to housing utility, such as traffic poles and fire hydrant and pedestrian amenity such as benches and bus shelter. The purpose of this zone is to ensure that the pedestrian zone will be free of obstacles. It has minimam width of 1.5m

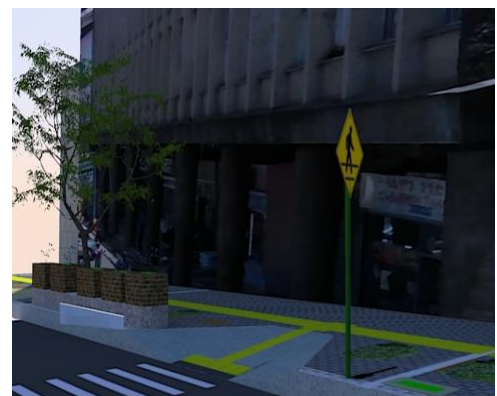
Figure 5-5: Curb ramp design

**Curb ramp:** The curb ramps are used at every curb cuts and crossing wheelchair users comfortable and accessible to the sidewalk. The sidewalk cross slope is about 2% and curb ramp has maximum 8.3% gradient down walking area with tactile pavement to visually impaired.
