**Landslide Susceptibility Analysis and Developing Remedial  
Measures for  
Gore - Masha - Tepi  
Road Project.**

A Thesis Submitted to the Department of Civil Engineering, College  
of Civil Engineering and Architecture

Presented in Partial Fulfillment of The Requirement for The Degree  
of Masters in Civil Engineering (Geotechnical Engineering)

Adama Science and Technology University

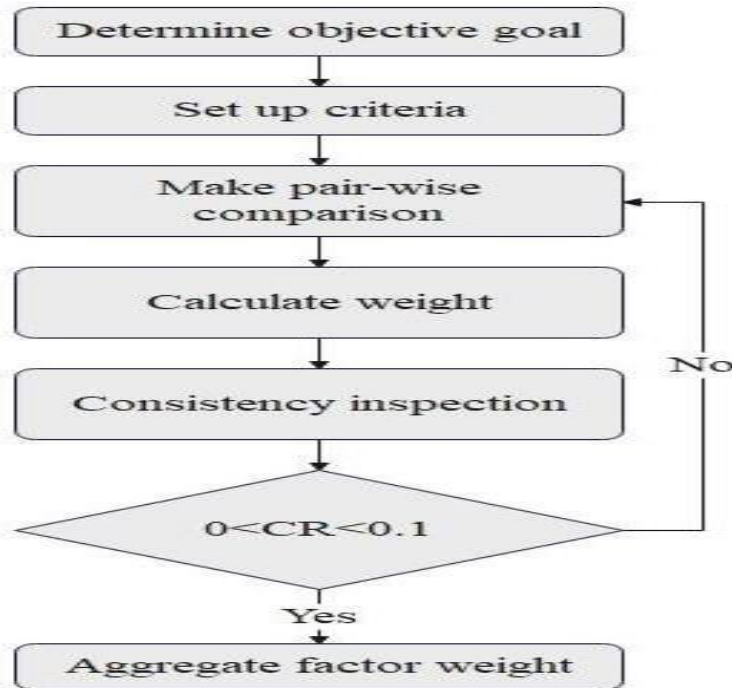
**Figure3.7:** Landslide contributing factors weighting using Analytical Hierarchy process

Key landslide occurrence factors, including lithology, elevation, rainfall, slope, slope aspect, land use/cover, distance to streams, distance to roads, and curvature, were arranged hierarchically, given relative weights, and integrated in a GIS environment using the Analytical Hierarchy Process (AHP). A landslide susceptibility map was created using ArcGIS's weighted overlay method, which divided the region into low, medium, and high-risk zones. Comprehensive geological and geotechnical analyses were carried out for the critical cut slopes. Slope behavior under current conditions and under several reinforcement scenarios was simulated using finite element modeling with PLAXIS2D software. These models assessed variables such as safety factors, failure surfaces, and slope deformation.

By combining the thematic raster map of nine pertinent features with their assigned weights, the Analytic Hierarchy Process (AHP) technique was used to construct the landslide susceptibility map for the study road section.

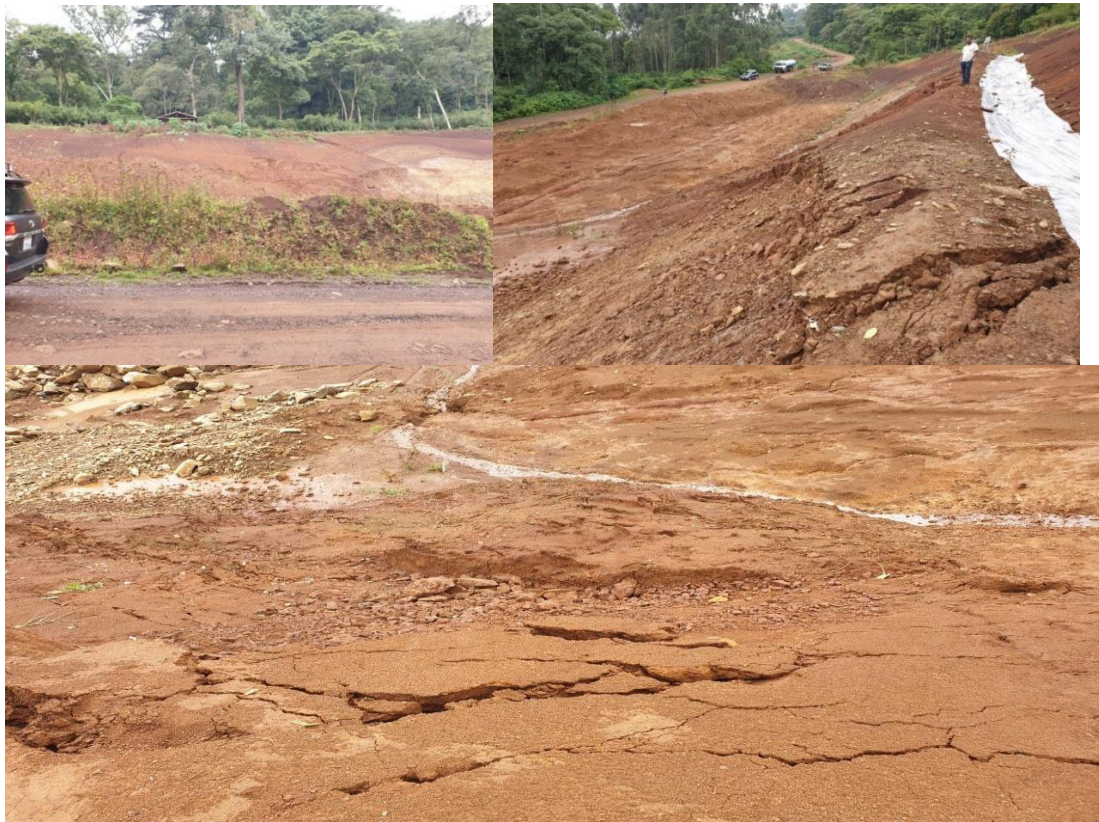
**Figure 4.3:** Landslide movement at station 45+350-45+440

The main reason for failure is the saturation of weak cut slope material by the action of rainfall which resulted in the saturation and collapse of soil layer that couldn't able to stand with the existing back slope ratio.

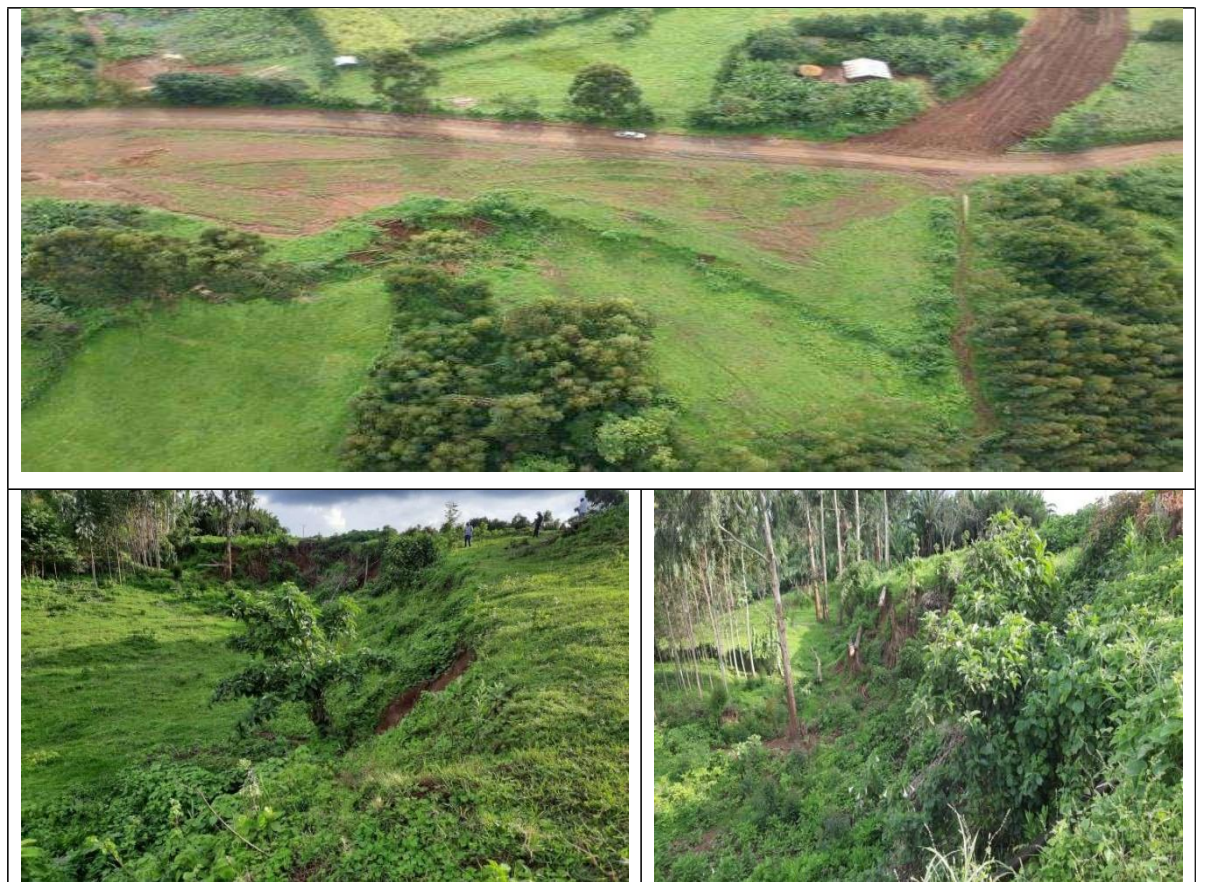
**Figure 4.5:**Landslide movement from station 67+500 – km 67+570

The geological soil profile presented reveals that the topmost layer is generally deep yellow silty clay (residual weathered material). The thickness varies from 0 to 1.2 meter Below the that, yellowish gray silty clay.

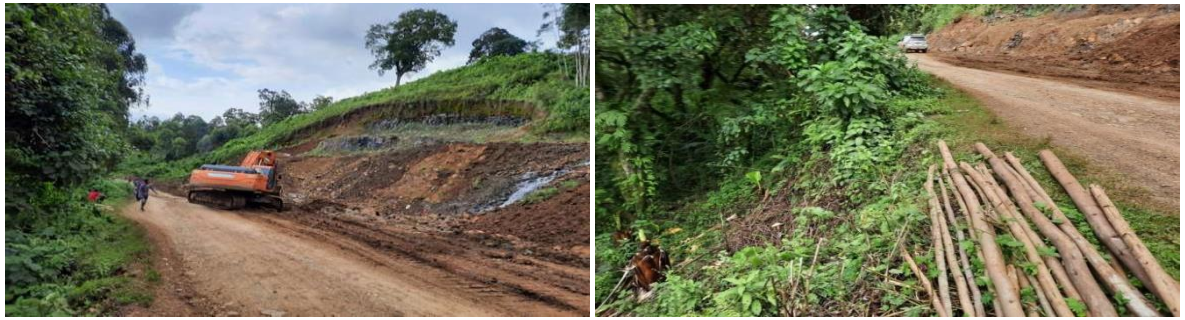
**Figure 4.6:** Landslide movement at station 69+180 – km 69+220 LHS

The toe erosion and undercutting of the natural slope material by the stream crossing the road is identified as the main cause of the active landslide. In addition, the saturation of the sides lope material by rainfall and surface runoff water contributes for the strength reduction of the slope material which contribute for the landslide.

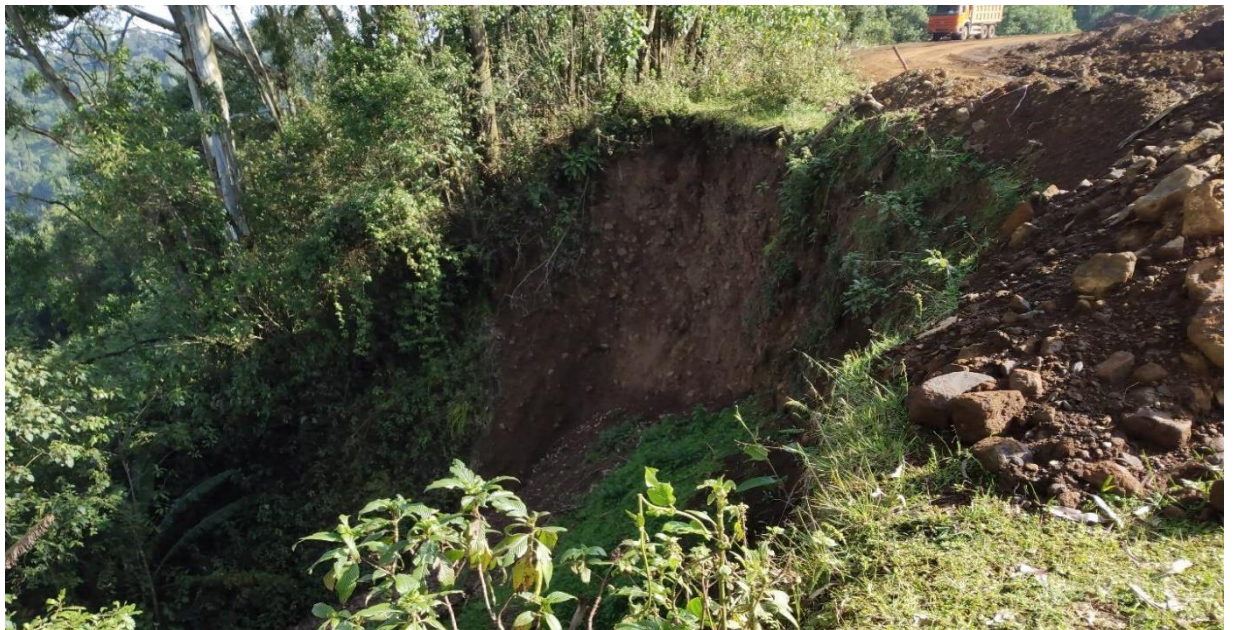
**Figure 4.7:** Landslide movement station from km 78+940-78+960 RHS

The main cause of the failure around this section is its morphology of the slope/steep slope profile and the nature of the material forming the slope which is a fill material. Even though the failure is observed very far from the center of the current alignment, it will cause future damage on the road unless proper remedial measure is taken on time.

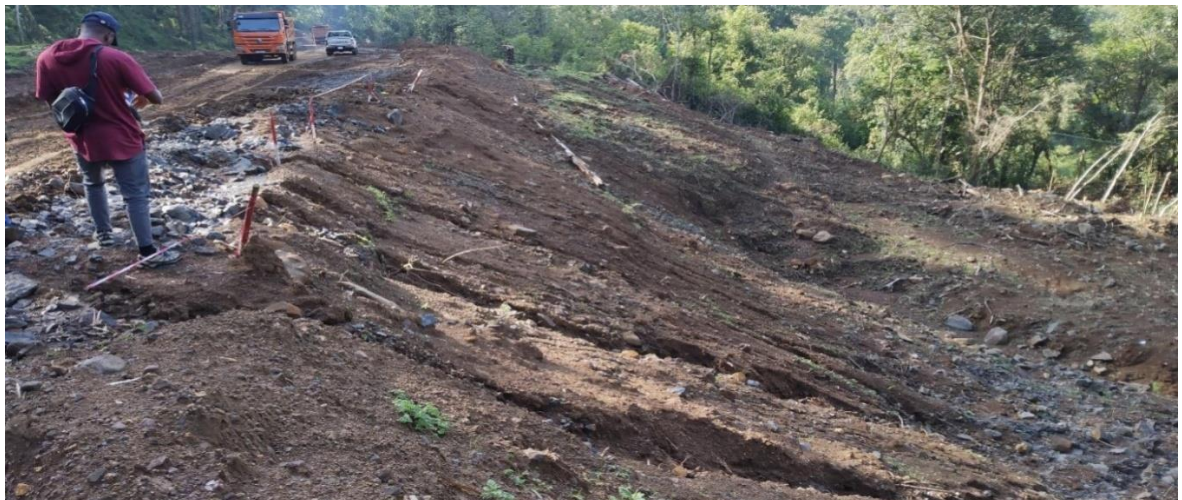
**Figure 4.8:** Landslide with settlement or movement station from 79+980 – km 80+010

In this specific section, the main causes of the subsidence/settlement is the underground erosion due to subsurface water flow and compaction due to traffic load of the soft fill material and the soft residual soil present in the subsurface.
