# **DAMAGES AND REMEDIAL MEASURES DUE TO EXPANSIVE SOIL ON THE BUILDINGS IN BISHOFTU TOWN**

A Thesis Submitted to  
The department of Civil Engineering,  
School of Civil Engineering and Architecture

Presented in Partial Fulfillment of the Requirement for the Degree of Master's  
in Civil Engineering (Specialization in Geotechnical Engineering)

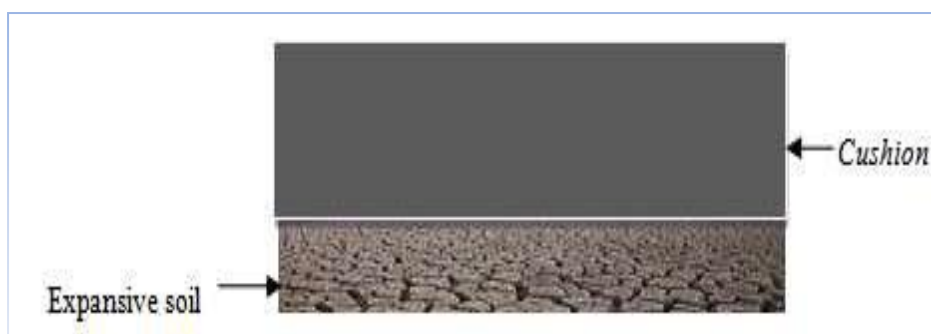
In this technique the expansive soil is replaced either in part or full (Figure.2.10) with a material that does not undergo swell. The load of the cushion provides the load necessary to counter heave (Tefera, 2008; Chen, 2018).

Figure 2. 10: Sub excavating or replacing the expansive soil by cushions (Chen, 2018).

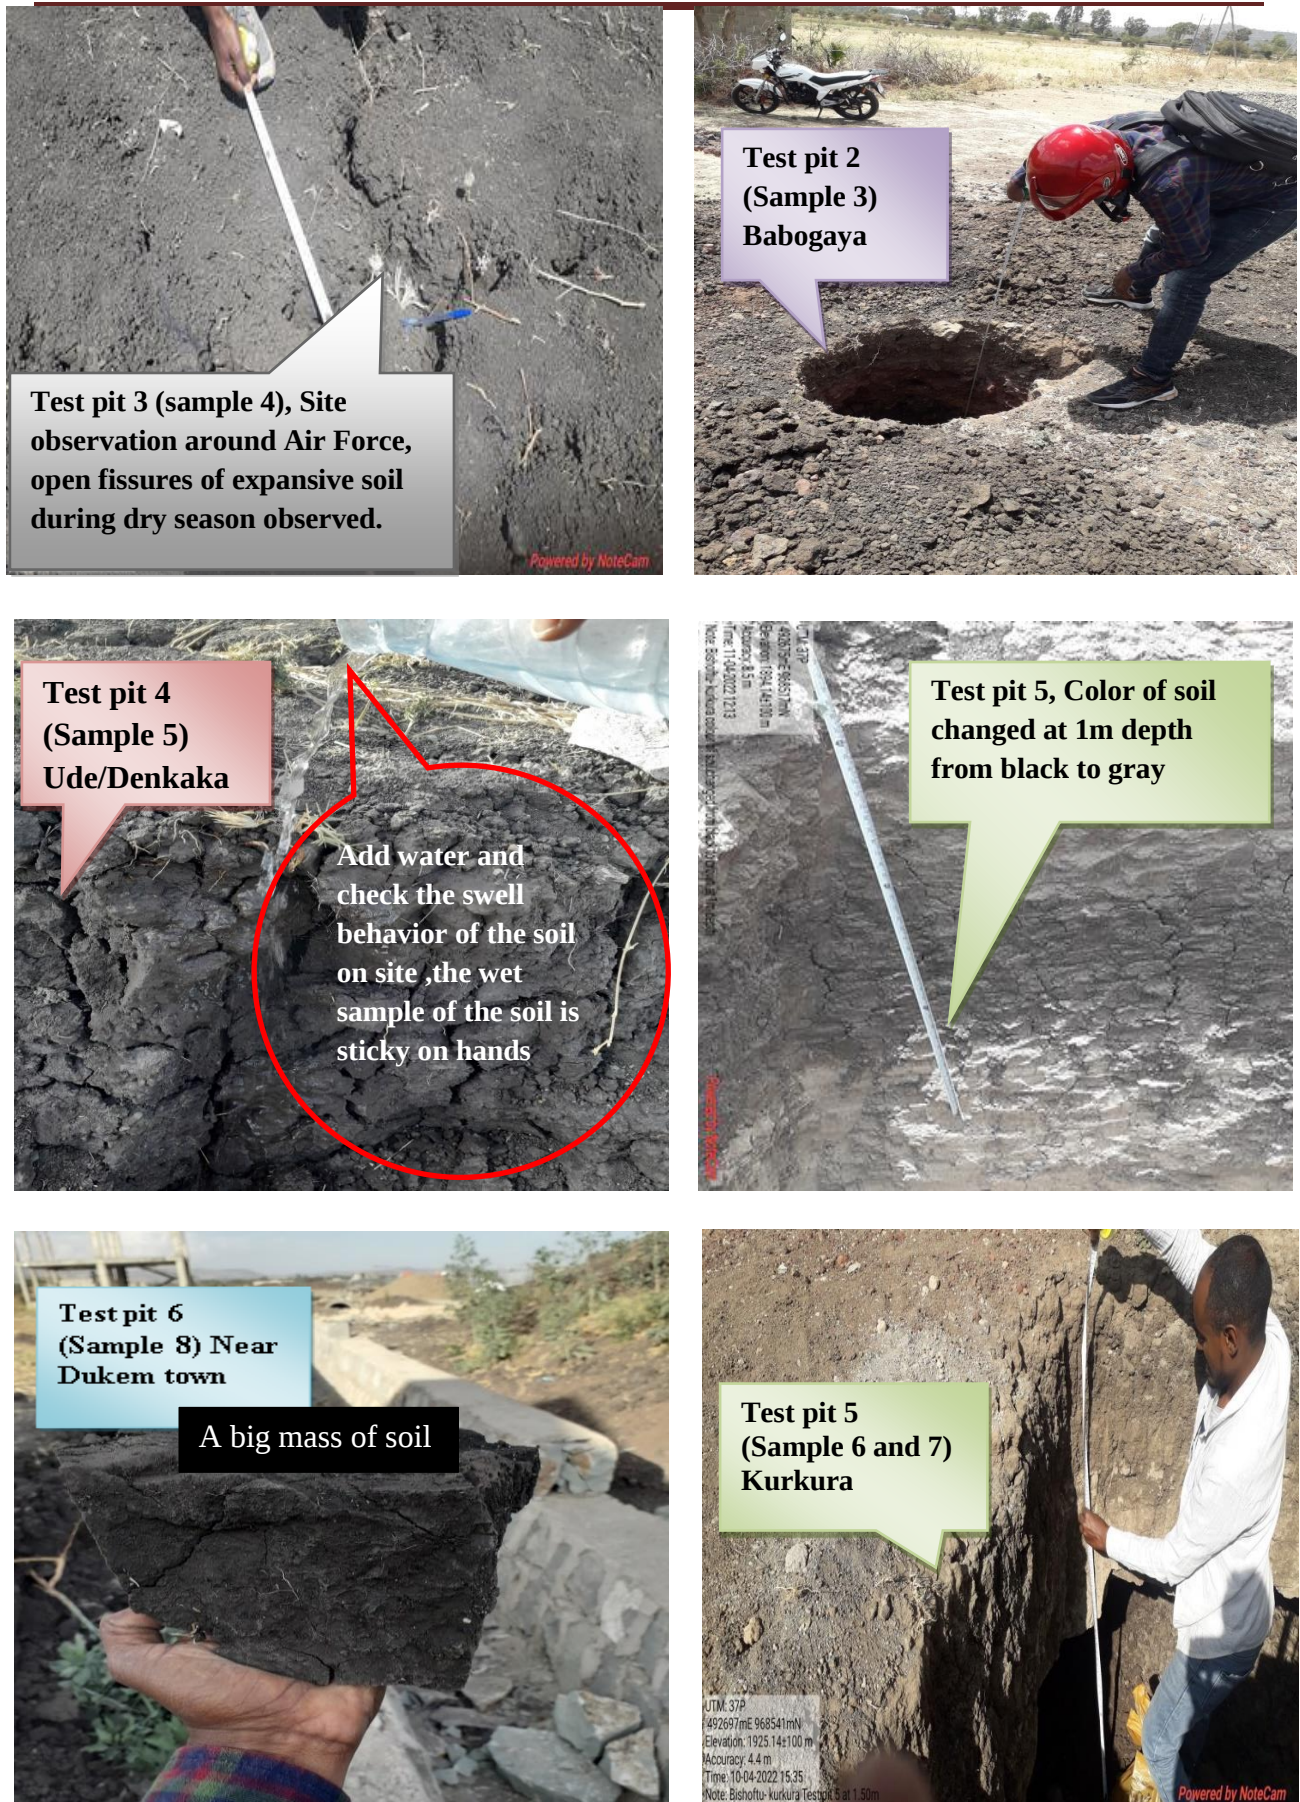
Figure 3. 3: Soil samples and site description

- ✓ Sample 1 and 2 from the compound of individual house owners during toilet excavation around sunshine area at a depth of 1m and 2m respectively.
- ✓ Sample 3 and 4 from holes prepared for electric pole replacement digging at a time, at a depth of 1.5m each around Babogaya and Air force respectively.
- ✓ Sample 5 from Ude/Denkaka area which is far from the center of the town circle square, samples are taken from under construction buildings at a depth of 1.5m.
- ✓ Sample 6 and 7 around Kurkura from the new G+2 building during footing pad excavation work, at a depth of 1m and 2m respectively.
- ✓ Sample 8 which is test pit 6 is around Bishoftu-Dukem border or in front of Eastern Industrial Zone, from ditch work excavation at a depth of 1.5m.

The disturbed soil was placed in a tight plastic bag with a reference tag to describe the location of the sample and the depth taken. This was done to avoid the possibility of contaminating the sample being collected. From each test pit 15kg of soil sample was taken. Samples taken from Ude/Denkaka and Near Dukem town are far from the center of the town Circle square, this makes in order to compare and contrast what look like the properties of expansive soil found in and around Bishoftu town. From investigation, expansive soil is dominated in the North, East and West part of the town. Soil samples and site description are given in Figure 3.1. The location name, the test pits designation, physical properties of the soil and the depth where the samples taken are shown in Table 3.1.

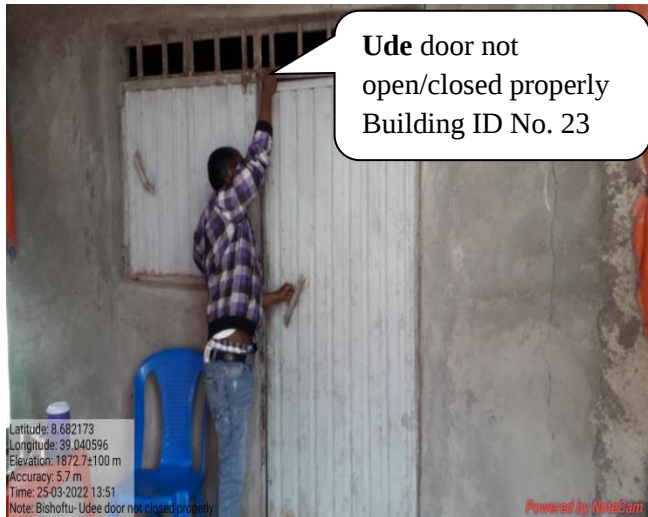
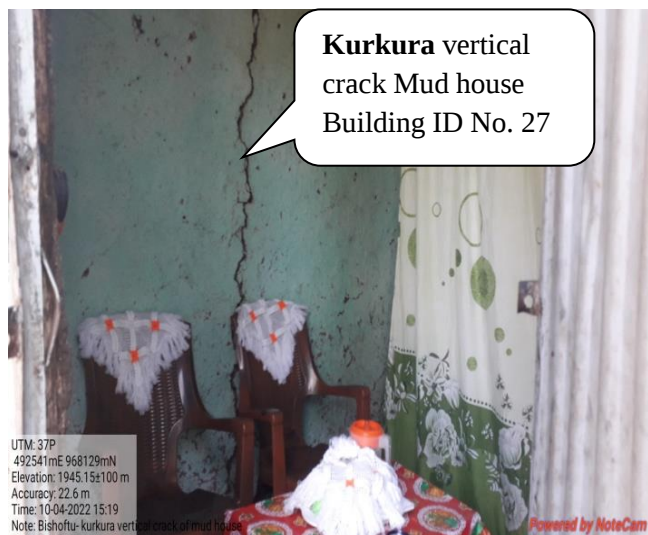
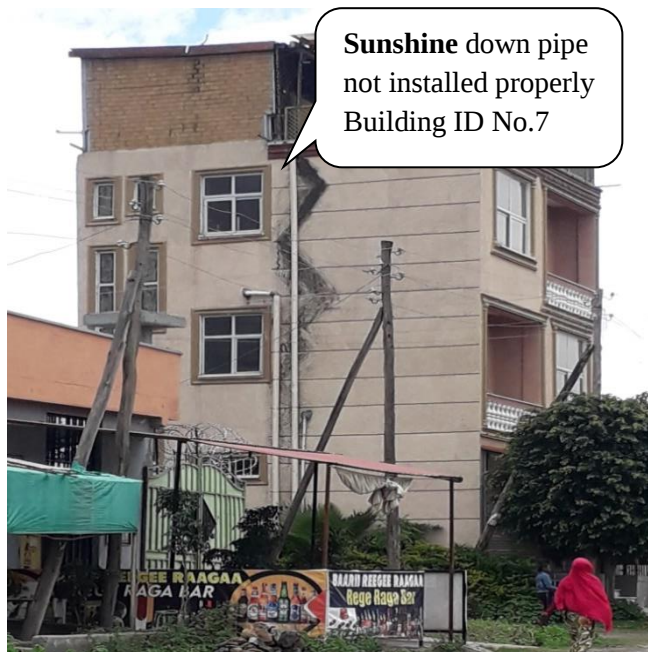
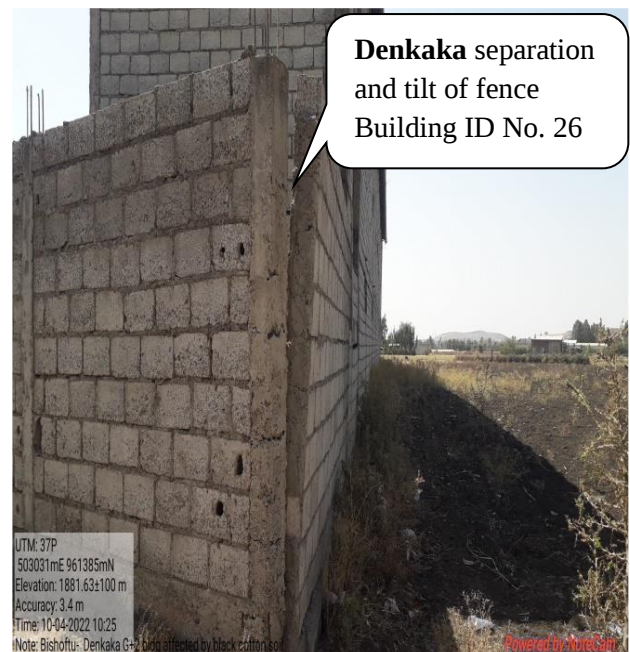
Figure 4. 12: Damage of some inspected buildings with type of building and its elements.

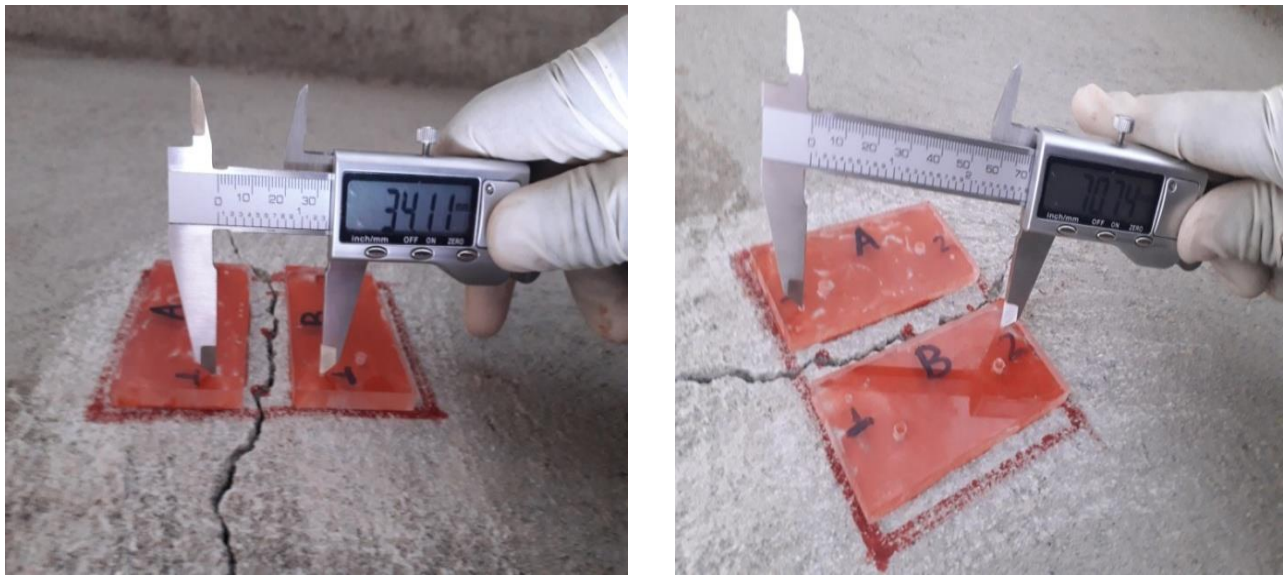
Figure 4. 13: 2D crack monitor measuring across and along the crack Building ID No.26

Figure 4.13 shows the initial reading data taken on June 4, 2022 from Denkaka G+2 building (Building ID No. 26) at first floor horizontal crack.

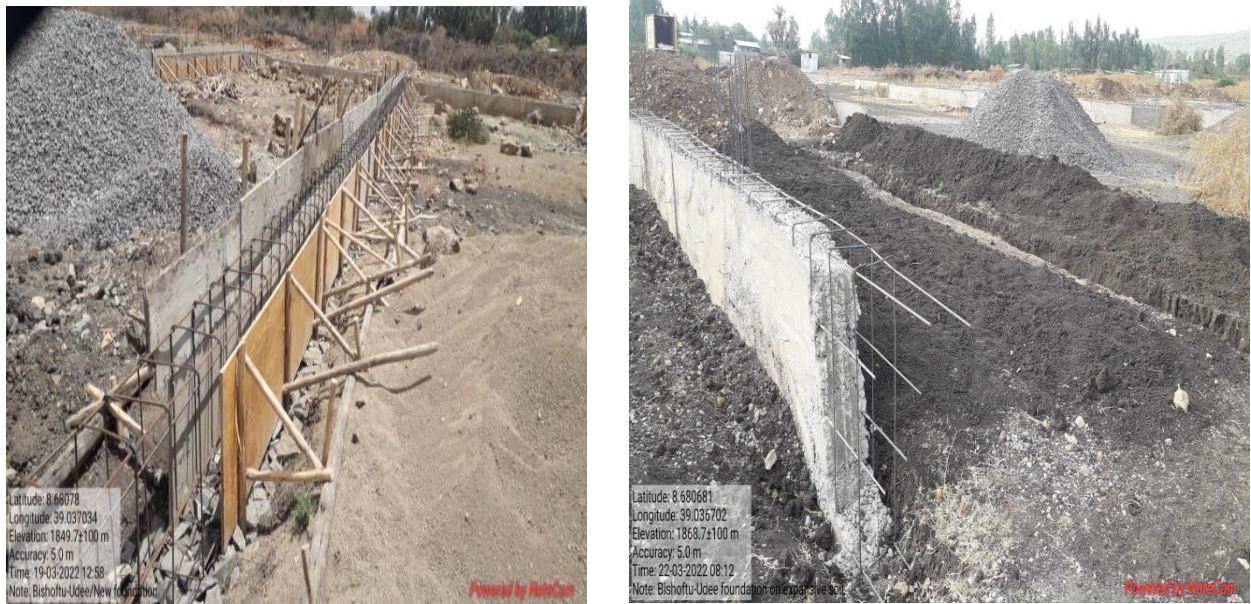
Figure 4. 16: Plinth beam foundation for G+0 buildings
