# **Analyzing Corrosion and Modeling of Damage Phenomena for Drinking Water Pipelines**

Presents in Fulfillment of the Requirement for the Degree of Doctor of  
Philosophy in Manufacturing Engineering

Adama Science and Technology University

April 2023

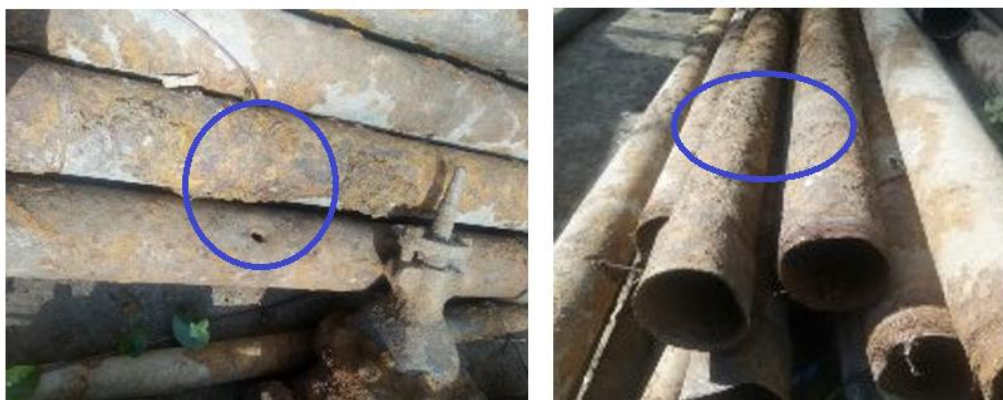
Figure 1.2 Photograph of pipe corrosion patterns
