**SLOPE STABILITY AND WATER TIGHTNESS ASSESSMENT OF GOLOLCHA  
DAM SITE, WEST HARARGHE ZONE, EASTERN ETHIOPIA.**

**A THESIS SUBMITTED TO THE DEPARTMENT OF APPLIED GEOLOGY**

**PRESENTED IN PARTIAL FULFILLMENT OF THE REQUIREMENT FOR THE  
DEGREE OF MASTER'S IN ENGINEERING GEOLOGY**

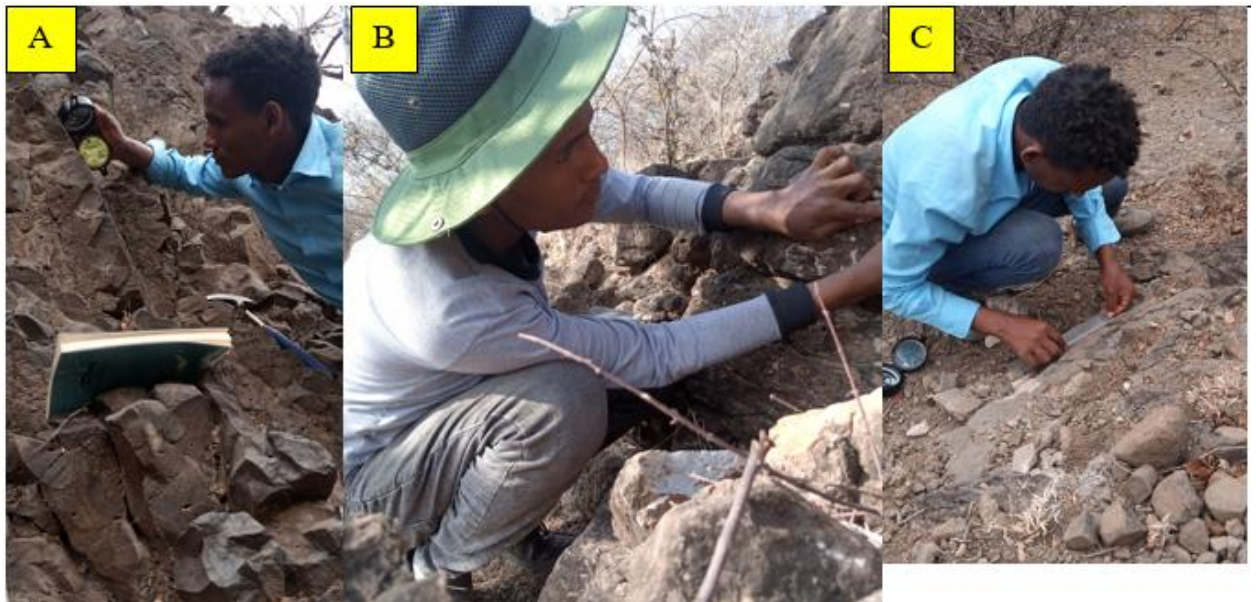
Figure 3. 1 Discontinuity survey from abutments and reservoir: A) Measuring dip direction and dip amount using Brunton compass, B & C Measuring discontinuity characteristics using ruler.

A numerical description of discontinuity characteristics like orientation, roughness, spacing, persistence, continuity, aperture (openness), filling material, groundwater condition, and joint set number was collected from exposed rocks at the abutment and reservoir. The orientation of the discontinuity was taken into account for rock slope instability and leakage potential during the discontinuity data collection. Also measured were slope geometry properties like dip and dip direction. A Brunton compass was used to measure joint orientations such as strike, dip, and dip direction, while a meter was used to measure spacing, continuity, and aperture (Figure 3.1).

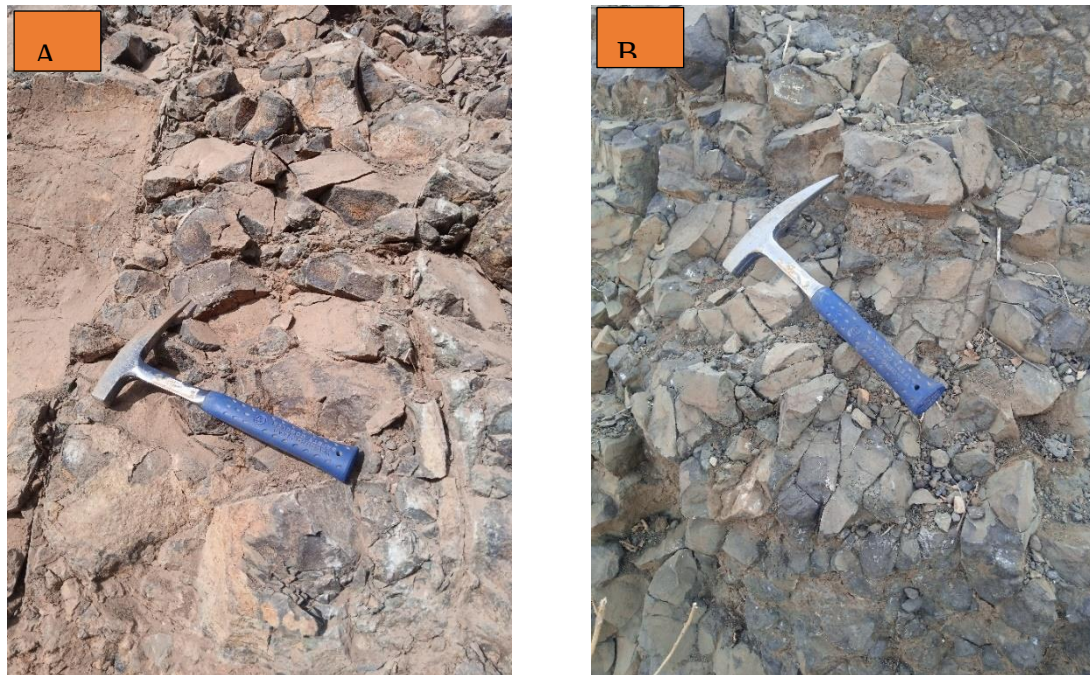
Figure 4. 2 Basalt exposure (A) exposure from the spillway and (B) exposure from the right abutment of dam axis moderately to highly weathered

abutment of the dam site (Figure 4. 5). It is highly fragmented and fractured at the exposed site in the reservoir area as well as on both right and left abutments of the dam. The unit is affected by pervasive jointing and fracturing. It is characterized by dark grey fresh colour and reddish to brownish weathered colour, moderate degree of weathering, aphanitic texture and highly fractured Figure 4. 2.

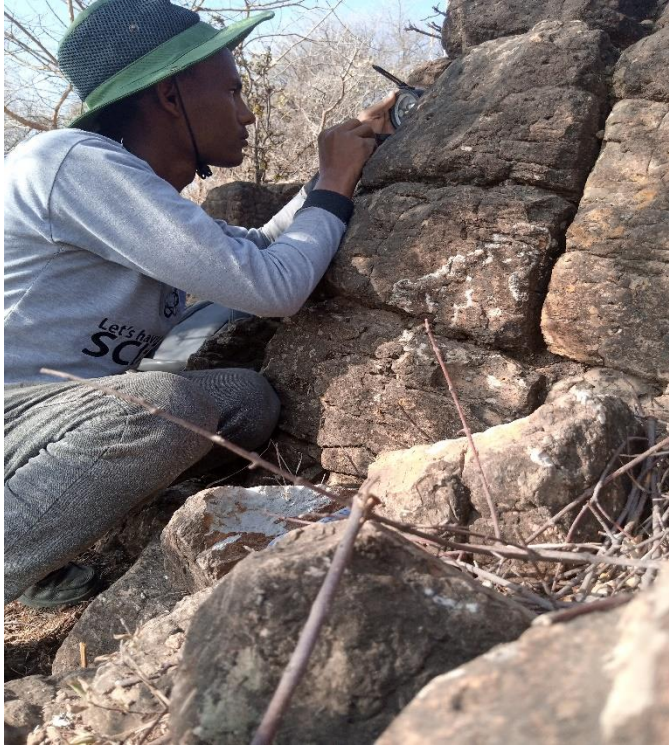
Figure 4. 3 Rhyolite exposure from downstream of left abutment

This rock unit is exposed at the left abutment on downstream of the dam axis (Figure 4. 5). It forms typically cliff and rugged topography as compared to the underlying sedimentary unit. It is characterized by high degree of weathering. The unit is frequently affected by intense vertical jointing (Figure 4. 3). It is fine grained and characterized by light creamy to grey colour, darkish brown colour on weathered surfaces. It can be a potential source of construction material for the dam as it is located closer to dam site.

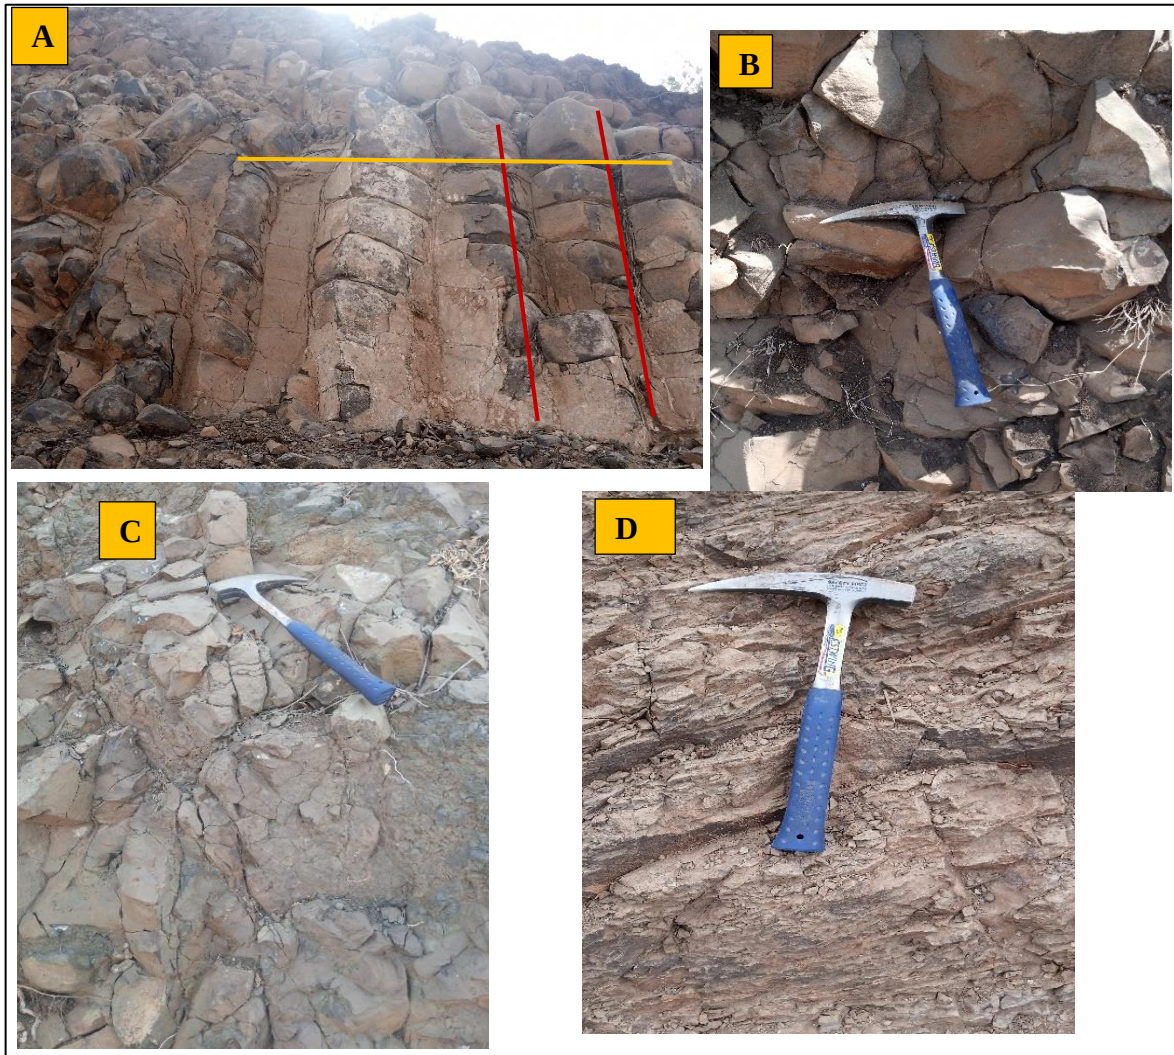
Figure 4. 4 Different joints at (A) Spill way, (B & C) right abutment and (D) left reservoir rim

In the study area, the joints are observed on exposed rock mass in dam abutments, reservoir rims and in excavated spillway area. The strike orientation and properties (persistence and spacing) of the joints are very complex, since the rock masses are highly fractured as shown in Figure 4. 4B, C&D. whereas, at excavated spillway area there is horizontal and vertical joint set as shown Figure 4. 4A.

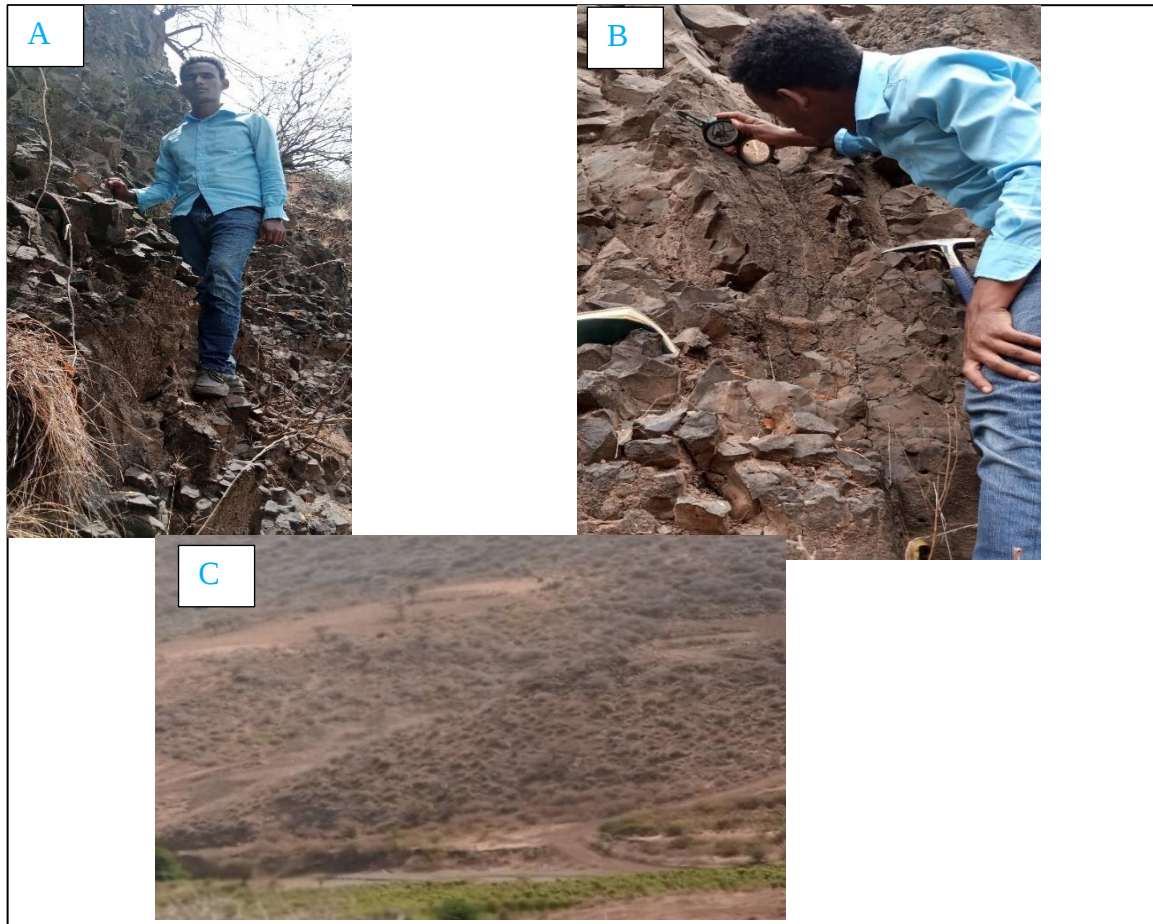
Figure 5. 20 Slope section from right abutment (A & B) RAS 2 and (C) RAS 1

Kinematic method employed the dip amount and dip direction to identify the possible mode of failure. The deterministic approach employed the geometry of the slope and shear strength parameters (cohesion, friction angle) and the unit weight of material, to determine slope stability in terms of the safety factor. From fieldwork slope geometry was measured, whereas the shear strength parameters (cohesion and friction angle) of rock used in the analysis were estimated from Hoek-Brown failure criteria using RocData software and the unit weight was determined from lab test. In addition, the slope geometry (height and slope angle) and material parameters during the stability analysis, external loads such as horizontal seismic acceleration and groundwater conditions were also taken into account. The study area is found in high seismic risk zone and horizontal seismic load coefficient with a magnitude ( $\alpha$ ) = 0.1 was considered for the analysis under dynamic condition (Ayele, 2017).
