**ASSESSMENT OF PRACTICAL IMPLEMENTATION CHALLENGES OF SOLAR-POWERED RURAL WATER SUPPLY SYSTEMS: THE CASE OF BOLOSO SORE WOREDA IN WOLAYITA ZONE, ETHIOPIA**

**A Thesis Submitted to the Department of Water Resource Engineering and Management, School of Civil Engineering and Architecture**

**Presented in Partial Fulfilment of the Requirement for the Degree of Master's in Water Resource Engineering (Specialisation in Water Supply and Environmental Engineering)**

**Adama Science and Technology University**

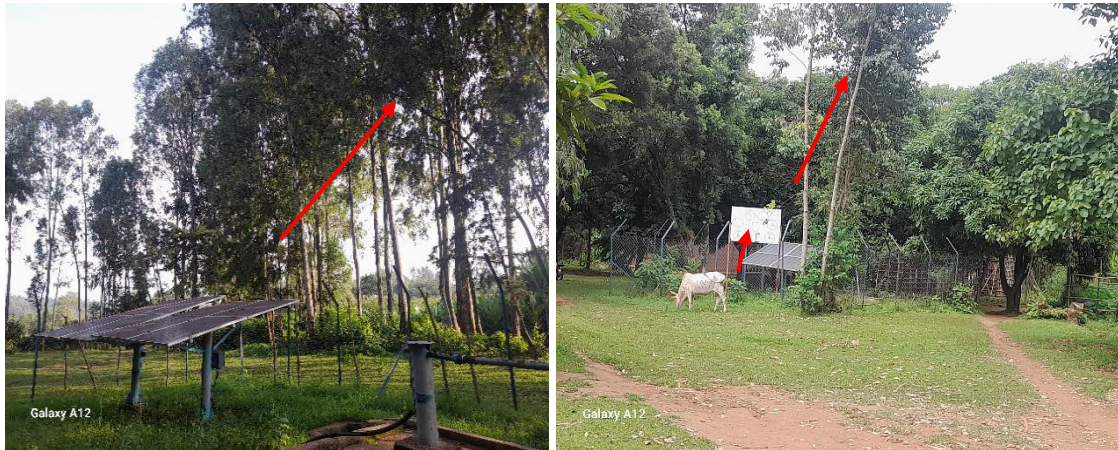
One of the assessment findings in **Table 6** indicated that 26 out of 345 respondents identified malfunctioning solar panels as a challenge. However, the issue was not related to technical problems; instead, it was caused by a cluster of trees located very close to the solar panels, which shaded them and blocked sunlight (**Appendix 14**). Almost all of the solar panels were found dirty during the physical observation as shown on the pictures (**Appendix 15**). Moreover, none of the operators have a routine cleaning schedule in place.

***Appendix 14. Solar panels shaded under long trees in Dubo and Achura Kebeles***

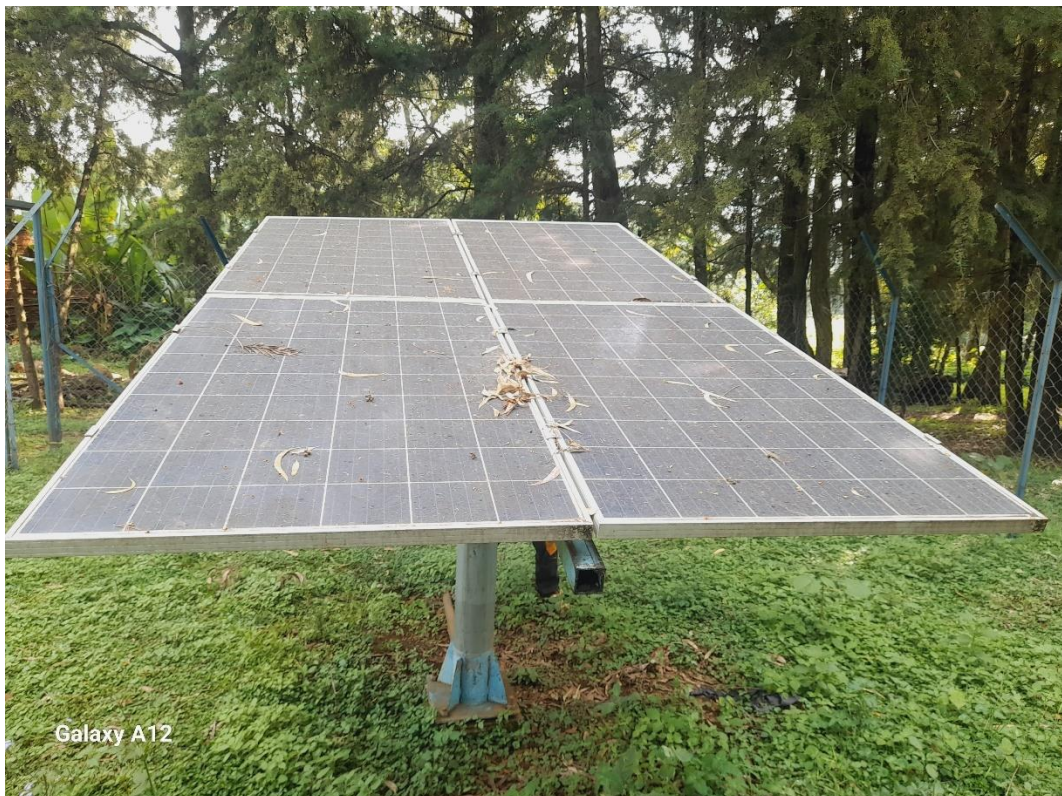
***Appendix 15. A solar panel full of dirt in Dijala Village, Wormuma Kebele***

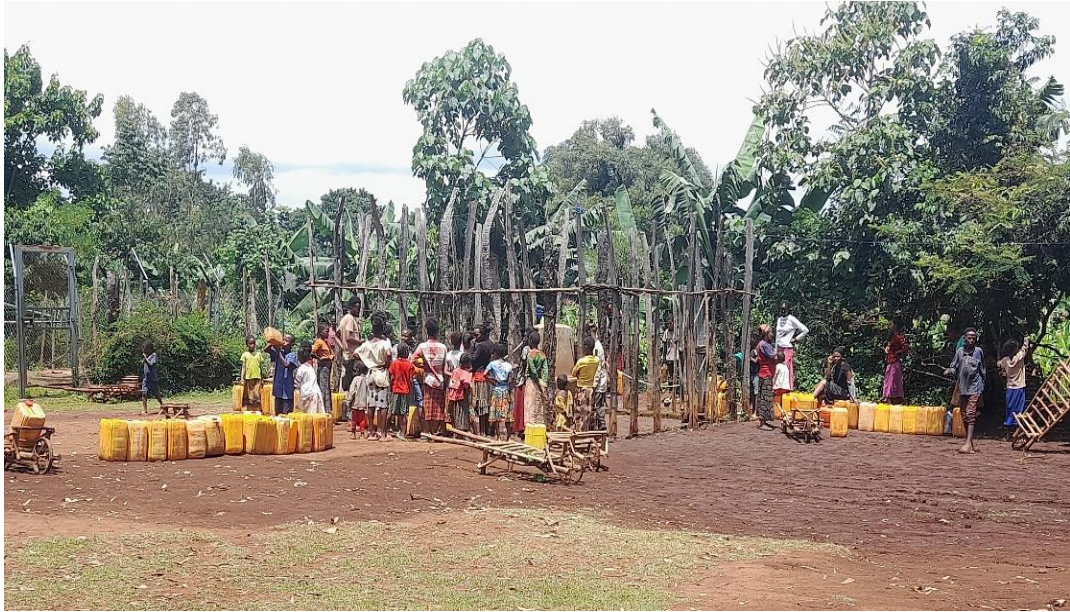
*Appendix 16. A large number of people waiting at water points in Mante Village*

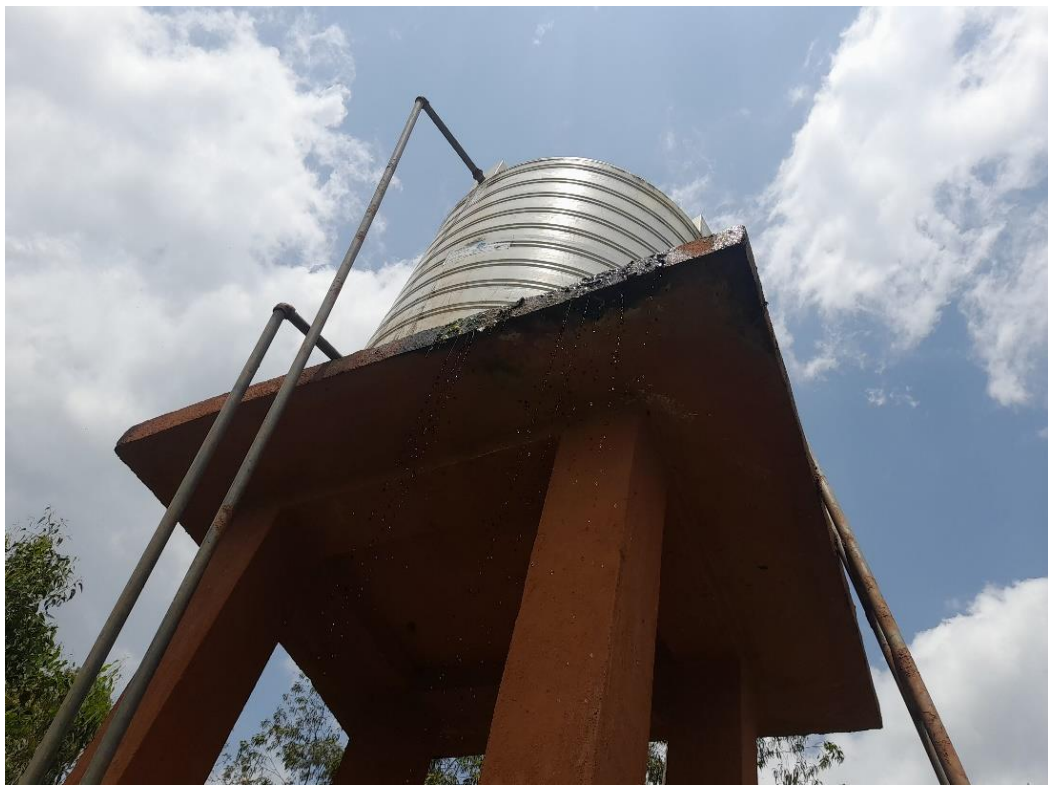
In addition to the proper design of the service reservoirs, two reservoirs were totally collapsed. The remaining five were leaking water, as shown in **Appendix 17**, causing a water loss that, in turn, affected the quantity of water the community could get from the water supply system. Similarly, one reservoir in Ocha village of Dubo Kebele was totally damaged, and the communities were forced to replace it with two plastic reservoirs of 1 m<sup>3</sup> each, putting the total storage at 2 m<sup>3</sup>, implying a loss of 8 m<sup>3</sup> in the quantity of water stored for distribution. Therefore, the water stored in the two replaced reservoirs gets empty within an hour, and it needs another three hours to fill before the community expects water to fetch from the water points. Additionally, all seven systems have inadequate storage for a one-day household demand. It is worth noting that longer water collection time was mentioned as a leading problem in all sites which directly relates to the available/storage capacity. The submersible pumps were reported to malfunction by 19% of respondents, and this could be due to the frequent starting and stopping of the pumps due to inadequate storage capacity. The same has been flagged on the national level operation and maintenance guidelines, which state that frequent pump starting and stopping causes overloading, hereby reducing the life of the equipment (Ministry of Water, 2018).

*Appendix 17. Reservoir leakage problem in Mante Village, Dubo Kebele*

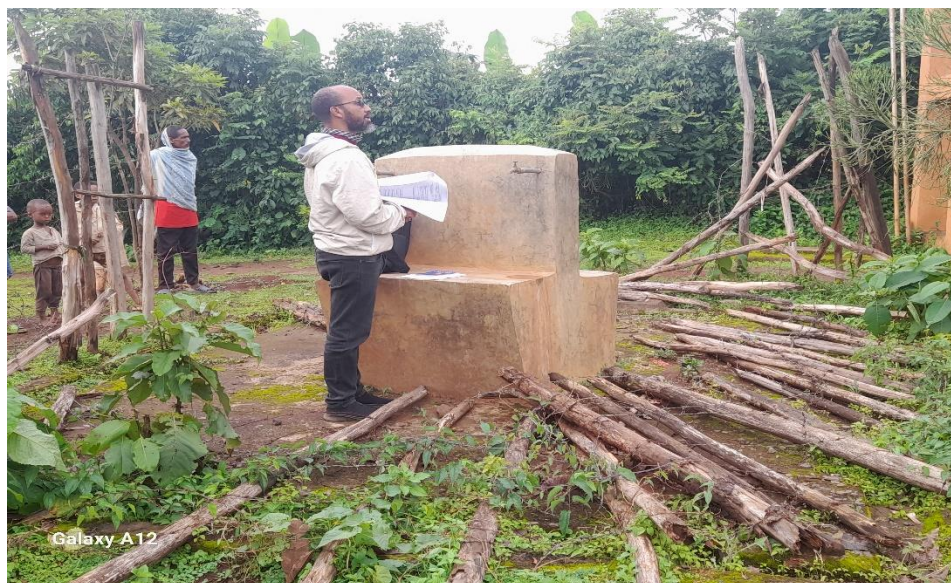
***Appendix 18. Damaged water point fencing in Boyna Kare Village***
