# ASSESSMENT OF CAUSE OF ROAD PAVEMENT FAILURE ALONG TEJI-TULU BOLO ROAD

A Thesis Submitted to the Department of Civil Engineering School of Civil Engineering  
and Architecture

Presented in Partial Fulfillment of the Requirement for the Degree of Master's in Civil  
Engineering (Geotechnical Engineering)

August, 2023  
Adama, Ethiopia

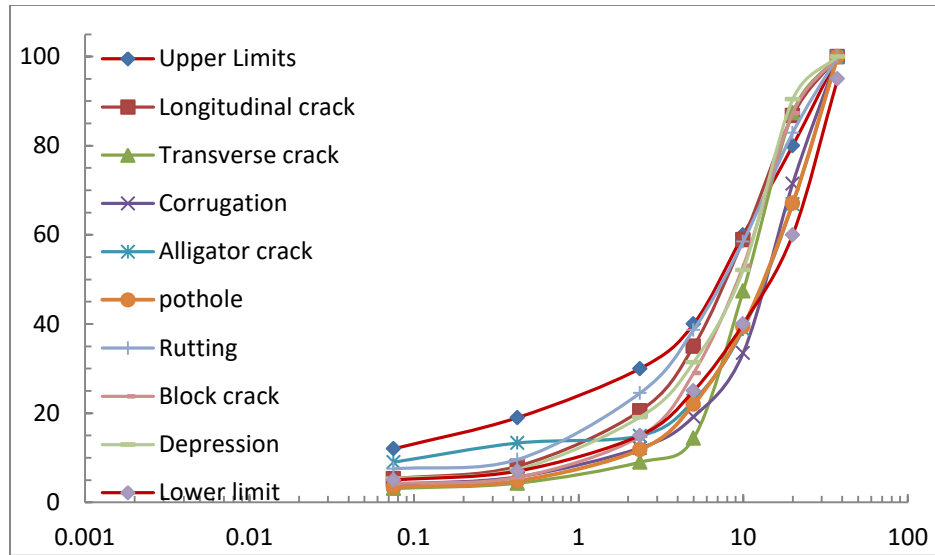
Figure 26 : Section B Grain size distribution of Base Course layer

The base course layer at every section of this segment was constructed with base course material obtained from crushed basaltic rock. Therefore the laboratory test results for gradation is compared with gradation envelop of crushed rock. The results showed that from all the three sections only C sections was within the limit. On the contrary gradation curve of section A alligator crack shows the material is finer than expected since it occurs above the upper limits curve and gradation curve of section B transverse crack shows the material is courser than expected since it occurs below the lower limits curve and this implies base course material at this two spot is poorly graded.

Poorly graded material would never be dense and durable since it lack in mechanical interlocking of various particle sizes. Due to less supporting resistance, it was displaced under stress as a result. Therefore, poorly graded base course materials may be the reason for the manifestation of section A alligator crack and section B transverse crack on the road sections.
