Assessment and Characterization of Road Embankment Failure

Along Bako-Shanbu Road Project

A Thesis Submitted to the department of civil Engineering

Adama Science and Technology University

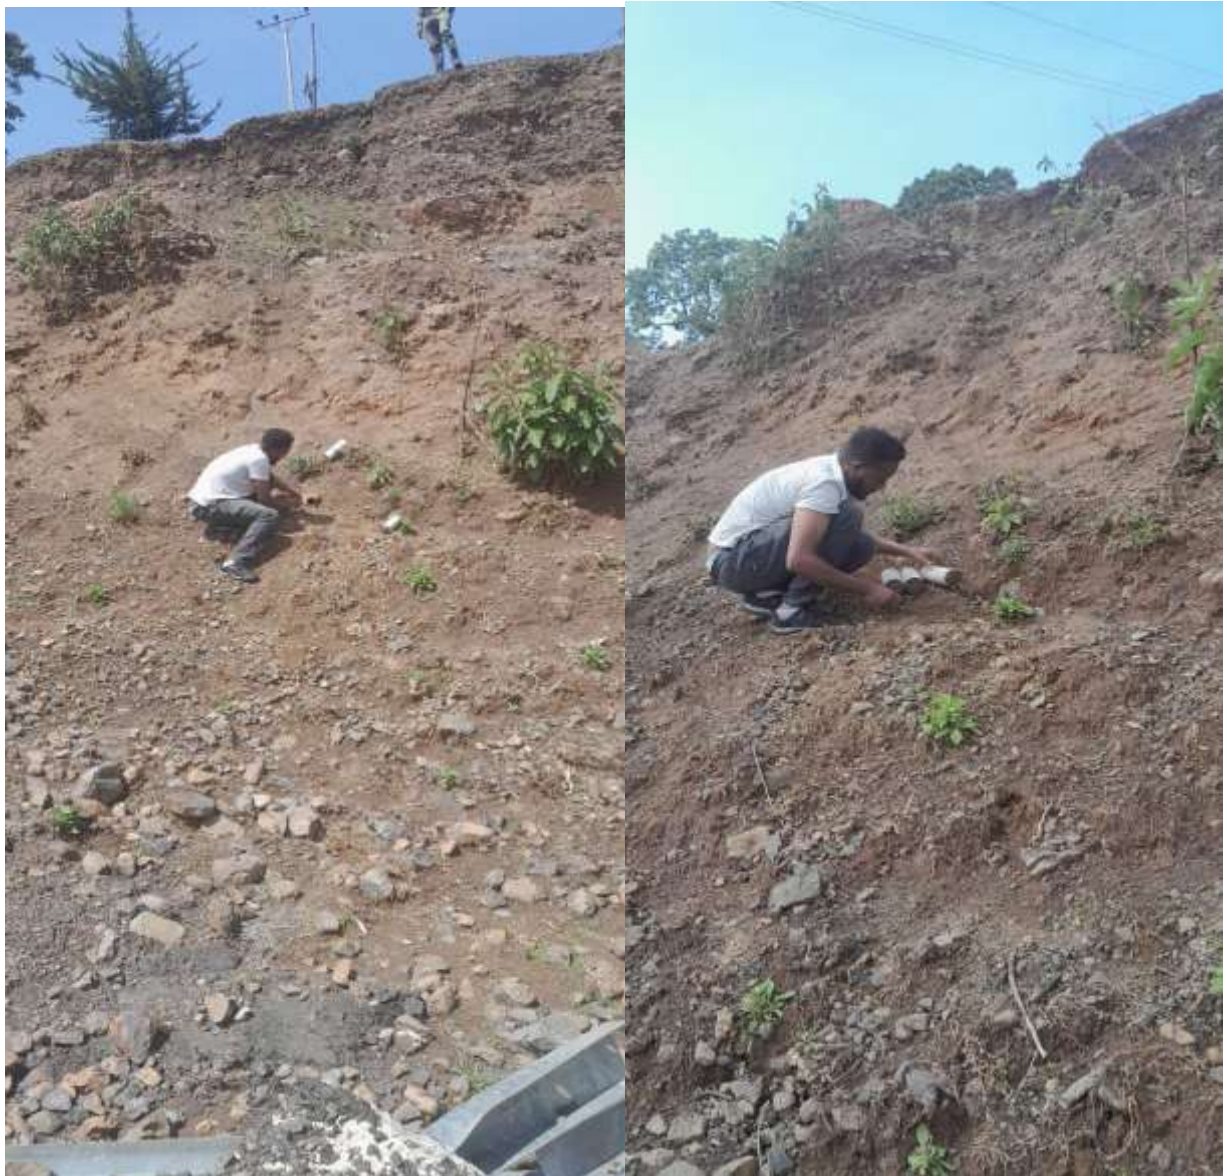
The undisturbed collected samples using cylinder tube and tied to plastic bag to prevent moisture loss was used for Direct Shear test for the determination of Shear strength parameters and in situ natural moisture content. The UN disturbed samples were collected from top, middle and bottom of the failed embankment at a depths of 1m, 5m and 9m.

Figure 3.11: Sample of Undisturbed Soil at different depths of Site 7 at station 104+140

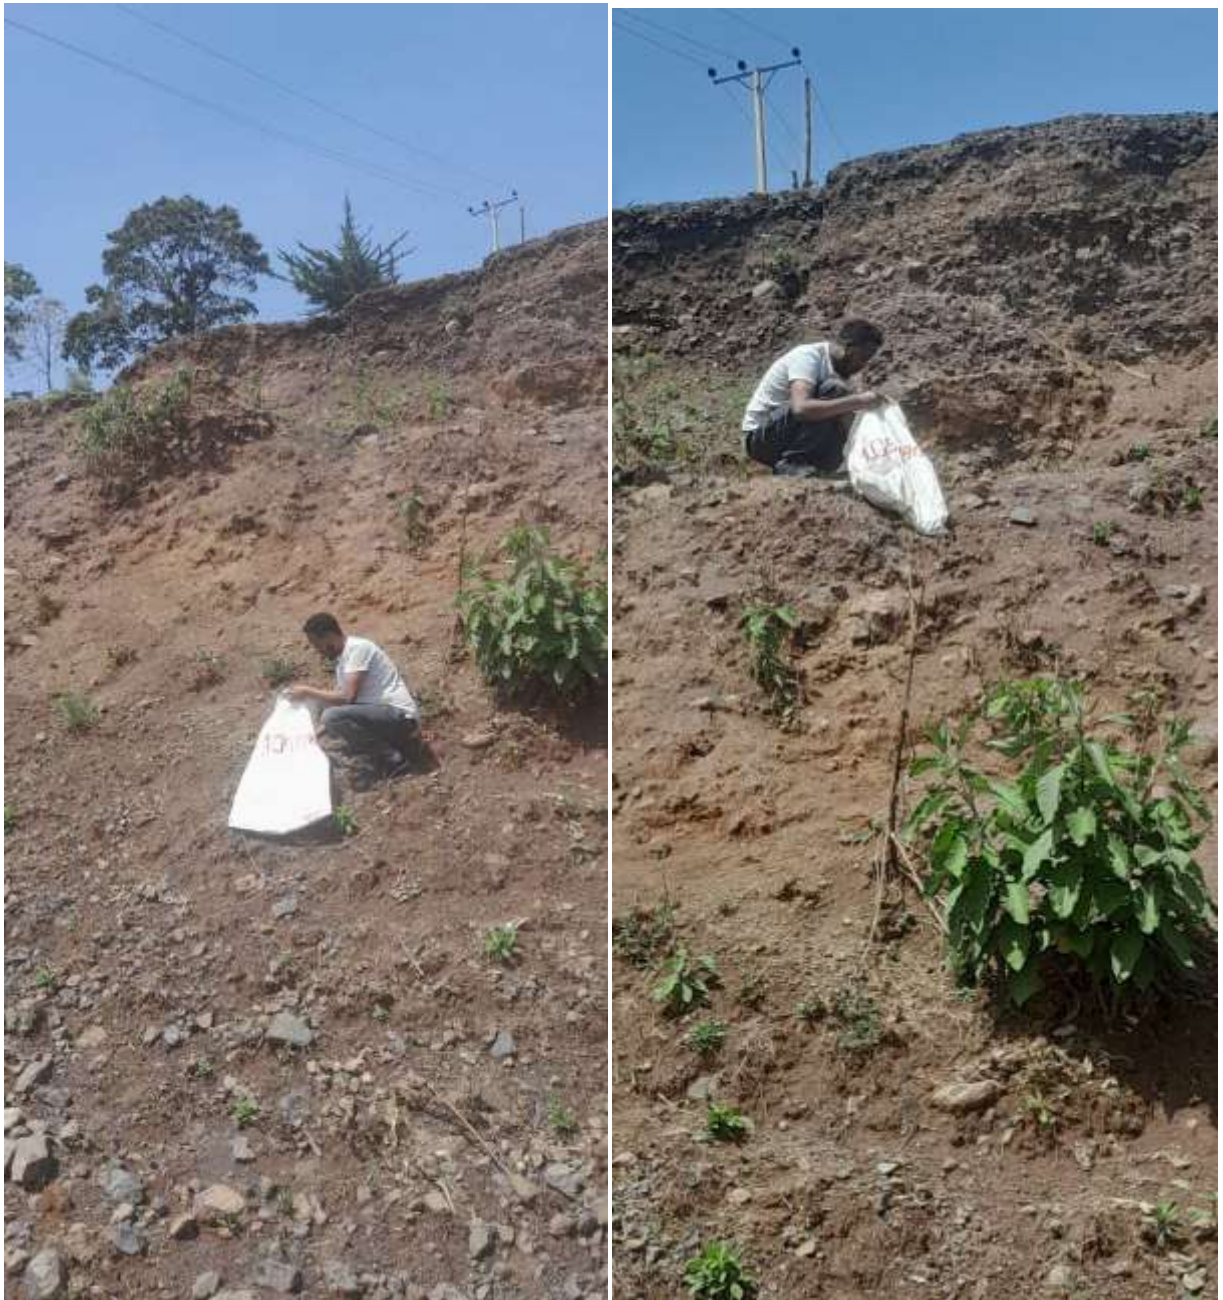
The Disturbed samples were also collected from top, middle and bottom of the failed embankment at a depths of 1m, 5m and 9m. And index and engineering properties of soils including liquid limit, plastic limit, plastic index, moisture content, unit weight soil classification, specific gravity were determined.

Figure 3.12: Sampling of Disturbed Soil at different depths of Site 7 at station 104+140

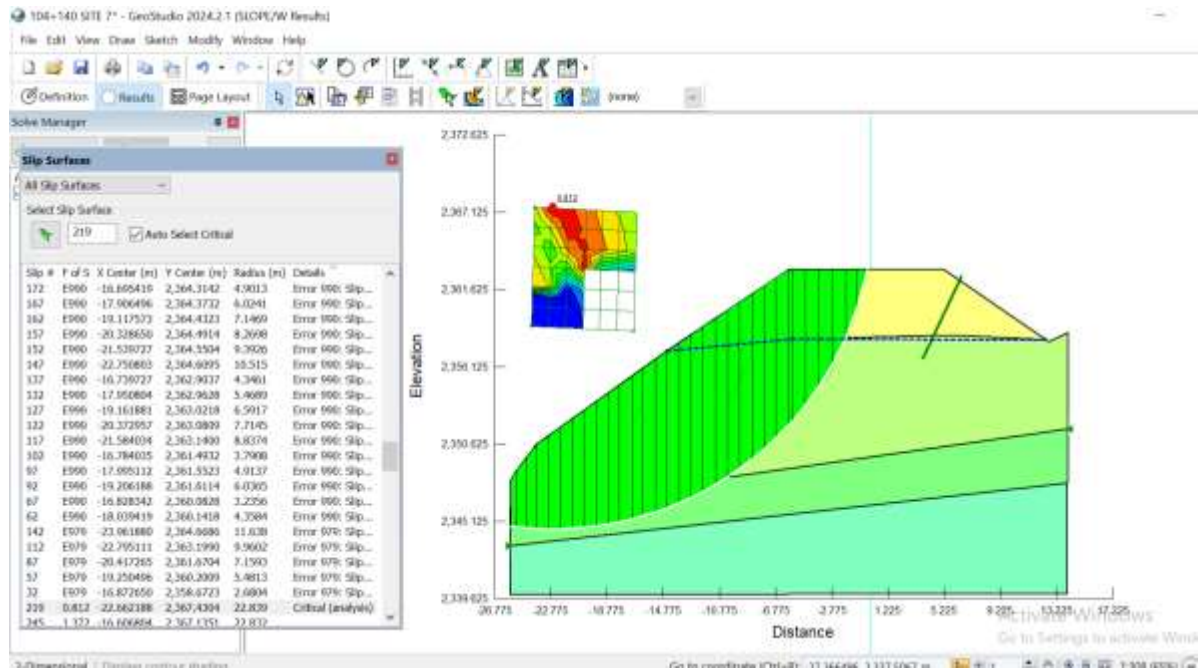
Figure 4.2: Critical Slip Surface using M-PM method

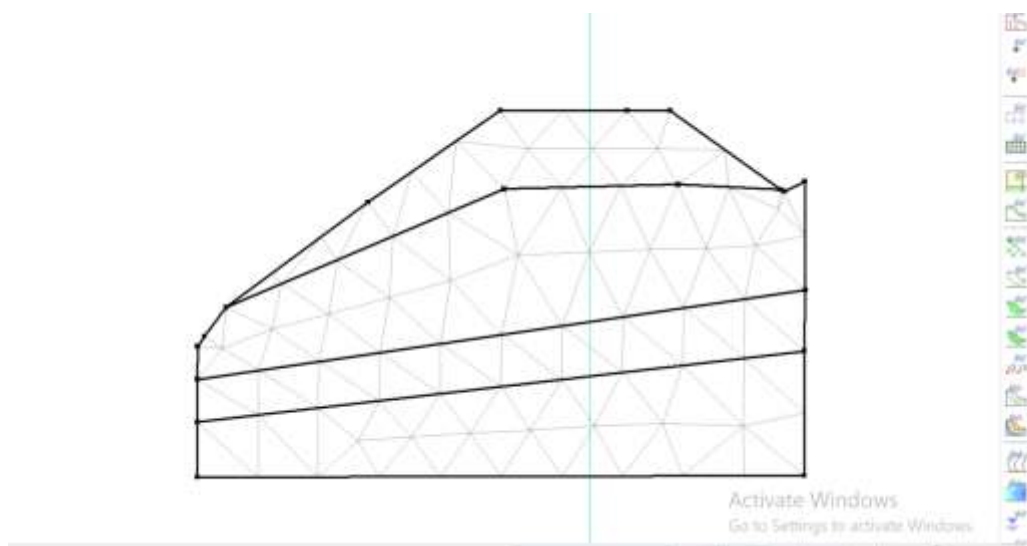
Figure 4.8: Meshing during running a software

6. Generating a Mesh after drawing the slip surface, then running the software and a number of triangulations are formed for defined numbers this triangulations are called meshes. after meshing the factor of safety are computed.

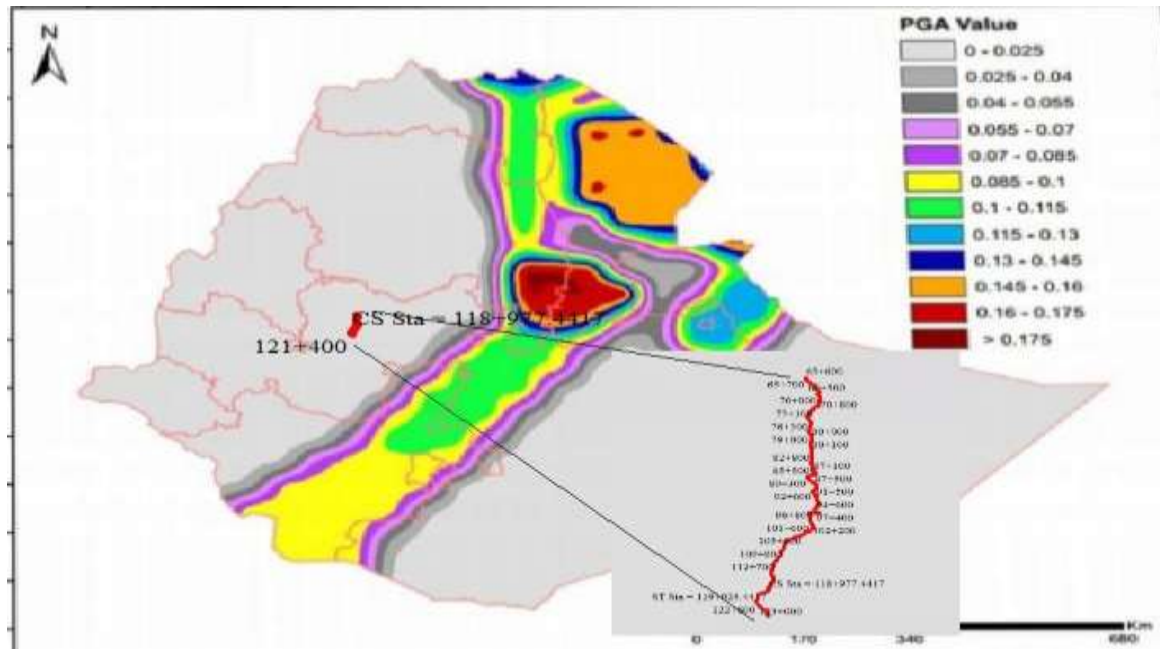
Figure 4.11: Seismic map of the study area

The seismic zone of the study area is belongs to Zone 0: Very low seismicity, seismicity has not been considered in the slope stability analysis.

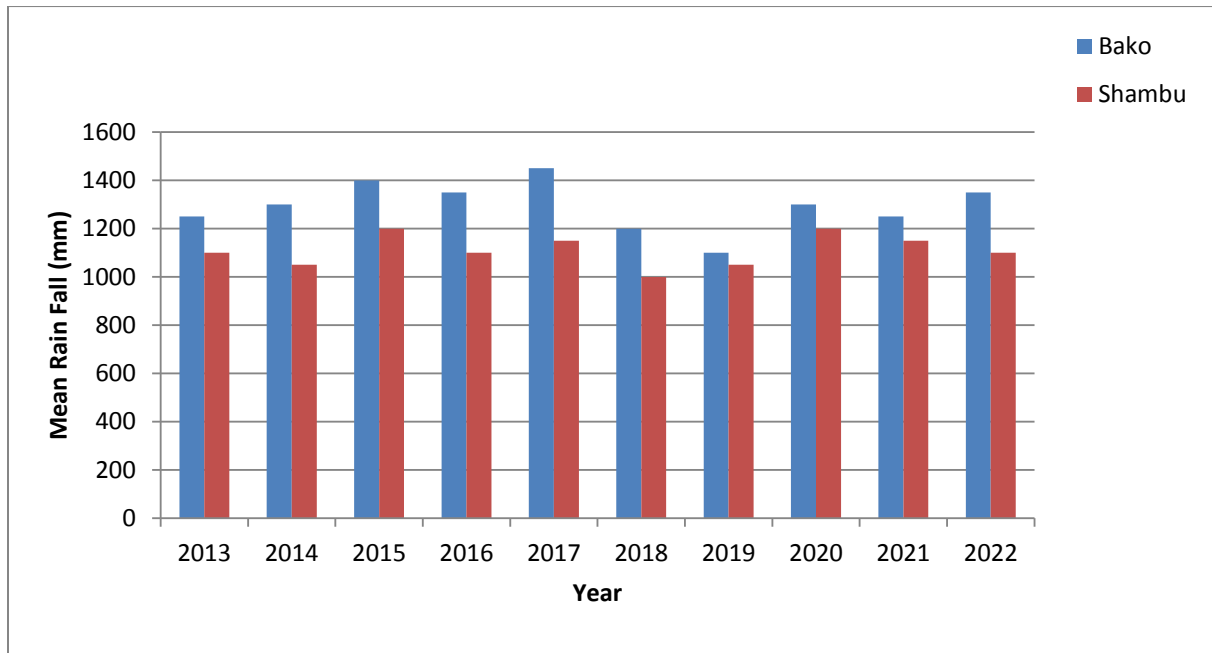
Figure 4.12: Annual rainfalls Analysis of Bako and Shambu Towns

Rain-induced slope instability is a common geotechnical issue. One of the main causes behind landslides in regions with significant annual rainfall is, predictably, the rain itself. Over time, extensive and heavy rainfall—particularly during the two monsoon seasons each year—can infiltrate into slopes and result in saturation at shallow depths (Idrus et al., 2023). For the Bako-Shambu road project, the average annual rainfall over the past decade has ranged from 1100mm to 1450mm, with specific years seeing totals between 1000mm and 1200mm. The highest rainfall recorded in Bako was in 2017, while Shambu saw its peaks in 2015 and 2020. The rainy season, primarily from June to September, brings the heaviest downpours, which further saturate the soil and reduce its shear strength, ultimately triggering landslides in the area. Thus, rainfall is a key factor to consider when assessing landslide risks in this region.
