A Project Submitted in partial fulfillment of the requirement for the  
Degree master of Engineering in construction technology and  
management.

An assessment of building defect the case : of National meteorological Agency  
head office Building .

*An assessment of Building defect: the case of the National meteorological Agency HQ Building*

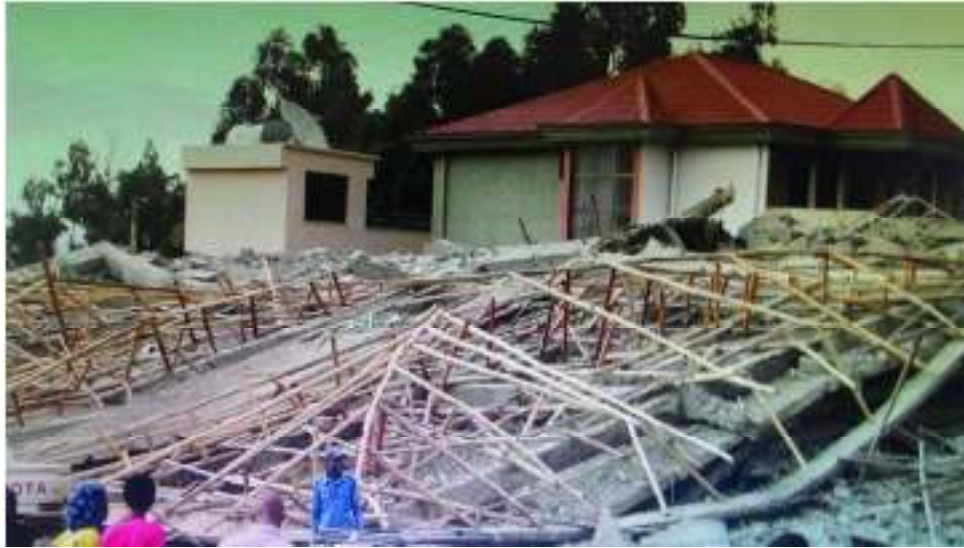
In the early hours of Wednesday, April 27, a five-storey building collapsed in the Bole district, in an area commonly known as Summit. Fortunately, its construction had not yet been completed and only the ground floor and some of the first floor were occupied.

Two banks, Abyssinia and Dashen, occupied the ground floor, while the floor above was being used as a prayer area. The time of day meant that no one was harmed, but the assets, cash and material of both banks was destroyed.

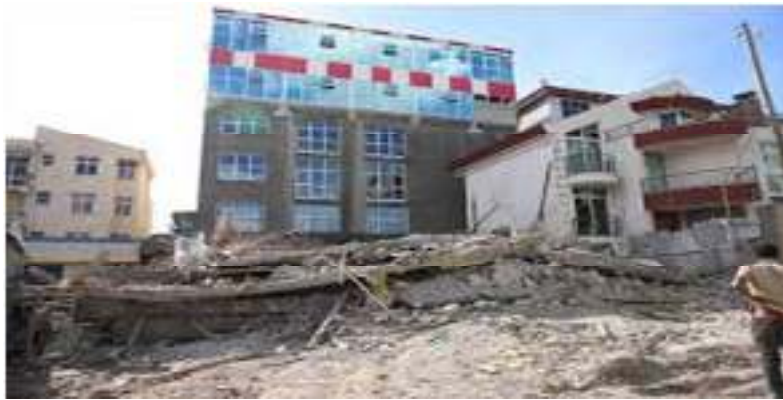
Last Tuesday morning around Summit Pepsi Industrial area in Bole Sub City, a three story building, which had been under construction for ten months, collapsed. This is the second time a building has collapsed in the same area while being constructed. No reason has been given for the building's demise and the value of the loss is not known as the incident is still under police investigation.

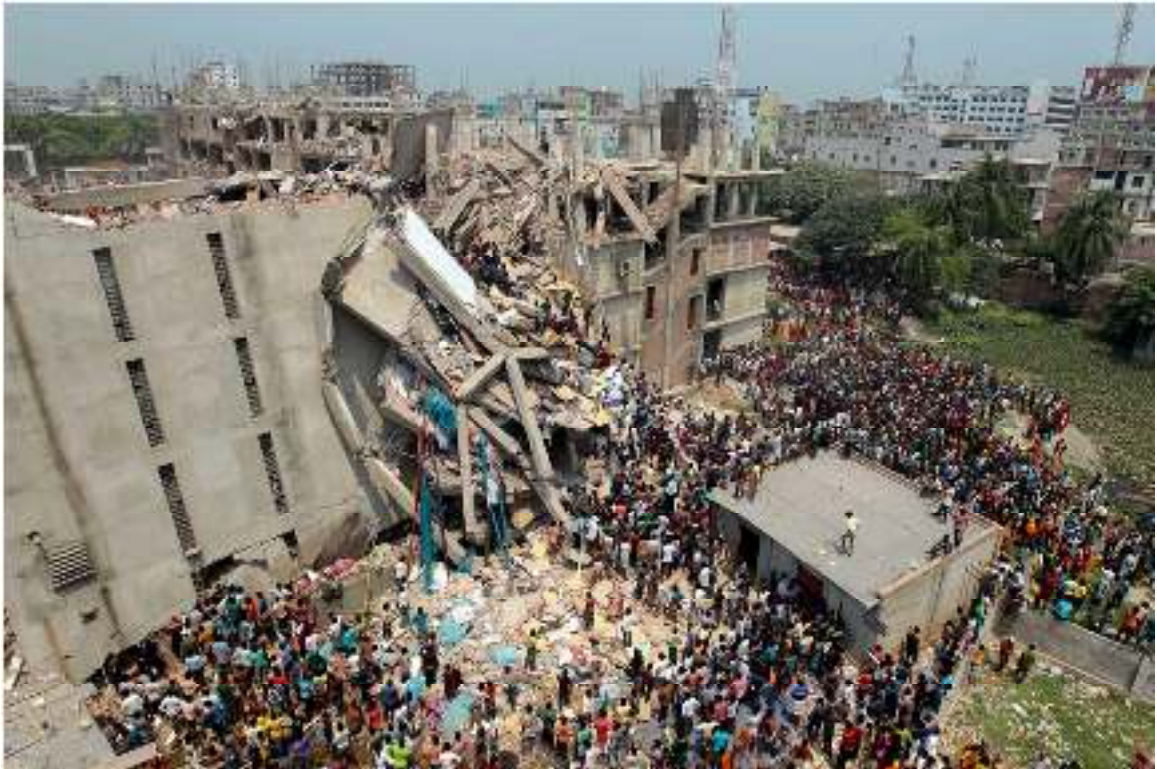
People and rescuers gather after an eight-story building collapsed near Dhaka, Bangladesh, on April 24.

**The substandard construction methods that are suspected of triggering the deadly collapse of an eight-story building in Bangladesh on Wednesday are a common problem in developing countries, where construction materials can be expensive and building inspections infrequent, experts say.**

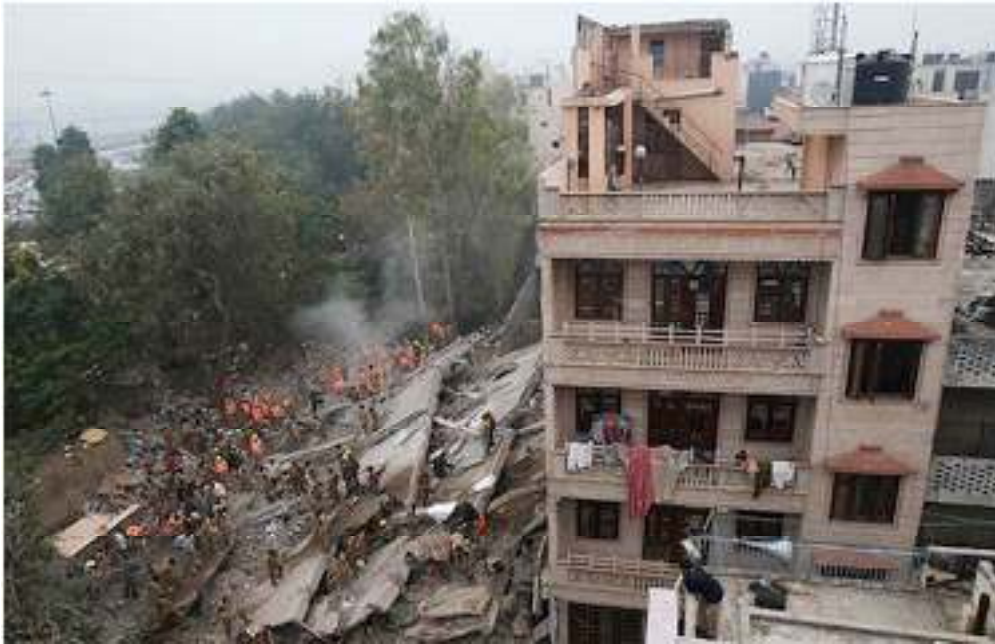
## **Delhi Building Collapse, New Delhi, India**

On November 15, 2010, monsoon rains and a swollen river proved too much for a poorly constructed tenement building in New Delhi, India. Tragically, 67 people died in the collapse and a further 150 were injured.

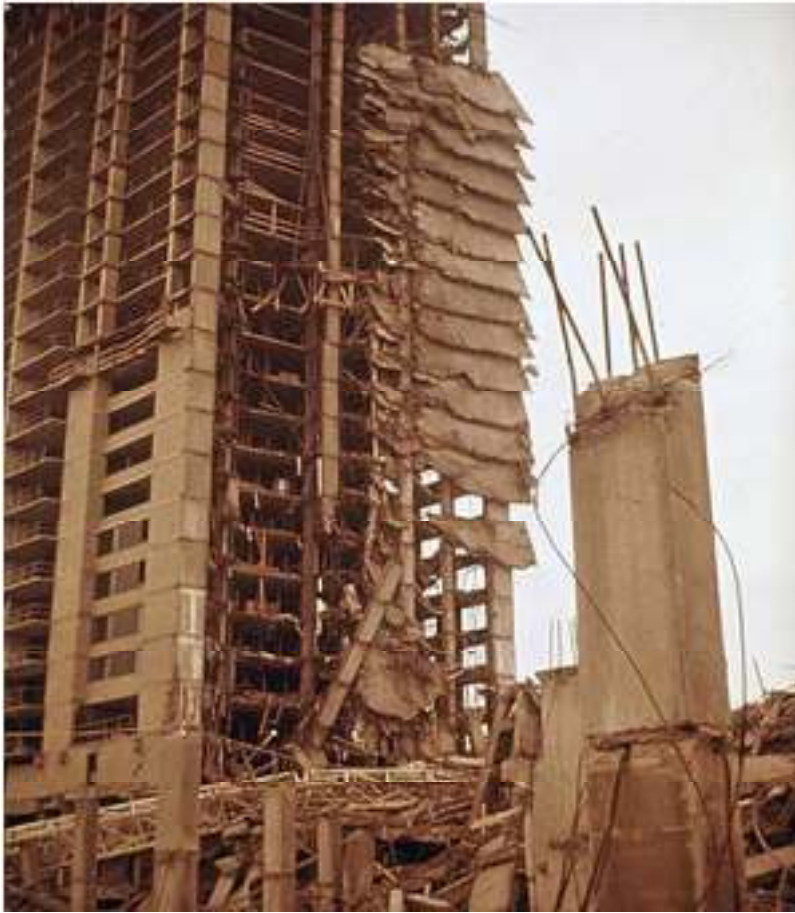
## Skyline Plaza, Virginia, USA

On March 2, 1973, tragedy struck the Skyline Plaza complex in Bailey's Crossroads, Virginia. One of the complex's towering apartment buildings collapsed, leaving a huge, eerie cloud of dust and debris where it once stood. Perhaps surprisingly, construction hadn't even completed at the time of the disaster. The building was not due to open until August.

Although there was no flaw in the design per se, the forms supporting the concrete columns on the 22nd floor were prematurely removed. The cement hadn't yet hardened completely and couldn't bear the weight of the 24th floor.

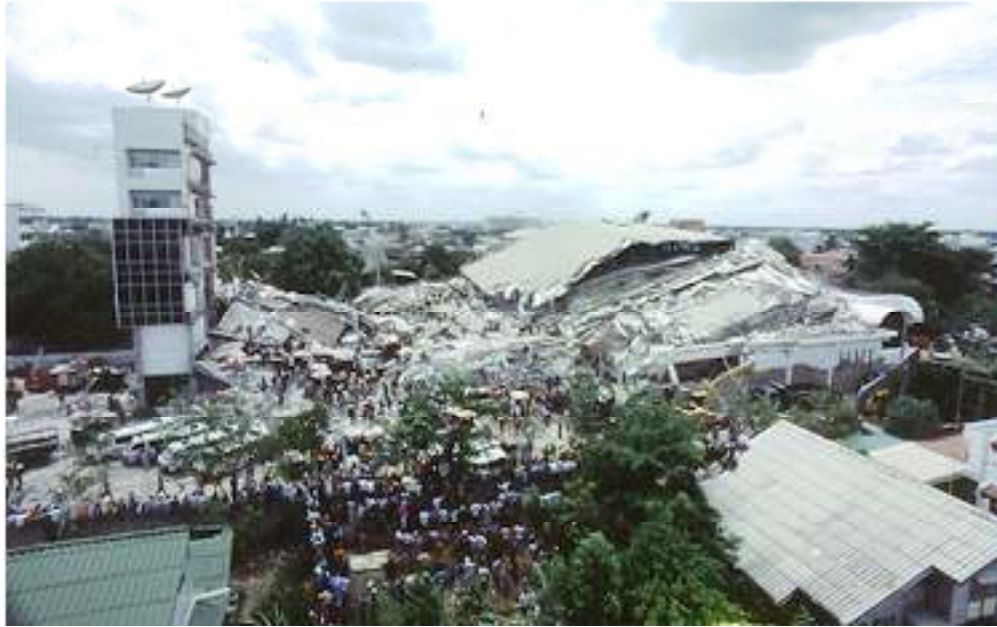
### **Royal Plaza Hotel, NakhonRatchasima, Thailand**

On August 13, 1993, at around 10:00 am, the once splendid six-story Royal Plaza Hotel in NakhonRatchasima, Thailand came crashing down in less than 10 seconds, that's 1.6 seconds per floor! Tragically, 137 people were killed and 227 more were injured in the collapse.

review. Also, a huge amount of water was being stored on the roof of the hotel ahead of an expected water shortage.

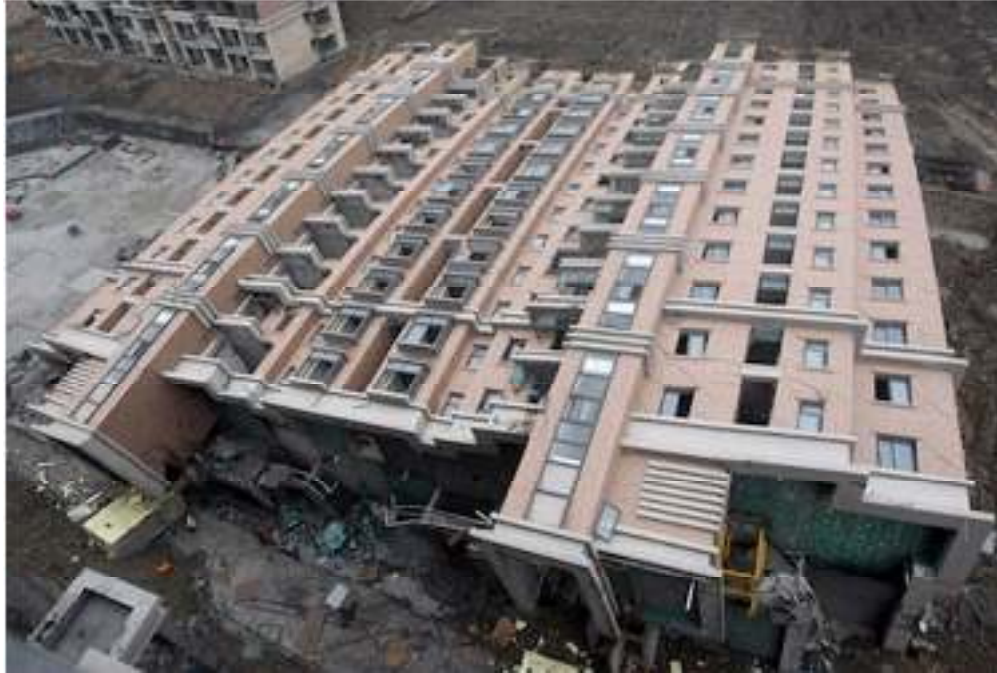
### **Lotus Riverside Compound, Shanghai, China**

On June 27, 2009, Block 7, one of eleven 13-story apartment buildings making up the Lotus Riverside compound in Shanghai, toppled over, completely intact. The high-rise was still under construction, and luckily, most of the workers were able to evacuate the building when they felt it start to fall over. Unfortunately, one man wasted too many precious seconds collecting his tools. He was then forced to jump out of a window as the building began to go down. He fell to his death.

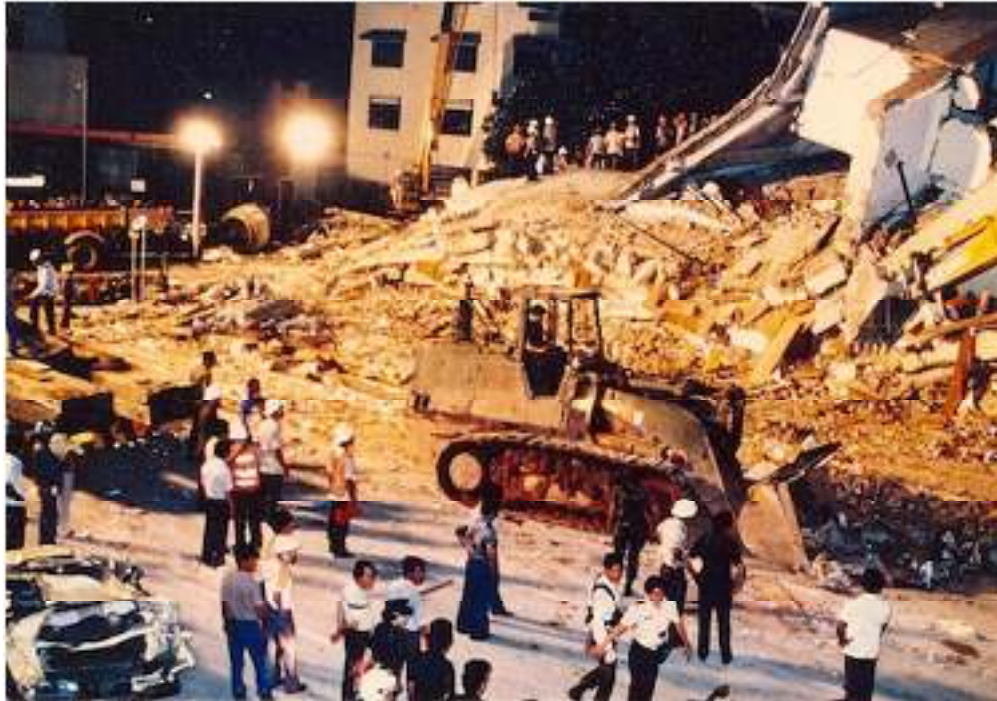
### **Hotel New World, Singapore**

On March 15, 1986, all six stories of Hotel New World collapsed in less than 60 seconds. The building housed a hotel, a bank and a nightclub, all of which disintegrated into piles of rock and twisted metal, burying 50 people inside. It was the worst disaster Singapore had experienced since World War II, and it shocked the nation.

After intensive research, investigators discovered a terrible error in the original design of the building. The structural engineer had completely left out the building's "dead load," in other words, the weight of the building itself, during the design process. As a result, it wasn't strong enough to hold itself up. Tragically, Hotel New World was doomed from the beginning.

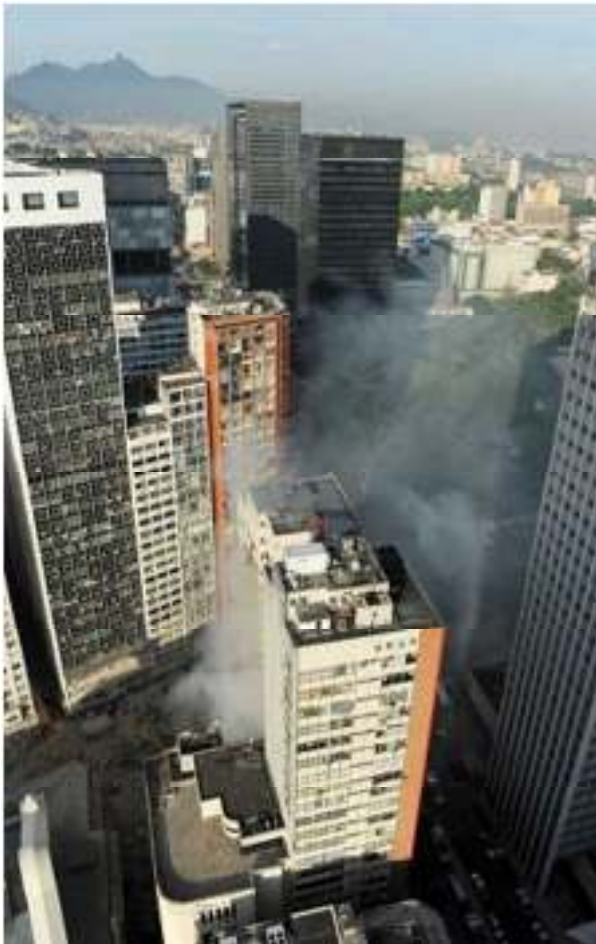
### **Three High-Rise Office Buildings, Rio, Brazil**

On January 26, 2012, a 20-story building in Rio de Janeiro, Brazil spontaneously collapsed. The gigantic high-rise crashed into another ten-story building and a smaller "three or four" story building, reducing all three structures to one huge pile of rubble. The impact sent an enormous wave of dust and detritus through the streets of Cinelandia square, killing at least 17 people.

Authorities suggested that illegal construction work had weakened the 20-story building and caused it to fragment, which triggered a chain reaction and brought down the two smaller buildings. This catastrophe has led Brazilian authorities to call for reforms and stricter building and renovation regulations, especially ahead of the 2014 World Cup.

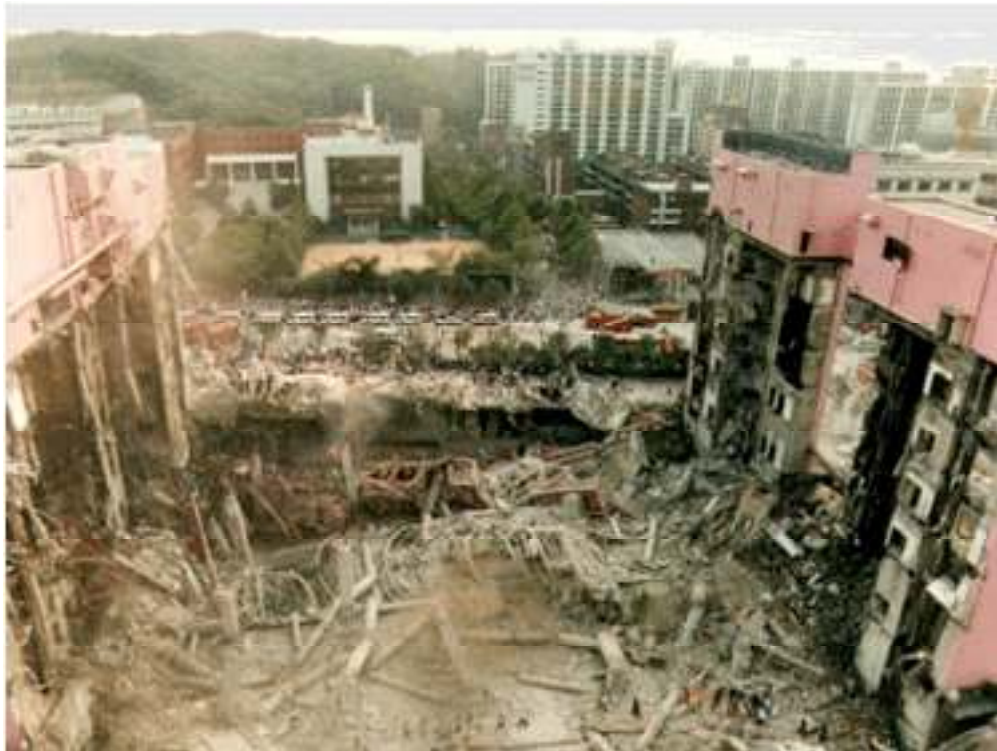
### **Sampoong Department Store, Seoul, South Korea**

On June 29, 1995, in the space of 20 seconds, the Sampoong Department Store in Seoul, South Korea fell to the ground, killing 502 people and injuring 937. Criminal negligence, blatant disregard for ethical engineering practices, and shoddy construction led to the largest peacetime disaster in South Korean history. The problems can be traced almost exclusively to the future chairman of the building, Lee Joon. Under his insistence, the building was changed from being an office building to a department store halfway through its construction.

To install the escalators, several key support columns had to be eliminated. When the contractors refused to continue building after the changes, they were fired, and Joon hired his own company. Later, Joon had a fifth floor added to the building. Despite warnings, Joon once again hired his own company. Not only was the building not meant to support a fifth story, but his extra level was made with a thick, super-heavy, heated floor.

In April 1995, extensive cracks were spotted, yet nothing was done. These fractures grew exponentially on the day of the disaster, but because management didn't want to lose the day's revenue, they refused to evacuate the building. Top executives, however, left as a precaution. Seven minutes before the collapse, the building began to pop and crack, and employees sounded the alarm, but it was too late to avert disaster, and 1,500 people were trapped inside.

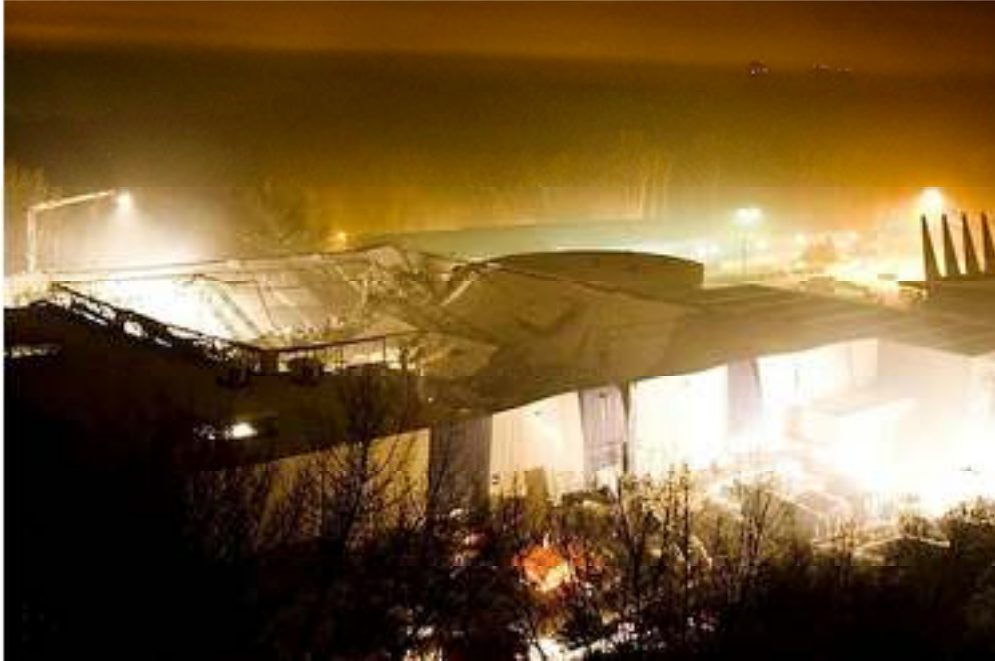
**Bonus entry: Katowice Trade Hall, Silesia, Poland**

On January 28, 2006, in the midst of a frigid Polish winter, the Katowice Trade Hall was hosting the 56th National Exhibition of Carrier Pigeons. What the 700 people attending didn't know was that the managers of the building had not had the snow and ice removed from the roof. Damningly, the roof had buckled under the winter snow four years earlier and been rebuilt without being properly inspected or tested.

On this fateful day, the accumulation of snow overloaded the roof of the building by 100 percent, and the roof smashed down on the exhibition, trapping hundreds of people beneath its weight, and exposing them to dangerous sub-zero temperatures.
